Client:	GE Corporate Environmental Programs	Project:	Site Demolition Activities
Site Name:	Former Pacific Airmotive Facility	Site Location:	3003 N Hollywood Way, Burbank, California

Client:	GE Corporate Environmental Programs	Project:	Demolition Activities
Site Name:	Former Pacific Airmotive Facility	Site Location:	3003 N Hollywood Way, Burbank, California

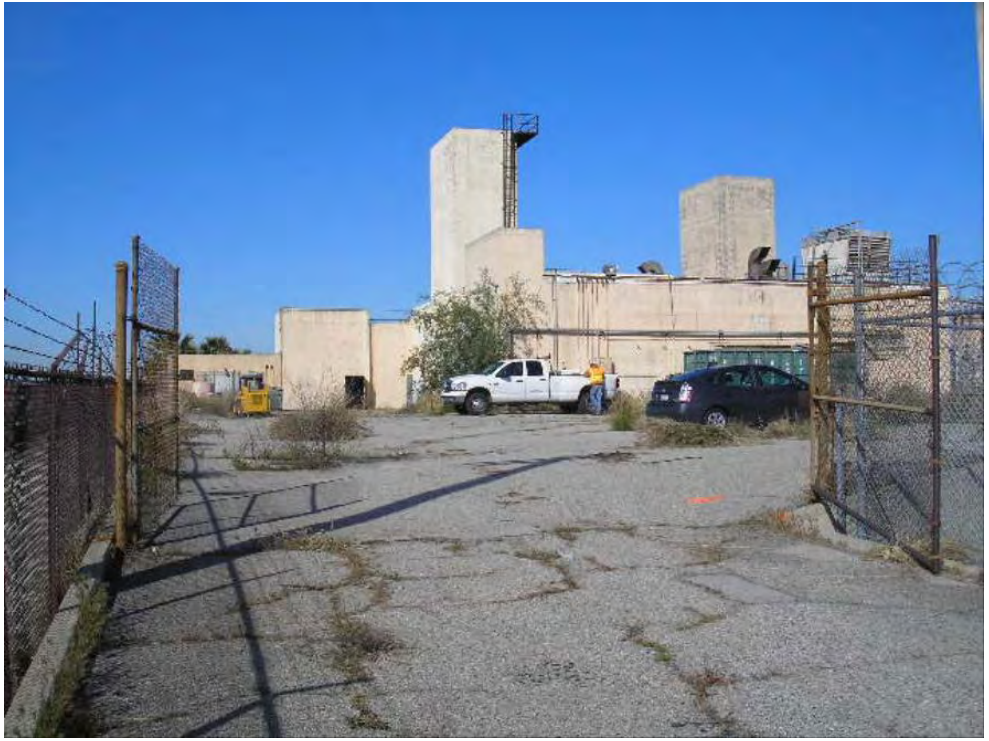
Photograph ID: 1

Photo Location: Site entrance	
Direction: W	
Survey Date: 2/28/2011	
Comments: View of parking areas and Jet Engine Test Cell Building from site gate.

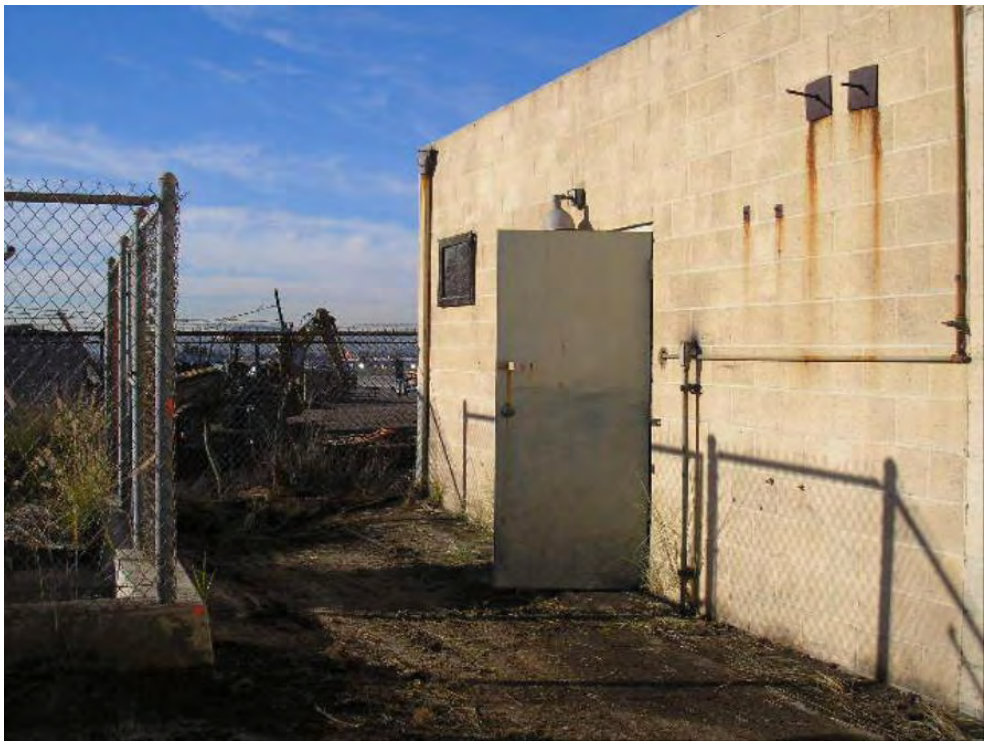
Photograph ID: 2

Photo Location: Maintenance Shop	
Direction: S	
Survey Date: 2/28/2011	
Comments: Exterior view of Maintenance Shop.

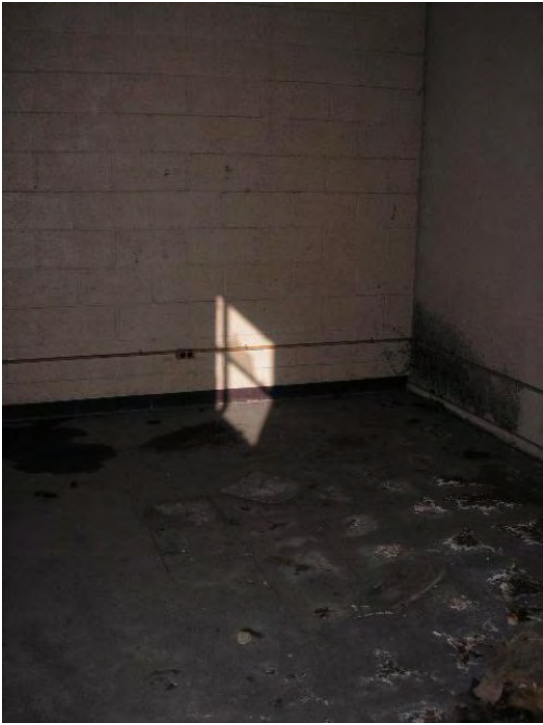
Photograph ID: 4

Photo Location: Maintenance Shop	
Direction: W	
Survey Date: 2/28/2011	
Comments: View of tiles and debris in south room of Maintenance Shop.

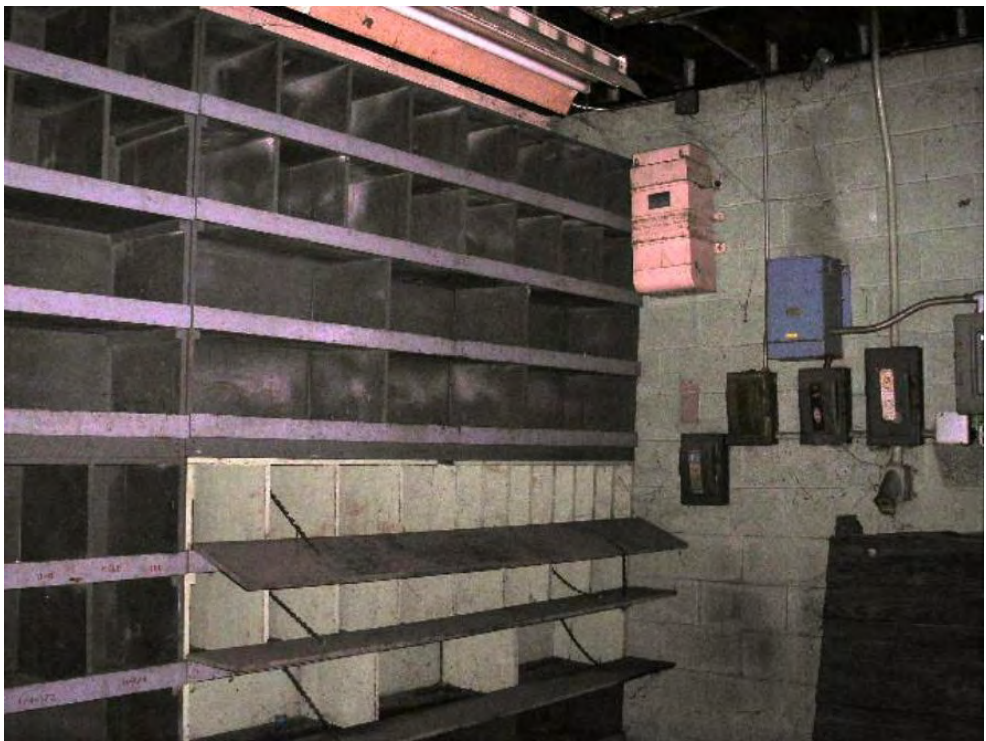
<p>Photograph ID: 5</p> <p>Photo Location: Maintenance Shop</p> <p>Direction: NE</p> <p>Survey Date: 2/28/2011</p> <p>Comments: View of shelving on north wall of Maintenance Shop.</p>

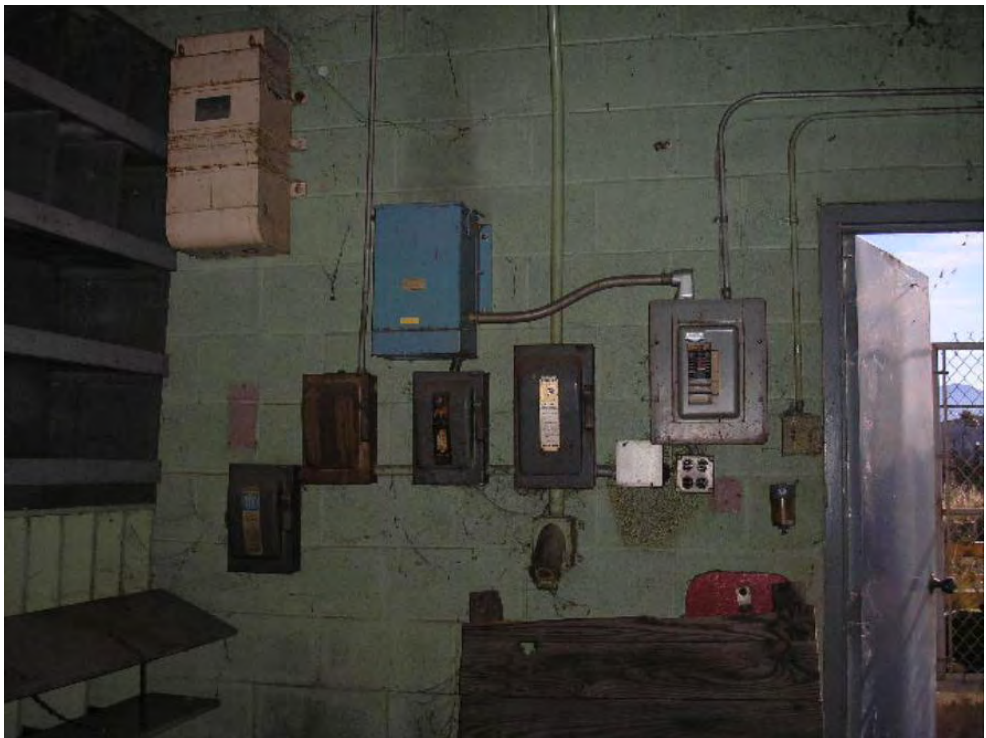
<p>Photograph ID: 6</p> <p>Photo Location: Maintenance Shop</p> <p>Direction: E</p> <p>Survey Date: 2/28/2011</p> <p>Comments: View of electrical shutoffs located along east wall.</p>

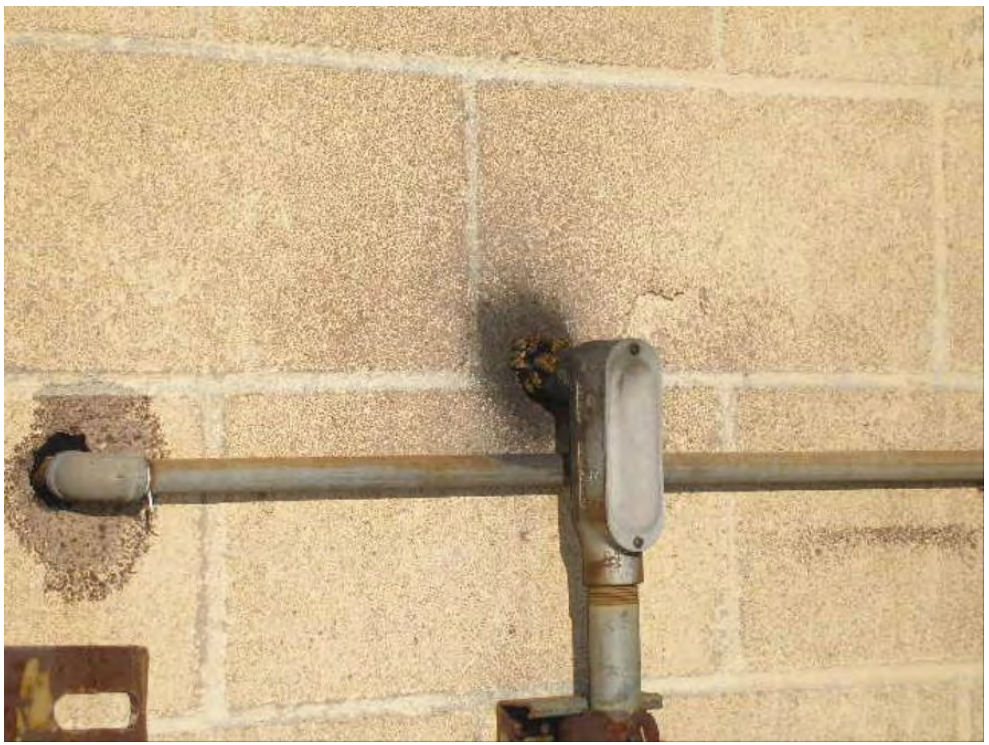
Photograph ID: 11

Photo Location: Maintenance Shop	
Direction: NW	
Survey Date: 2/28/2011	
Comments: Close-up view of bees' nest in electrical

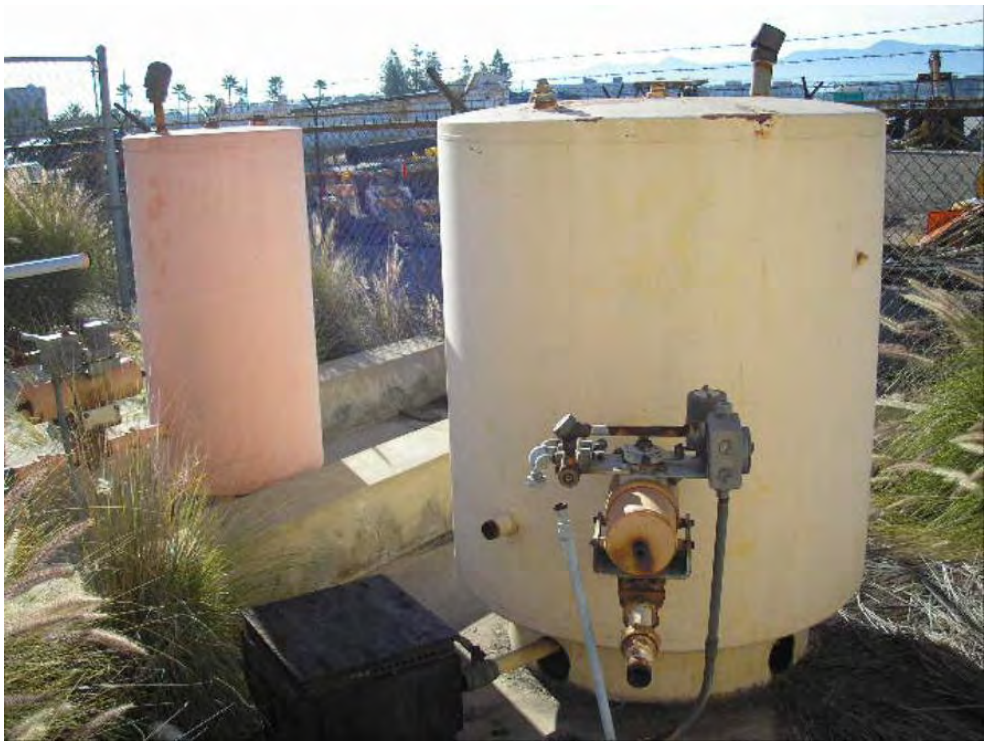
Photograph ID: 16

Photo Location: Compound	
Direction: SE	
Survey Date: 2/28/2011	
Comments: View of abandoned tanks within compound. Tanks observed to be separated by 1-inch high berms within compound. Pipes connected to tanks observed to be disconnected or capped.

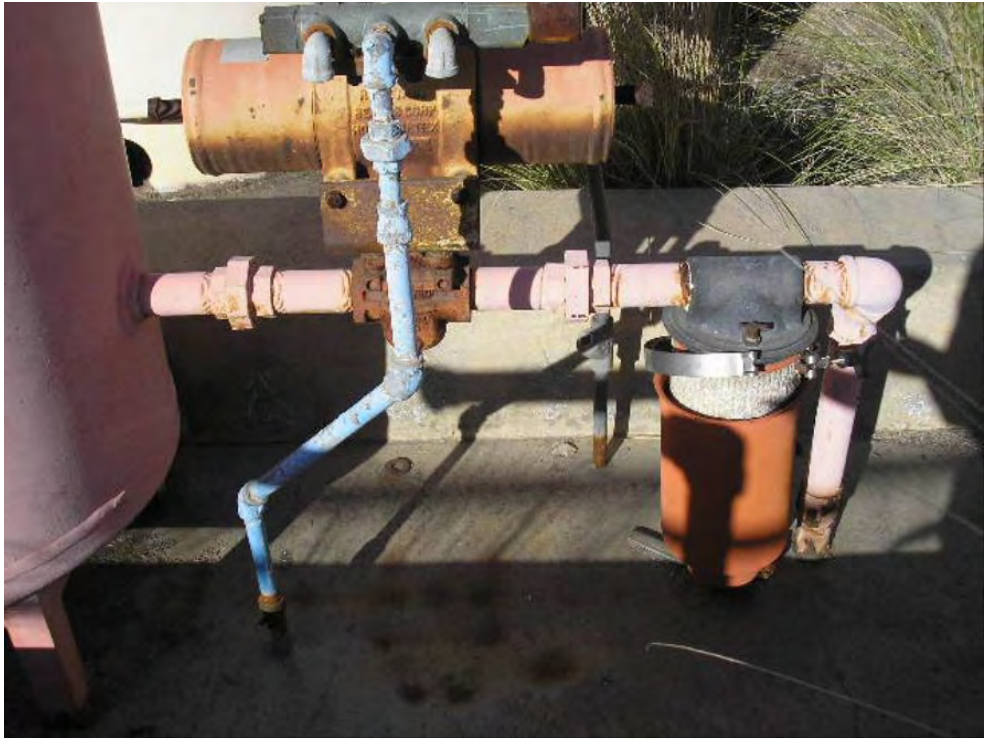
Photograph ID: 17

Photo Location: Compound	
Direction: Down	
Survey Date: 2/28/2011	
Comments: Filter observed connected to pink tank in compound.

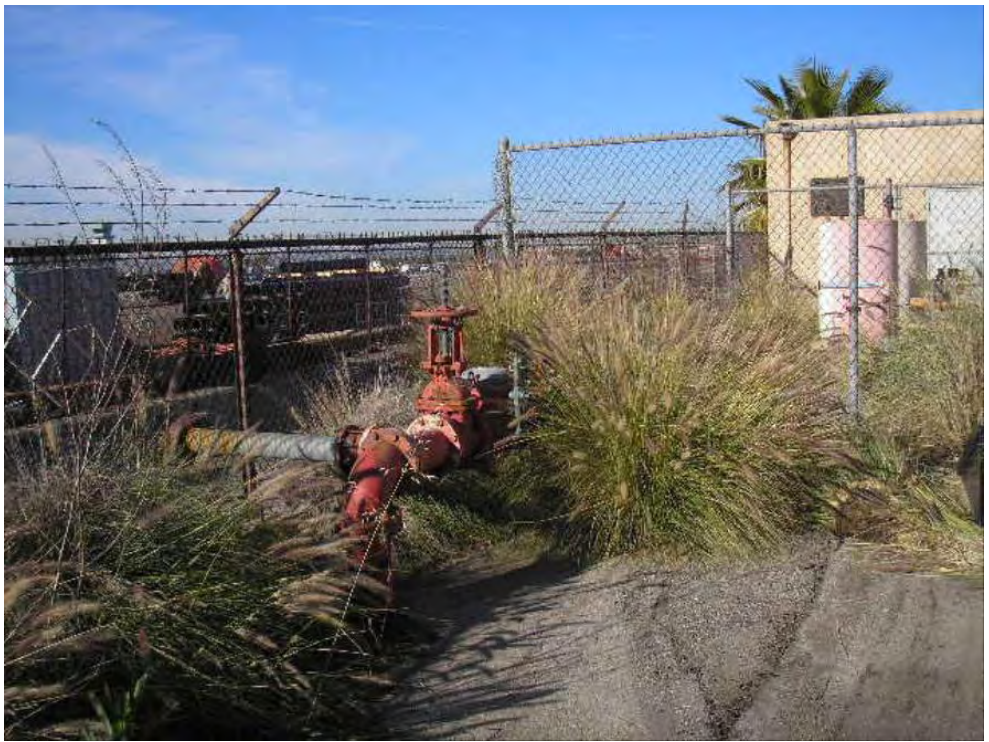
Photograph ID: 18

Photo Location: Near compound	
Direction: W	
Survey Date: 2/28/2011	
Comments: View of water control valve adjacent to compound.

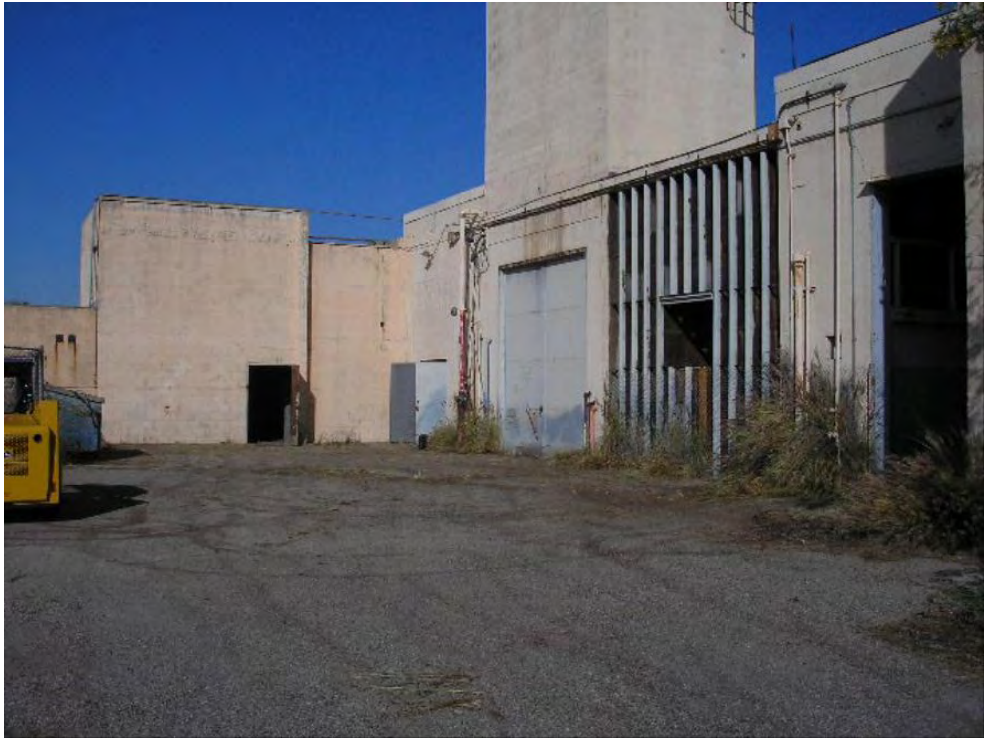
<p>Photograph ID: 19</p> <p>Photo Location: Outside of Jet Engine Test Cells</p> <p>Direction: NW</p> <p>Survey Date: 2/28/2011</p> <p>Comments: Exterior view of Test Cells No. 1, No. 2, No. 3, No. 4 and Control Rooms.</p>

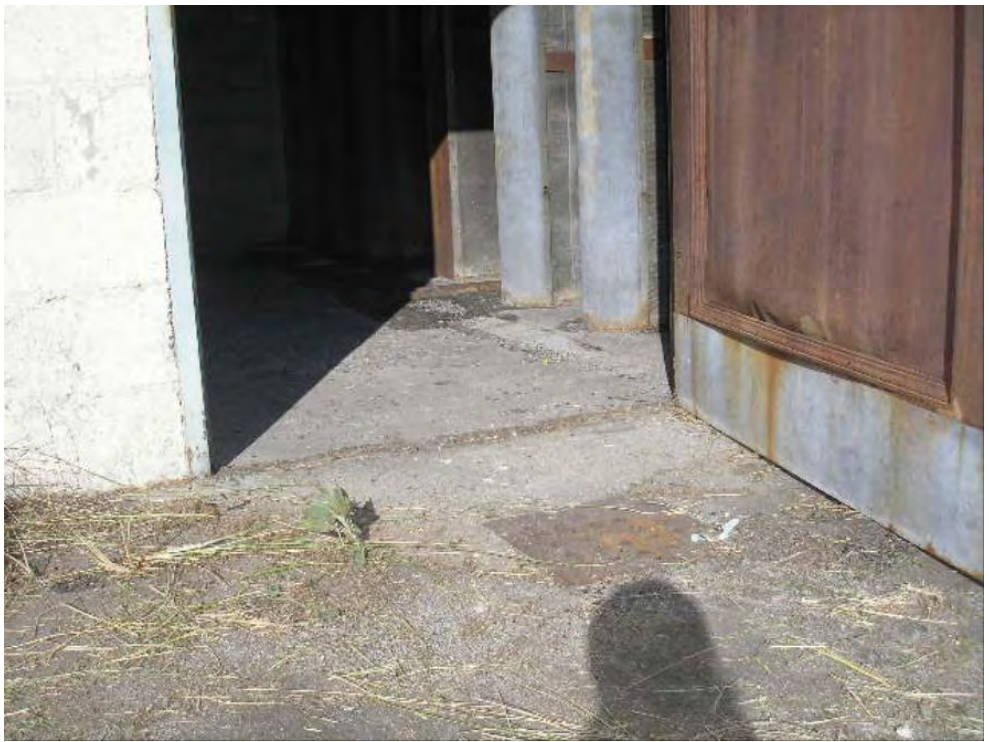
<p>Photograph ID: 20</p> <p>Photo Location: Outside of Test Cell No. 1</p> <p>Direction: Down</p> <p>Survey Date: 2/28/2011</p> <p>Comments: View of drain near doorway of Test Cell No. 1.</p>

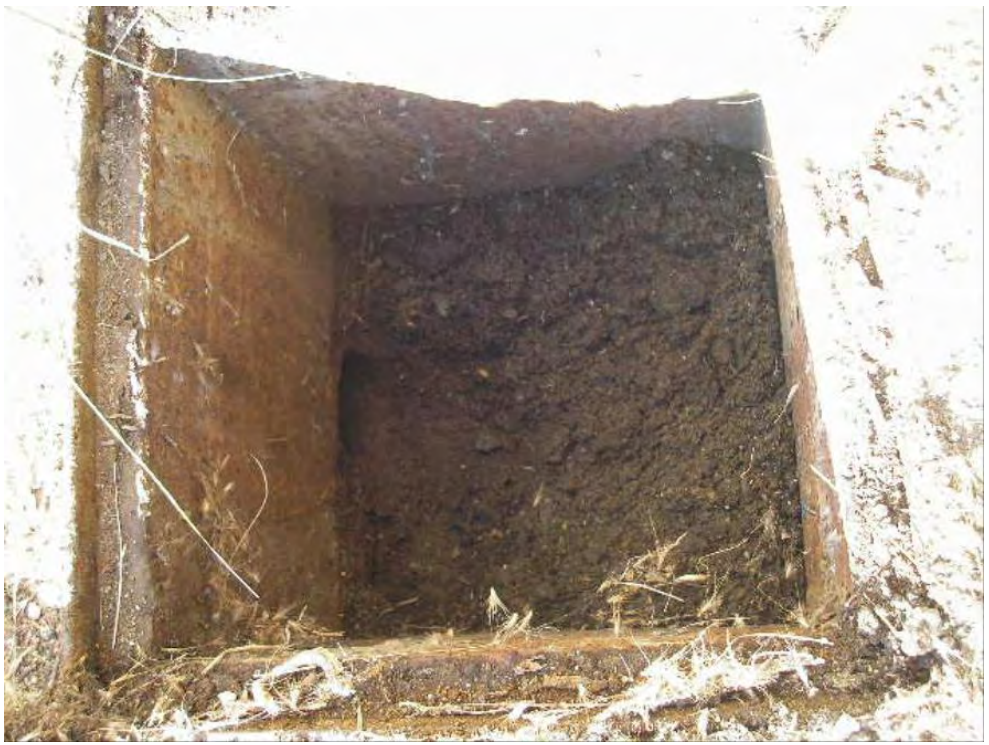
Photograph ID: 21

Photo Location: Outside of Test Cell No. 1	
Direction:	
Survey Date: 2/28/2011	
Comments: View of inside of drain near doorway of Test Cell No. 1.

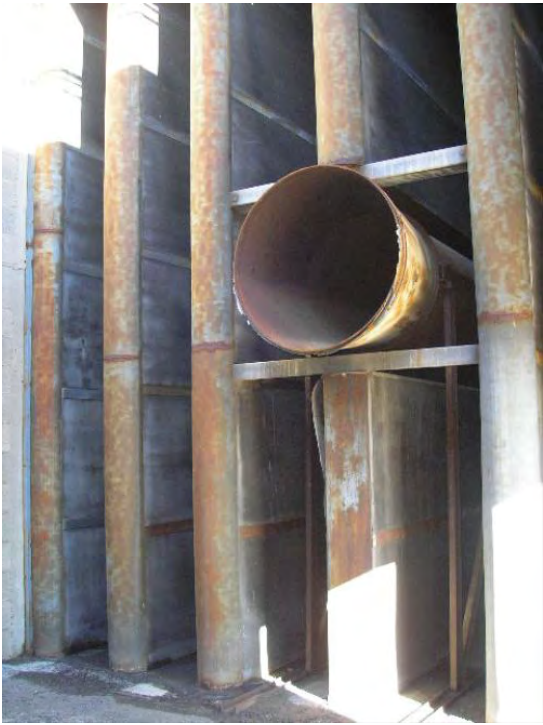
Photograph ID: 23

Photo Location: Test Cell No. 1 (south half)	
Direction: NW	
Survey Date: 2/28/2011	
Comments: View of air dispersers and gasket in Test Cell No. 1.

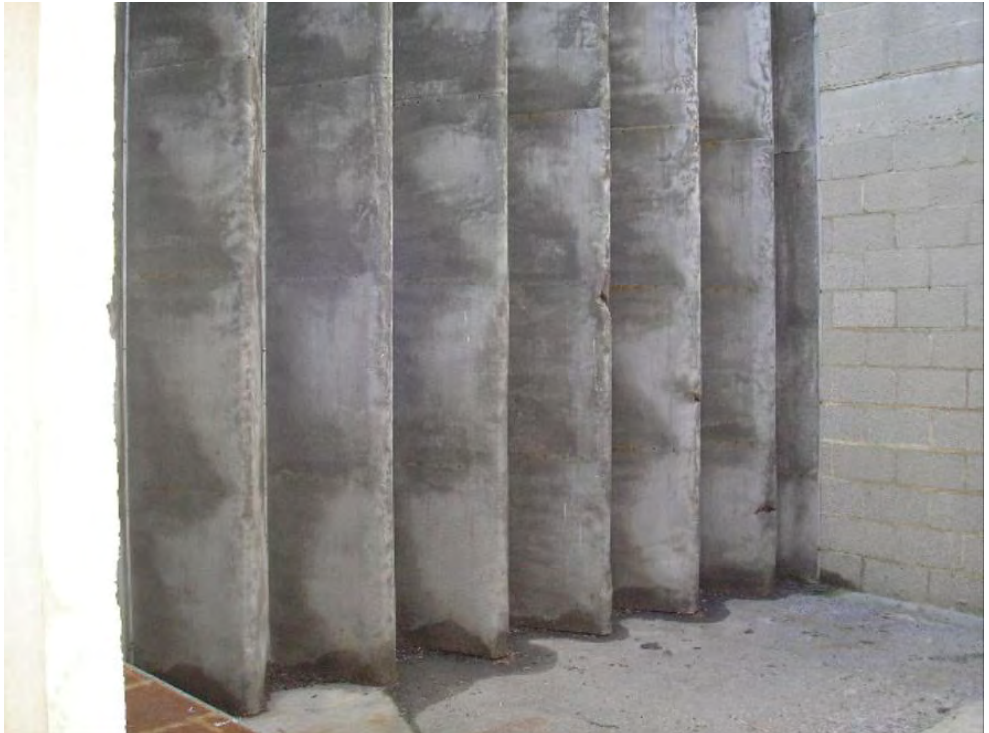
Photograph ID: 24

Photo Location: Test Cell No. 1 (south half)	
Direction: NE	
Survey Date: 2/28/2011	
Comments: View of air dispersers along south wall of Test Cell No. 1. Oil staining observed on dispersers and also near ground.

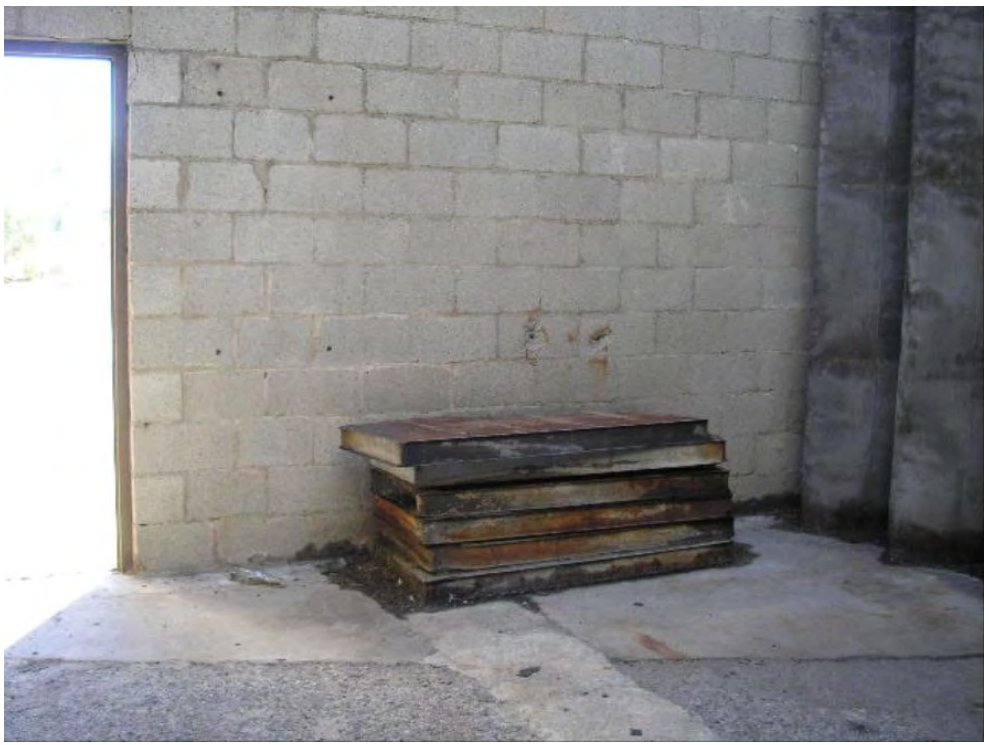
Photograph ID: 25

Photo Location: Test Cell No. 1 (south half)	
Direction: E	
Survey Date: 2/28/2011	
Comments: Storage of equipment along east side of Test Cell No. 1.

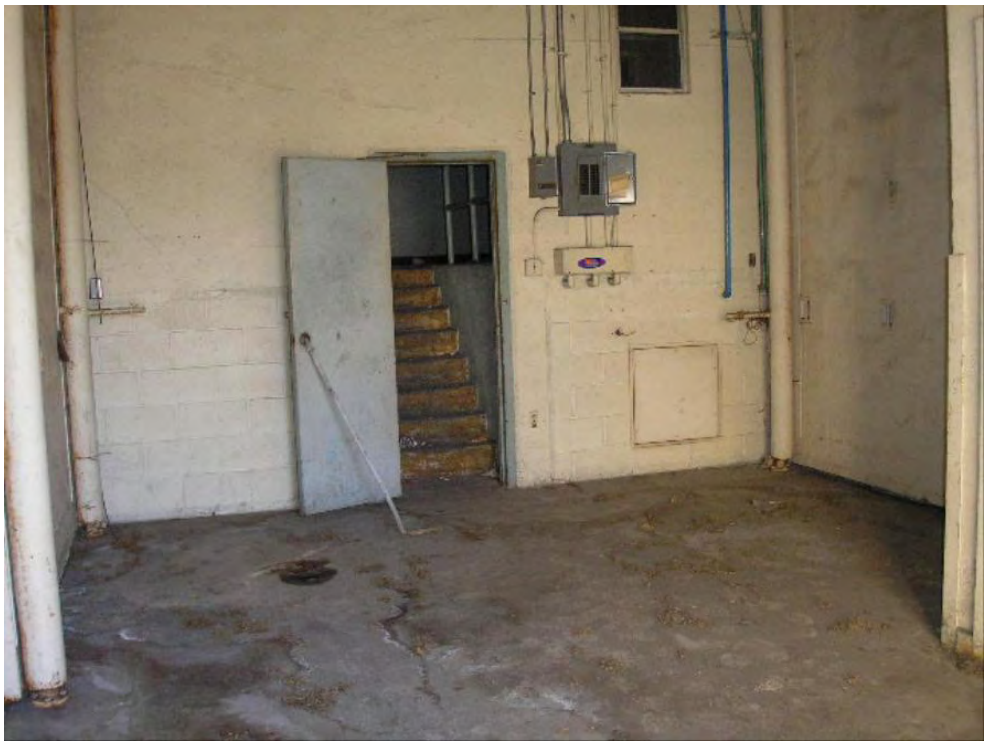
Photograph ID: 26

Photo Location: Control Room between Test Cells No. 1 and No. 2 (south half)	
Direction: N	
Survey Date: 2/28/2011	
Comments: View of north wall. Floor in room is painted concrete and water stains were observed.

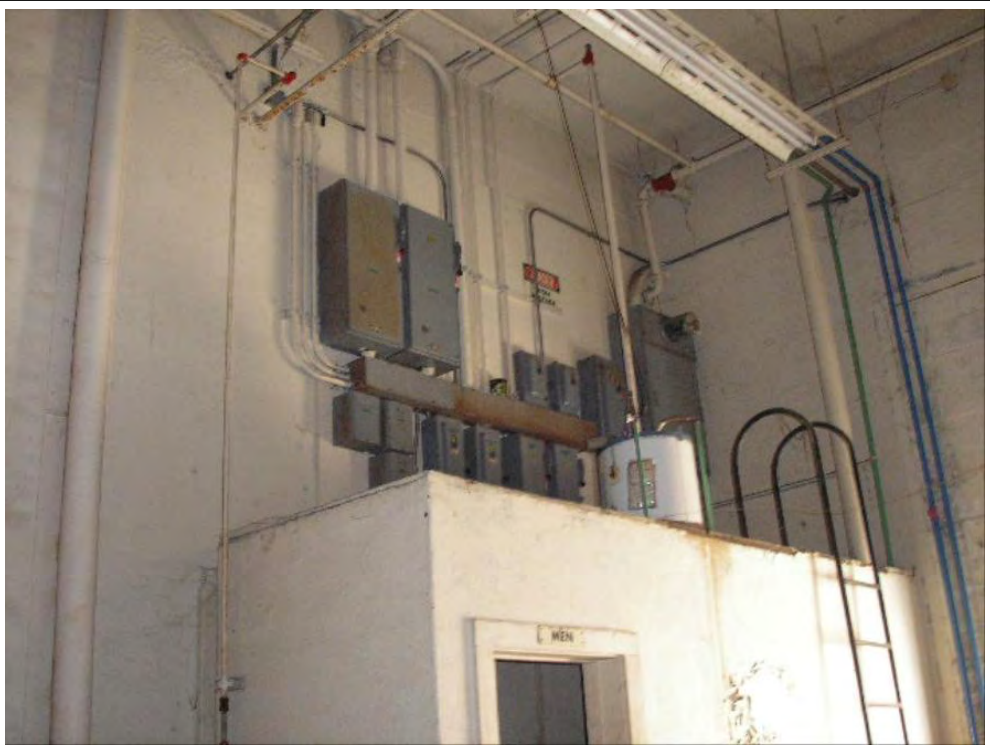
Photograph ID: 28

Photo Location: Control Room between Test Cells No. 1 and No. 2 (south half)	
Direction: Up	
Survey Date: 2/28/2011	
Comments: View of electrical equipment and water heater above men's restroom.

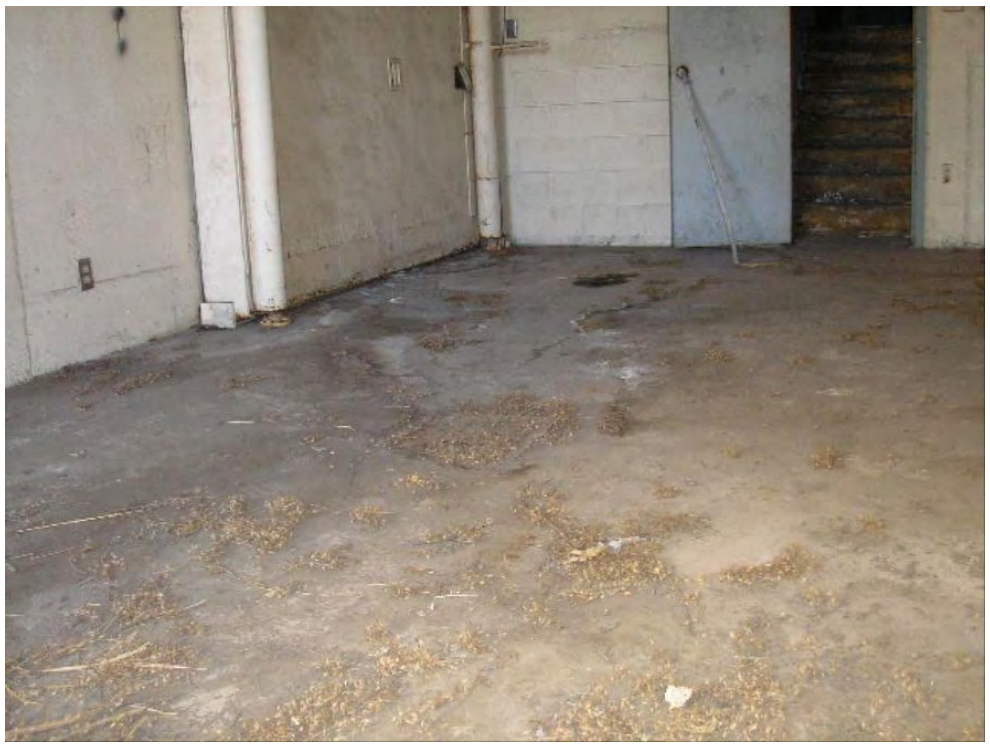
Photograph ID: 31

Photo Location: Control Room between Test Cells No. 1 and No. 2 (south half)	
Direction: Down	
Survey Date: 2/28/2011	
Comments: View of floor drain.

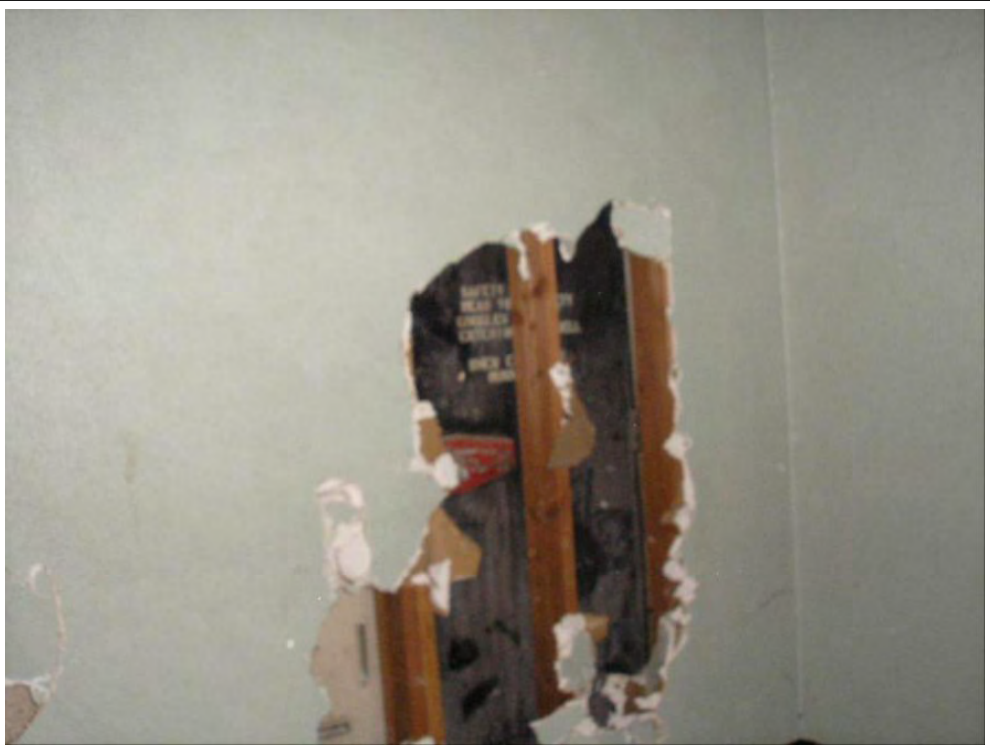
Photograph ID: 32

Photo Location: Control Room between Test Cells No. 1 and No. 2 (north half)	
Direction: NW	
Survey Date: 2/28/2011	
Comments: View of door sealed behind broken wall. Site contact did not know former use of this door.

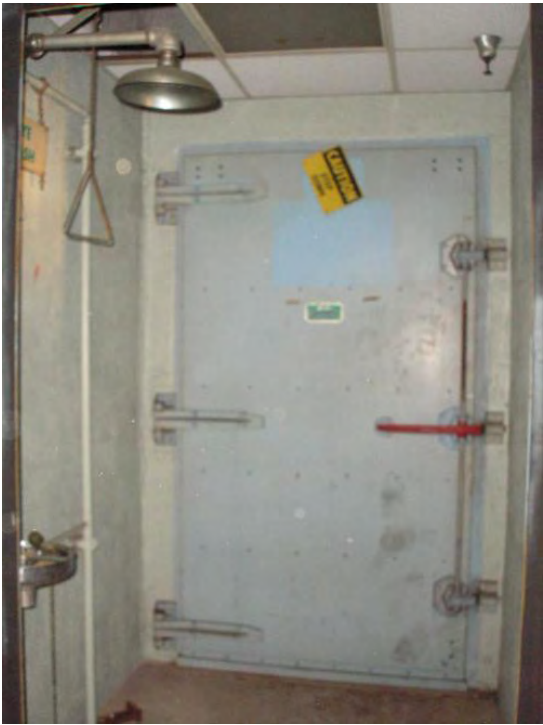
Photograph ID: 34

Photo Location: Control Room between Test Cells No. 1 and No. 2 (north half)	
Direction: E	
Survey Date: 2/28/2011	
Comments: View of emergency shower room. Door in back was stuck at the time of the site visit and could not be opened. Floor drain was observed below emergency shower.

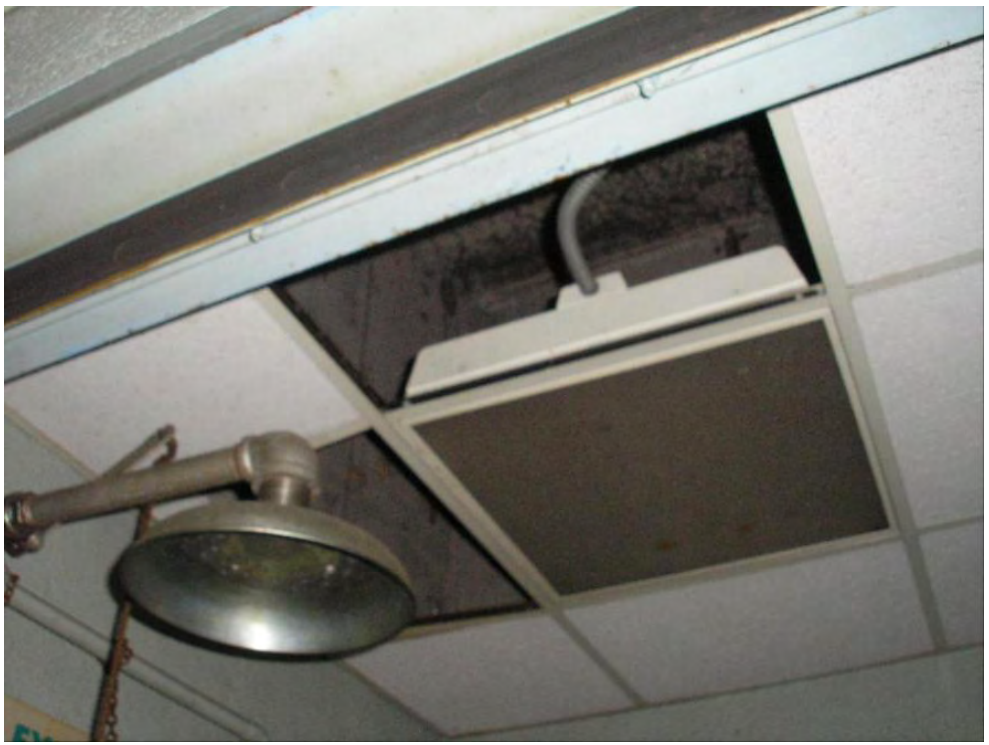
Photograph ID: 35

Photo Location: Control Room between Test Cells No. 1 and No. 2 (north half)	
Direction: Up	
Survey Date: 2/28/2011	
Comments: View of missing drop-in ceiling tiles.

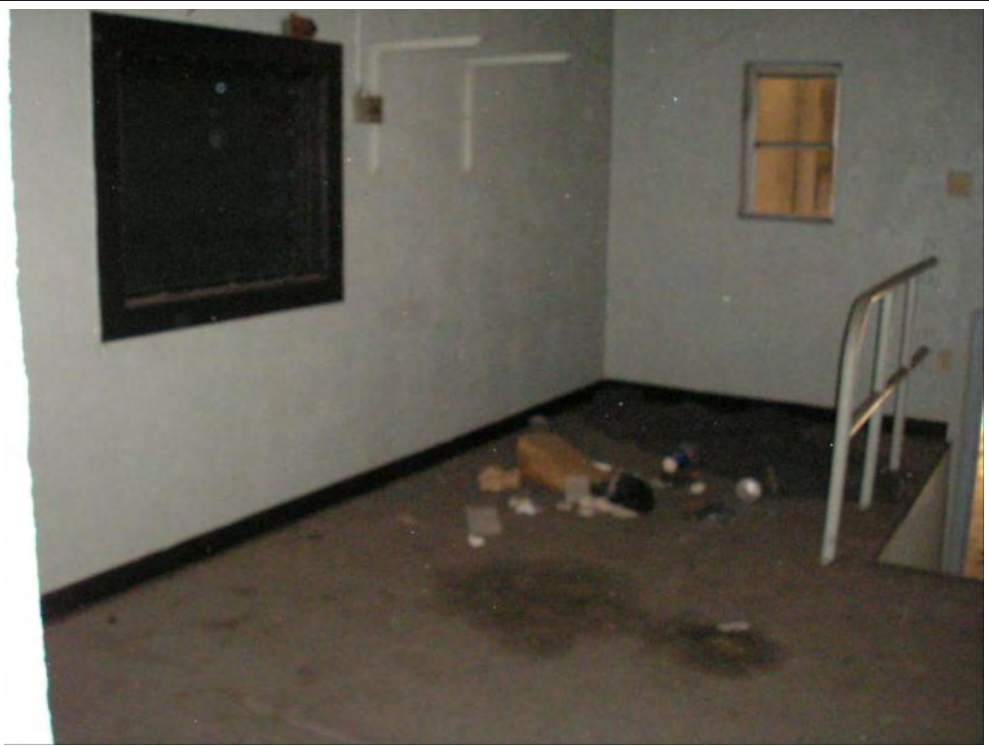
Photograph ID: 36

Photo Location: Control Room between Test Cells No. 1 and No. 2 (north half)	
Direction: SE	
Survey Date: 2/28/2011	
Comments: View of trash on south side of room. Tiles observed in floor.

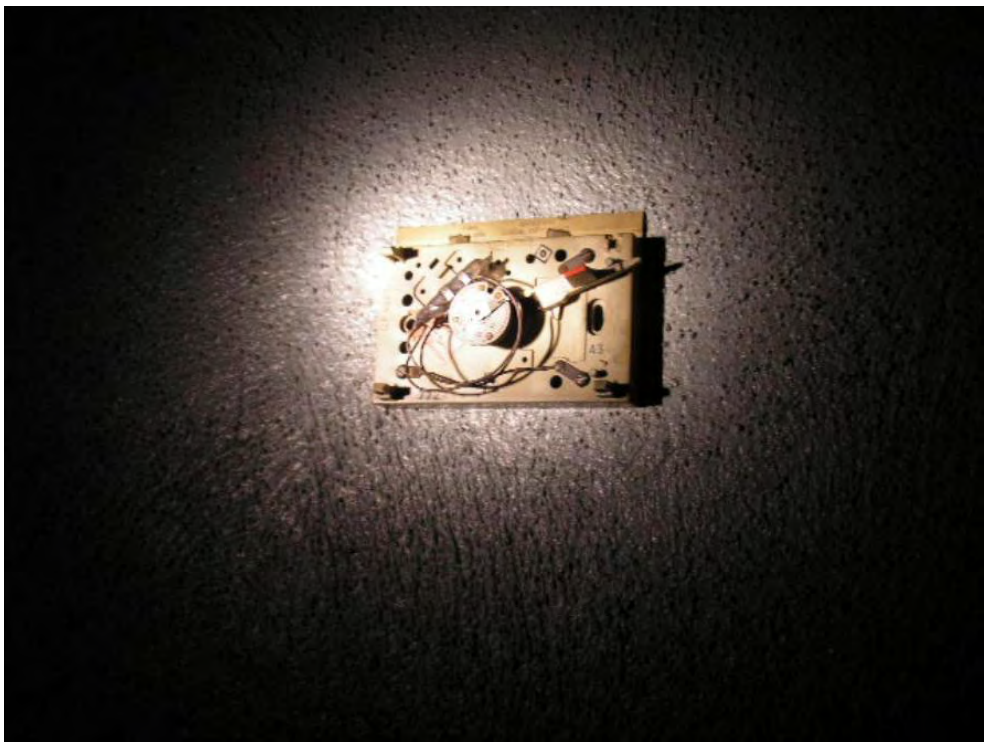
<p>Photograph ID: 37</p> <p>Photo Location: Control Room between Test Cells No. 1 and No. 2 (north half)</p> <p>Direction: W</p> <p>Survey Date: 2/28/2011</p> <p>Comments: View of mercury thermostat along west wall.</p>

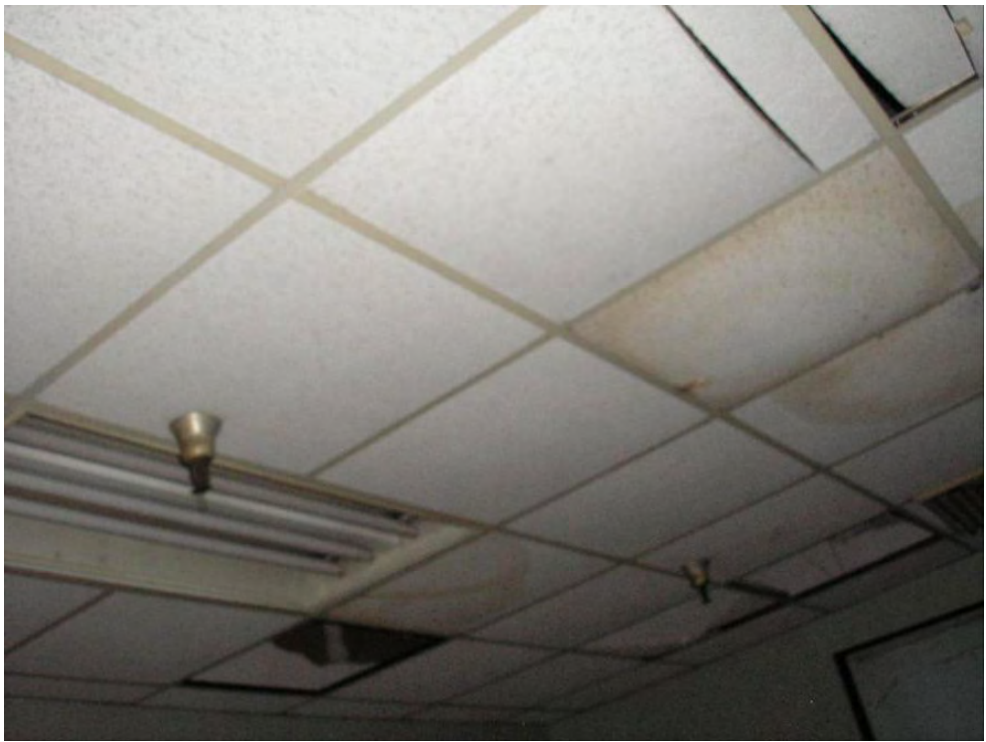
<p>Photograph ID: 38</p> <p>Photo Location: Control Room between Test Cells No. 1 and No. 2 (north half)</p> <p>Direction: Up</p> <p>Survey Date: 2/28/2011</p> <p>Comments: View of missing drop-in and stained ceiling tiles.</p>

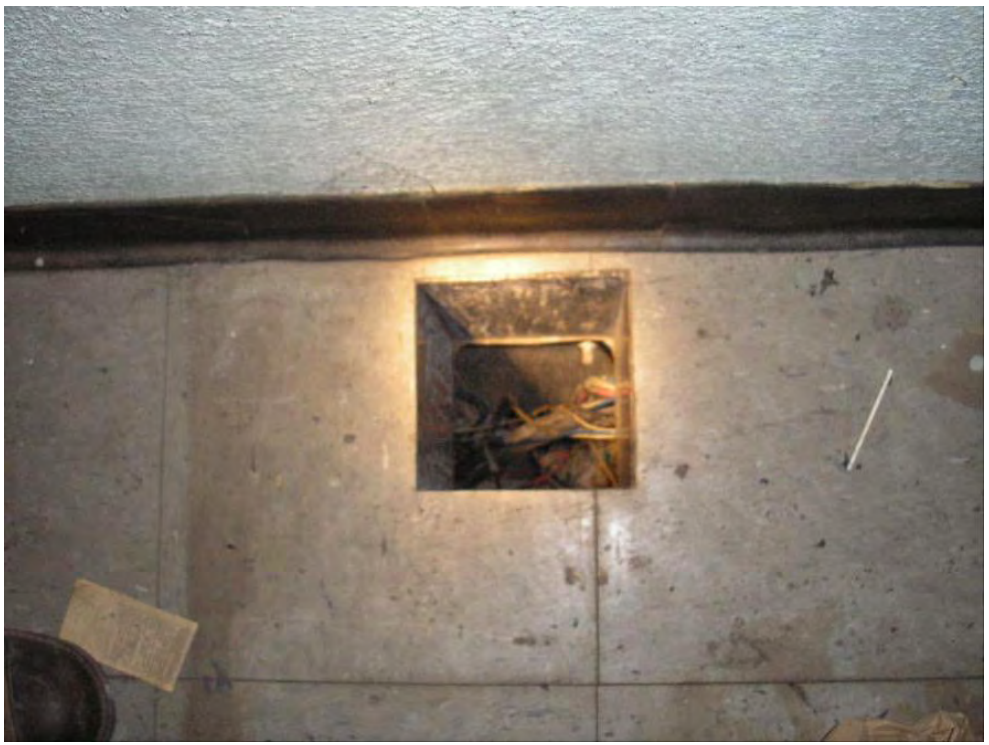
Photograph ID: 39

Photo Location: Control Room between Test Cells No. 1 and No. 2 (north half)	
Direction: Down	
Survey Date: 2/28/2011	
Comments: View of floor opening used for wiring.

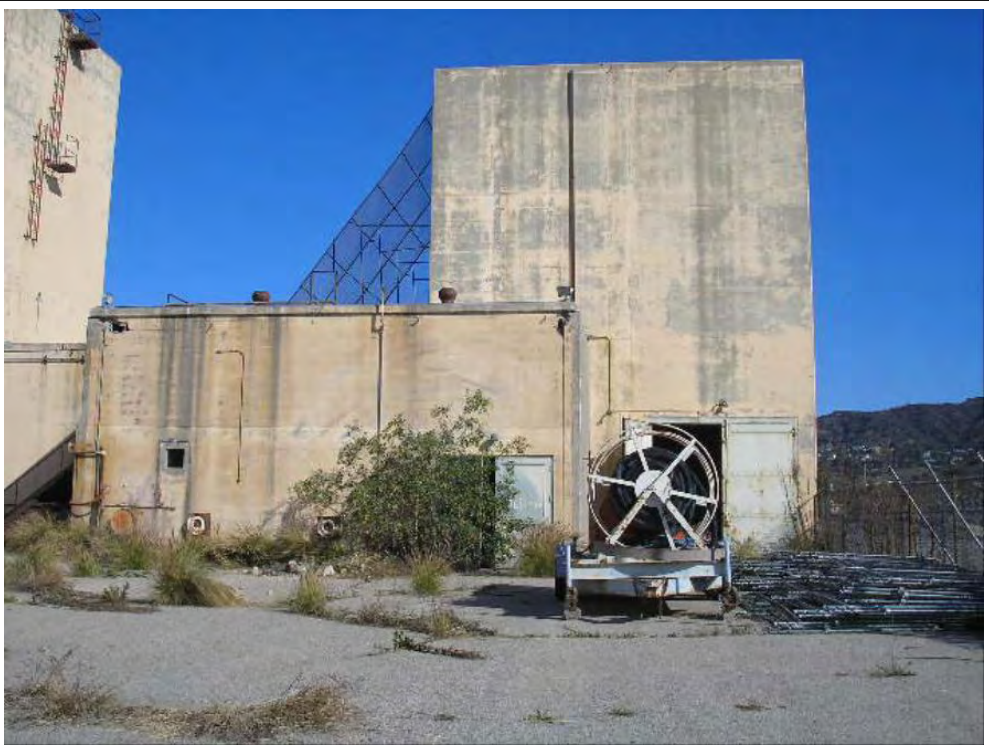
Photograph ID: 40

Photo Location: Outside of Engine Test Cell and Control Room	
Direction: N	
Survey Date: 2/28/2011	
Comments: Exterior view of Engine Test Cell and Control Room on northeast corner of the Site.

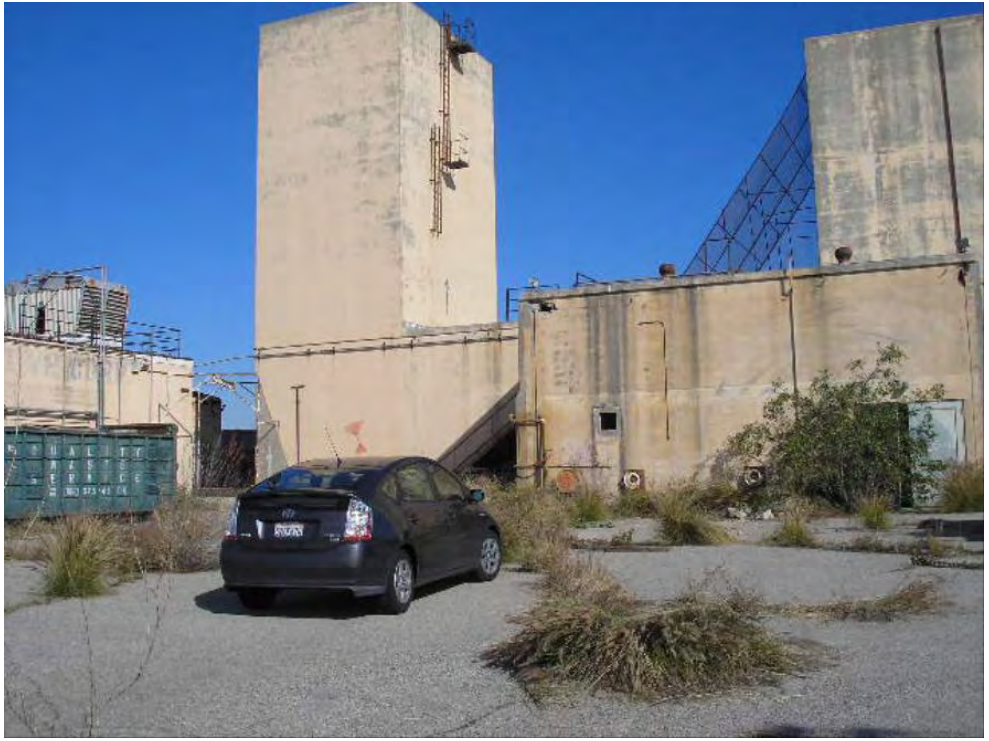
<p>Photograph ID: 41</p> <p>Photo Location: Outside of Engine Test Cell and Control Room</p> <p>Direction: N</p> <p>Survey Date: 2/28/2011</p> <p>Comments: Exterior view of Engine Test Cell and Control Room on northeast corner of the Site.</p>

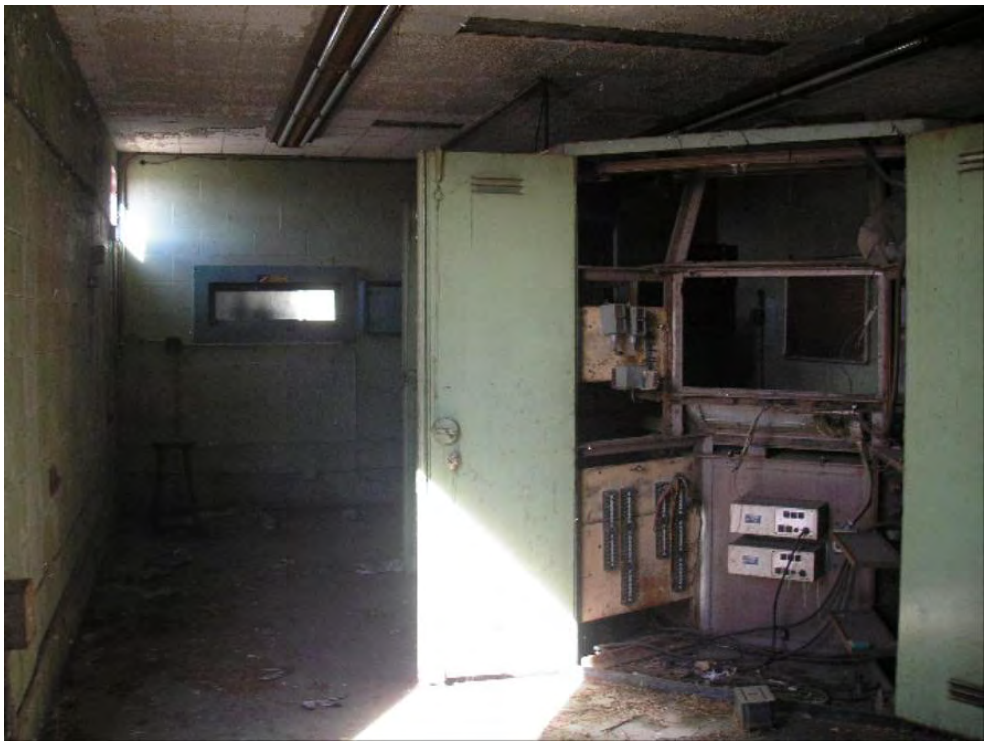
<p>Photograph ID: 42</p> <p>Photo Location: Control Room for Engine Test Cell</p> <p>Direction: W</p> <p>Survey Date: 2/28/2011</p> <p>Comments: View of remaining structures and wiring inside Control Room.</p>

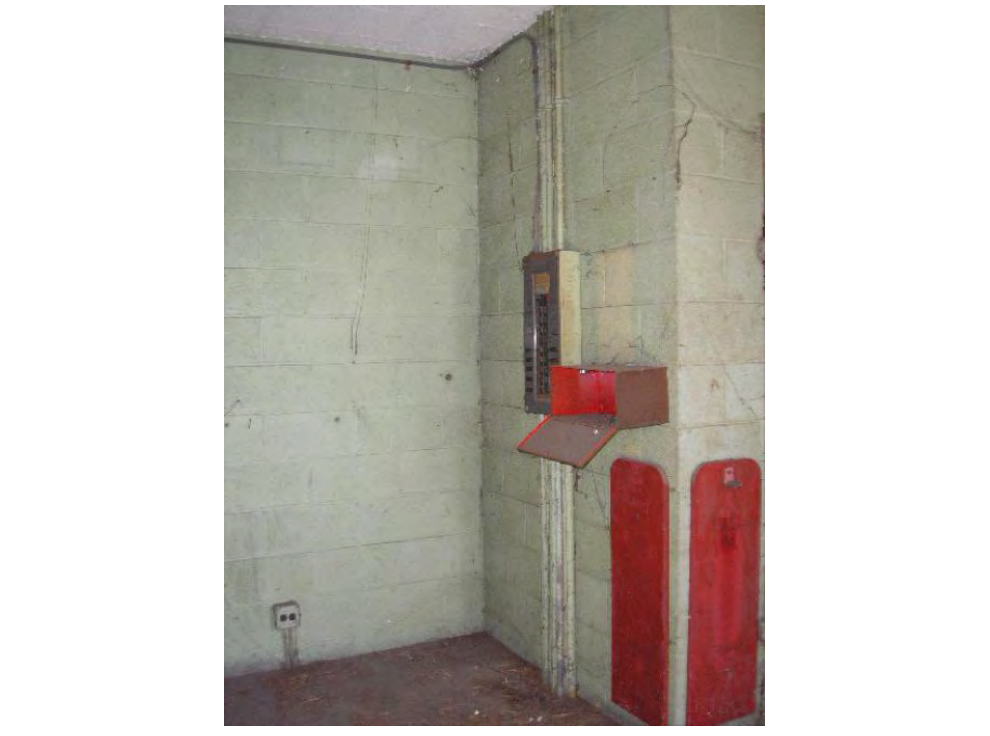
Photograph ID: 44

Photo Location: Control Room for Engine Test Cell	
Direction: NE	
Survey Date: 2/28/2011	
Comments: Electrical panel and conduit in northeast corner of room.

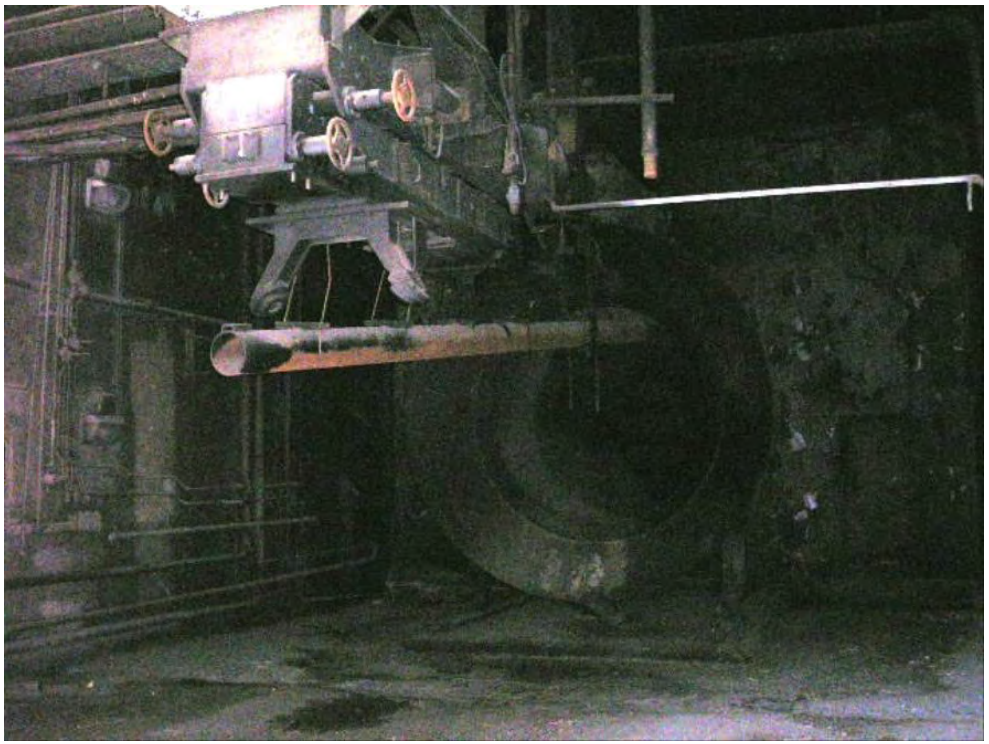
Photograph ID: 50

Photo Location: Engine Test Cell	
Direction: SW	
Survey Date: 2/28/2011	
Comments: Interior view of test cell. Oil staining was observed along back wall and on floors of test cell.
