Client:	GE Corporate Environmental Programs	Project:	Site Demolition Activities
Site Name:	Former Pacific Airmotive Facility	Site Location:	3003 N Hollywood Way, Burbank, California

Client:	GE Corporate Environmental Programs	Project:	Demolition Activities
Site Name:	Former Pacific Airmotive Facility	Site Location:	3003 N Hollywood Way, Burbank, California

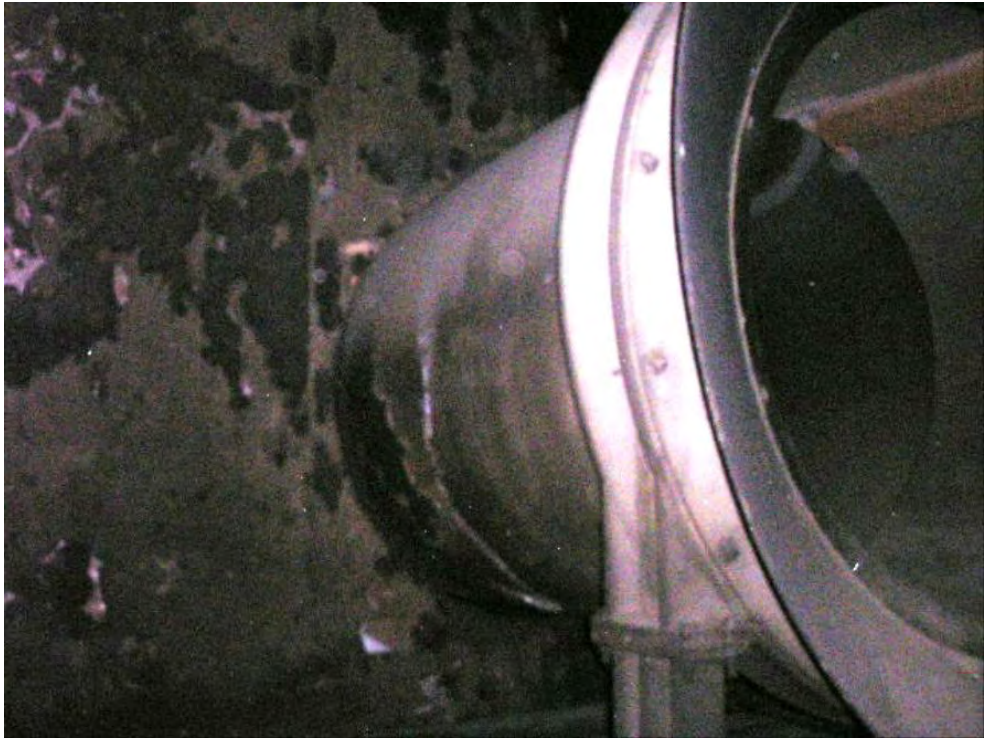
Photograph ID: 51

Photo Location: Engine Test Cell	
Direction: NW	
Survey Date: 2/28/2011	
Comments: Close-up view of chipped paint and staining on walls and equipment in Engine Test Cell.

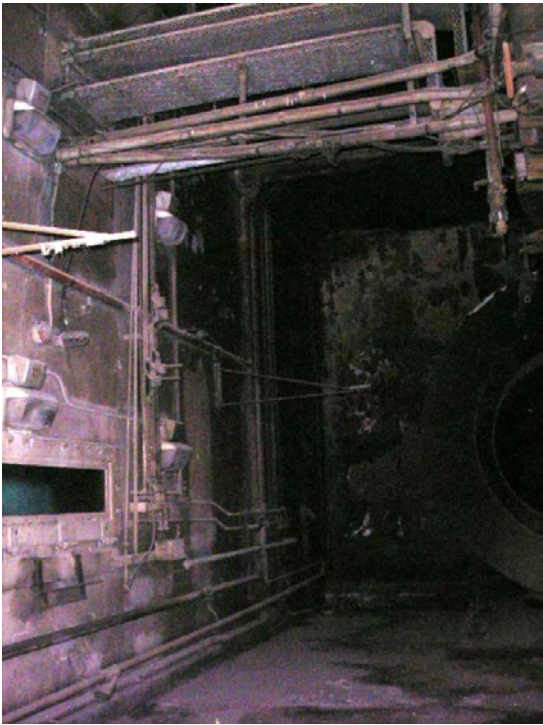
Photograph ID: 52

Photo Location: Engine Test Cell	
Direction: SW	
Survey Date: 2/28/2011	
Comments: View of electrical conduit and piping within test cell.

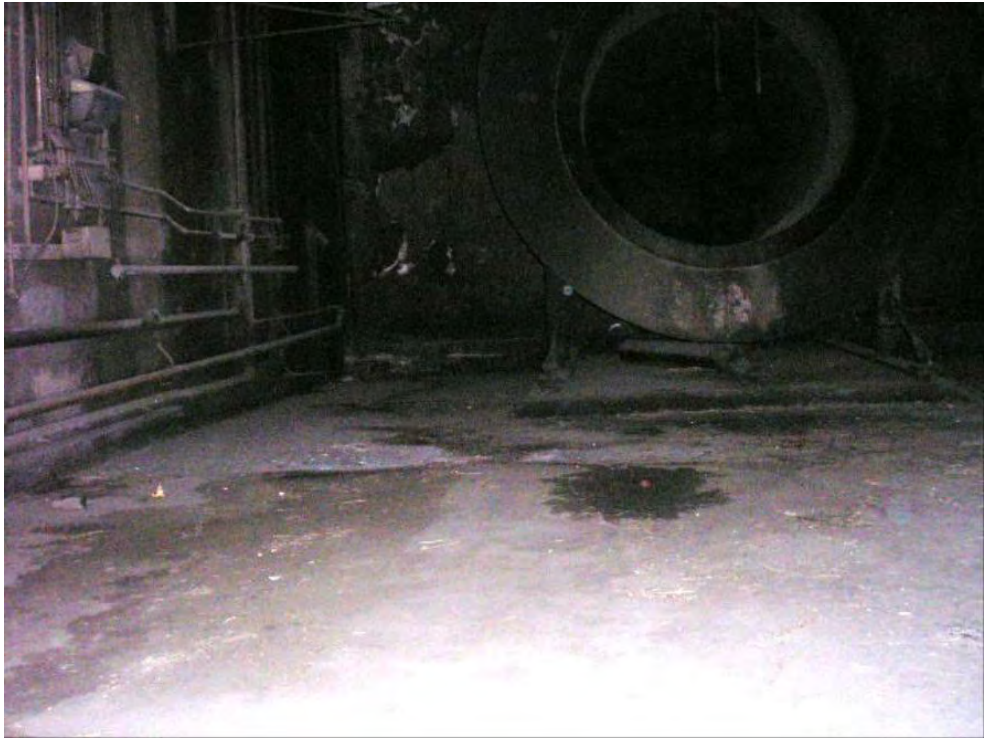
<p>Photograph ID: 53</p> <p>Photo Location: Engine Test Cell</p> <p>Direction: Down</p> <p>Survey Date: 2/28/2011</p> <p>Comments: View of oil stains on floor of test cell.</p>

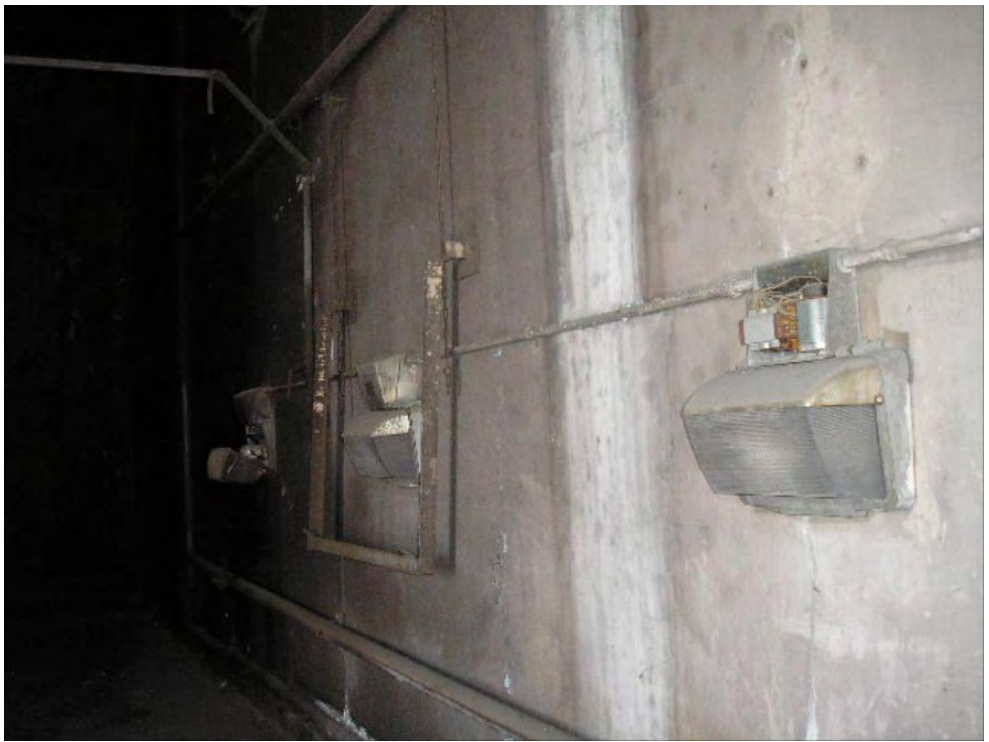
<p>Photograph ID: 54</p> <p>Photo Location: Engine Test Cell</p> <p>Direction: W</p> <p>Survey Date: 2/28/2011</p> <p>Comments: View of lights along north wall.</p>

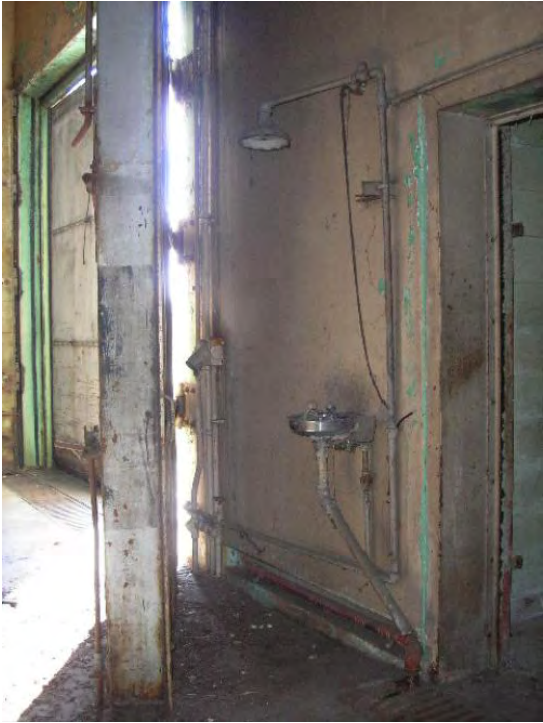
Photograph ID: 56

Photo Location: Engine Test Cell	
Direction: SE	
Survey Date: 2/28/2011	
Comments: View of eyewash station by entrance.

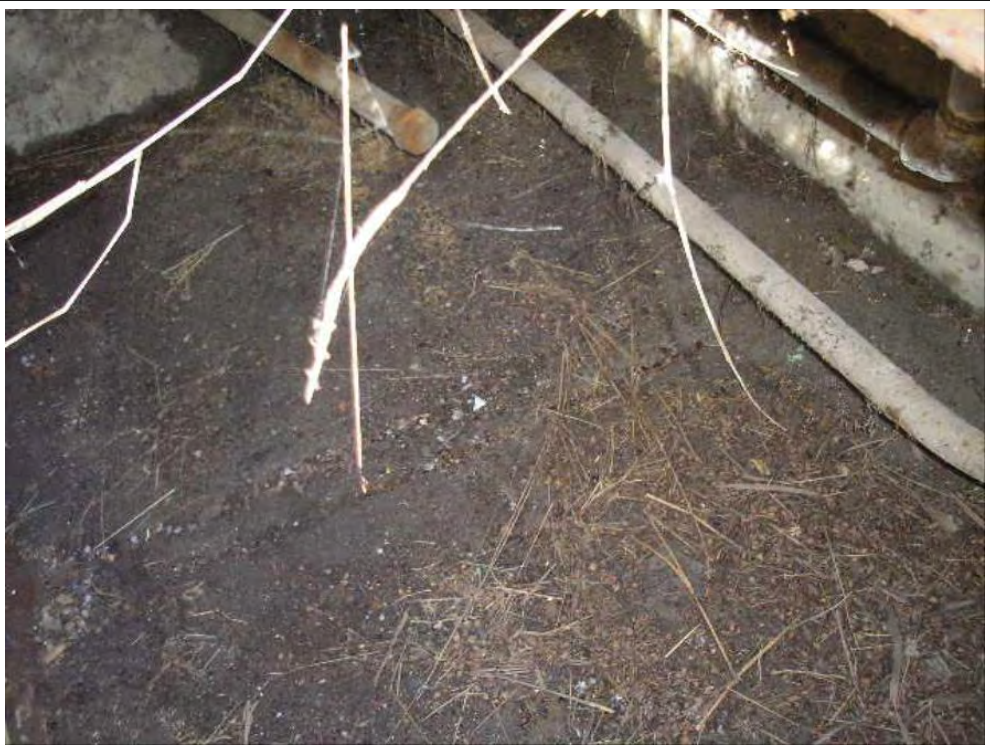
Photograph ID: 58

Photo Location: Outside of Engine Test Cell	
Direction: Down	
Survey Date: 2/28/2011	
Comments: Interior view of electrical vault with capped conduits.

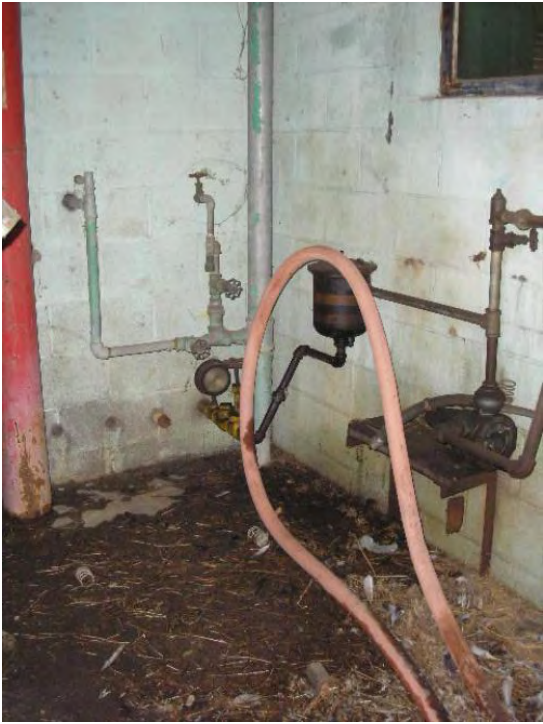
Photograph ID: 63

Photo Location: Behind Control Room for Engine Test Cell	
Direction: NE	
Survey Date: 2/28/2011	
Comments: View of room containing fire suppression equipment.

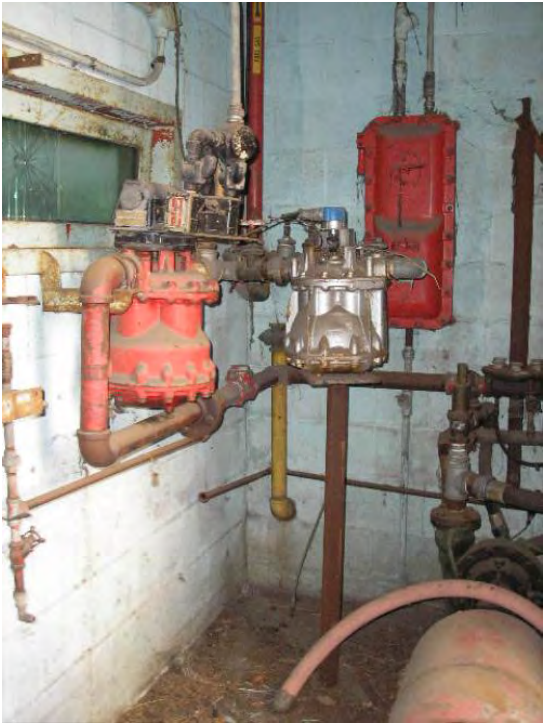
Photograph ID: 64

Photo Location: Behind Control Room for Engine Test Cell	
Direction: S	
Survey Date: 2/28/2011	
Comments: View of room containing fire suppression equipment.

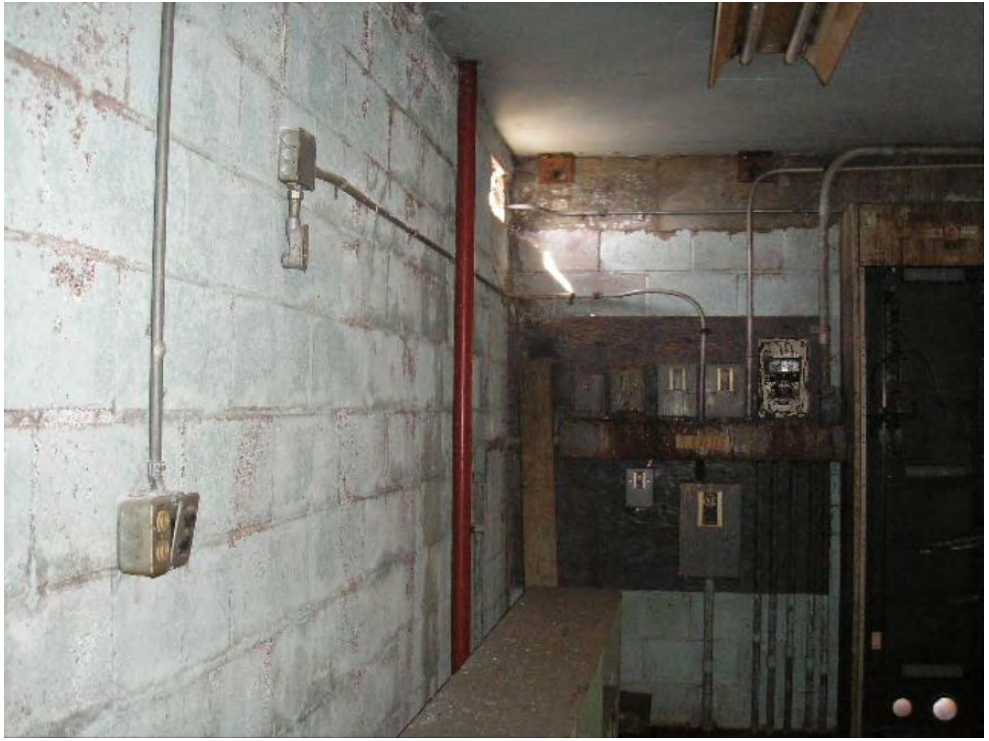
Photograph ID: 67

Photo Location: Room above Engine Test Cell	
Direction: W	
Survey Date: 2/28/2011	
Comments: View of electrical panels and piping in southwest corner of room.

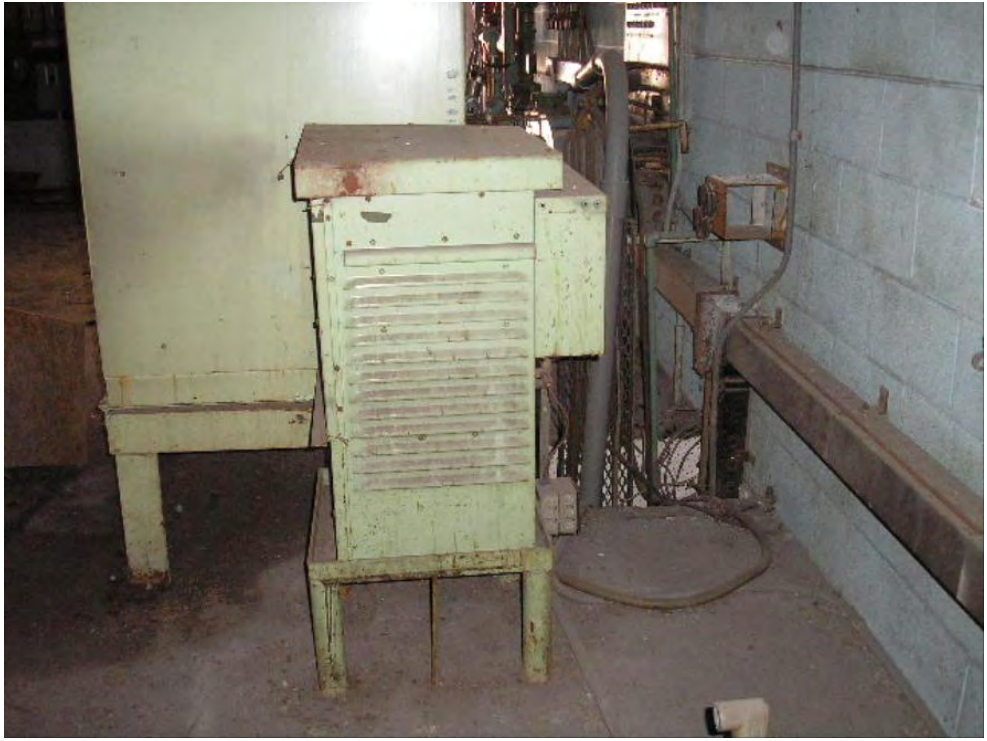
Photograph ID: 69

Photo Location: Room above Engine Test Cell	
Direction: Down	
Survey Date: 2/28/2011	
Comments: View of floor openings leading to Engine Test Cell used for conduit and pipe.

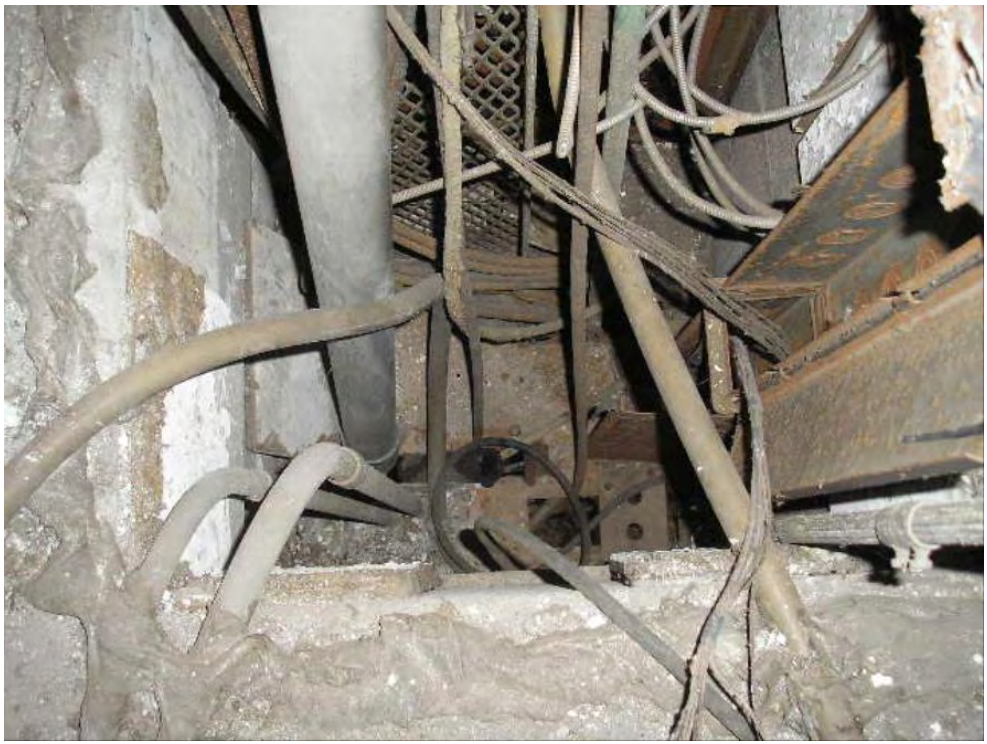
Photograph ID: 70

Photo Location: Room above Engine Test Cell	
Direction: Down	
Survey Date: 2/28/2011	
Comments: Close up view of piping and cables leading to Engine Test Cell.

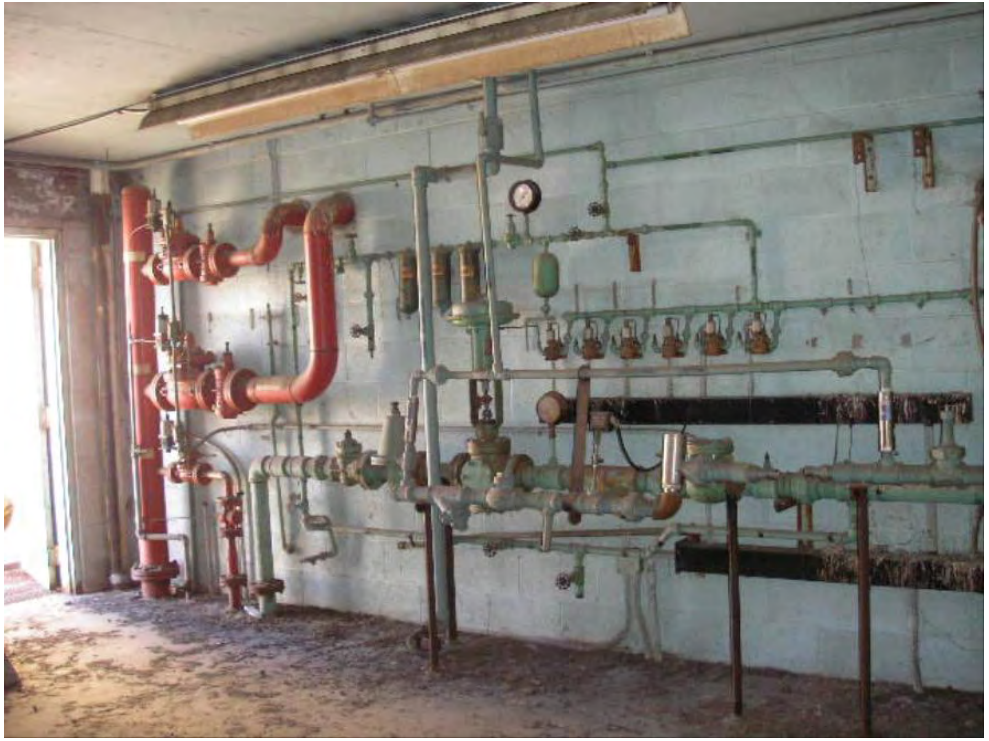
<p>Photograph ID: 71</p> <p>Photo Location: Room above Engine Test Cell</p> <p>Direction: NW</p> <p>Survey Date: 2/28/2011</p> <p>Comments: View of fire suppression system and piping leading down to Control Room and Engine Test Cell.</p>

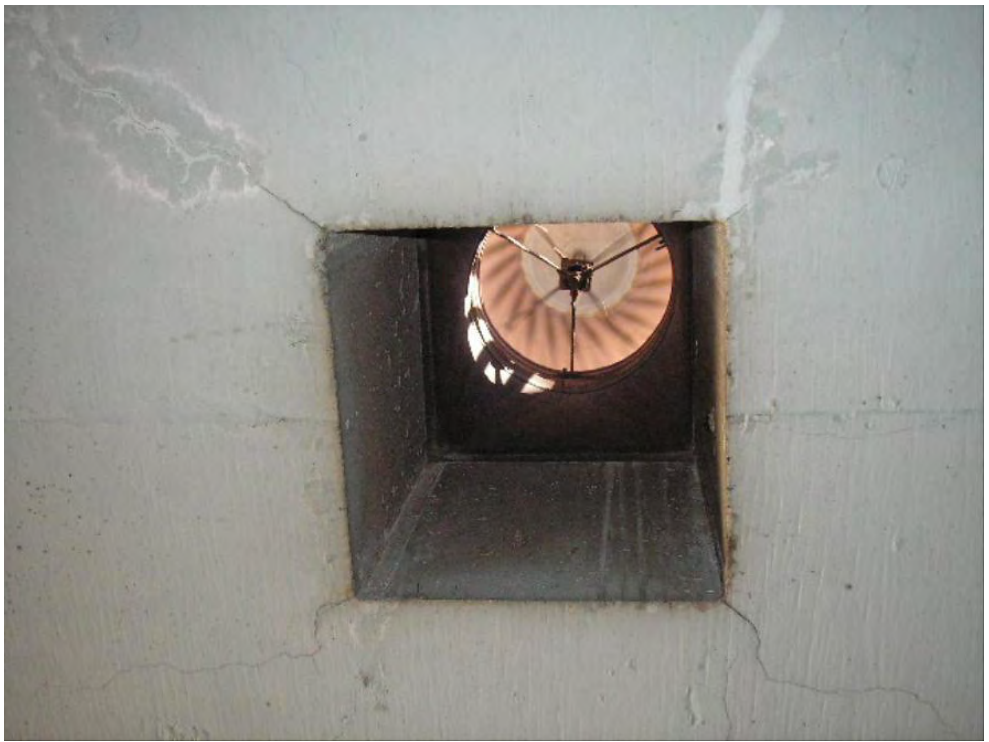
<p>Photograph ID: 72</p> <p>Photo Location: Room above Engine Test Cell</p> <p>Direction: Up</p> <p>Survey Date: 2/28/2011</p> <p>Comments: View of fan in ceiling.</p>

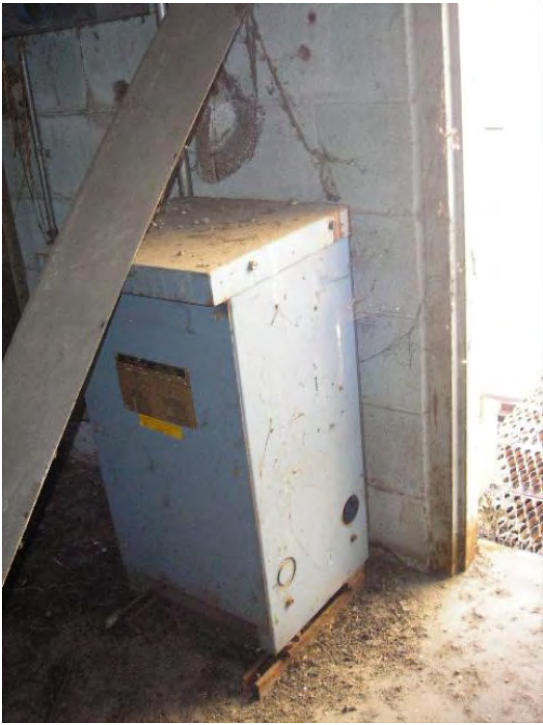
Photograph ID: 73

Photo Location: Room above Engine Test Cell	
Direction: SW	
Survey Date: 2/28/2011	
Comments: View of dry transformer by door.

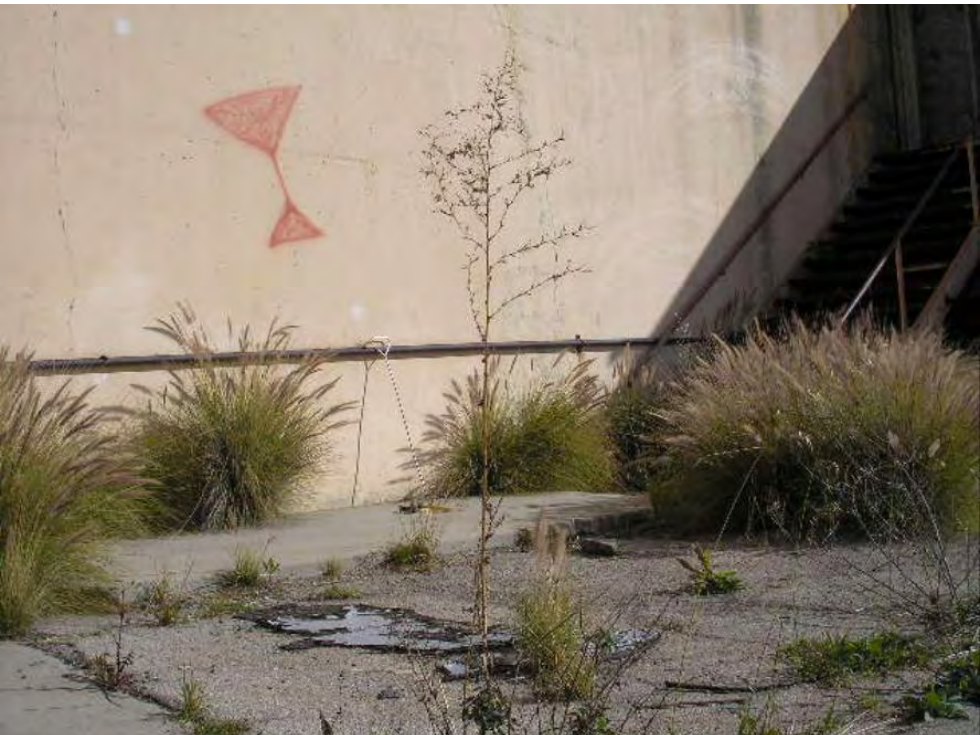
Photograph ID: 74

Photo Location: Outside of Engine Test Cell	
Direction: NE	
Survey Date: 2/28/2011	
Comments: View of concrete pad and asphalt patch outside of Engine Test Cell.

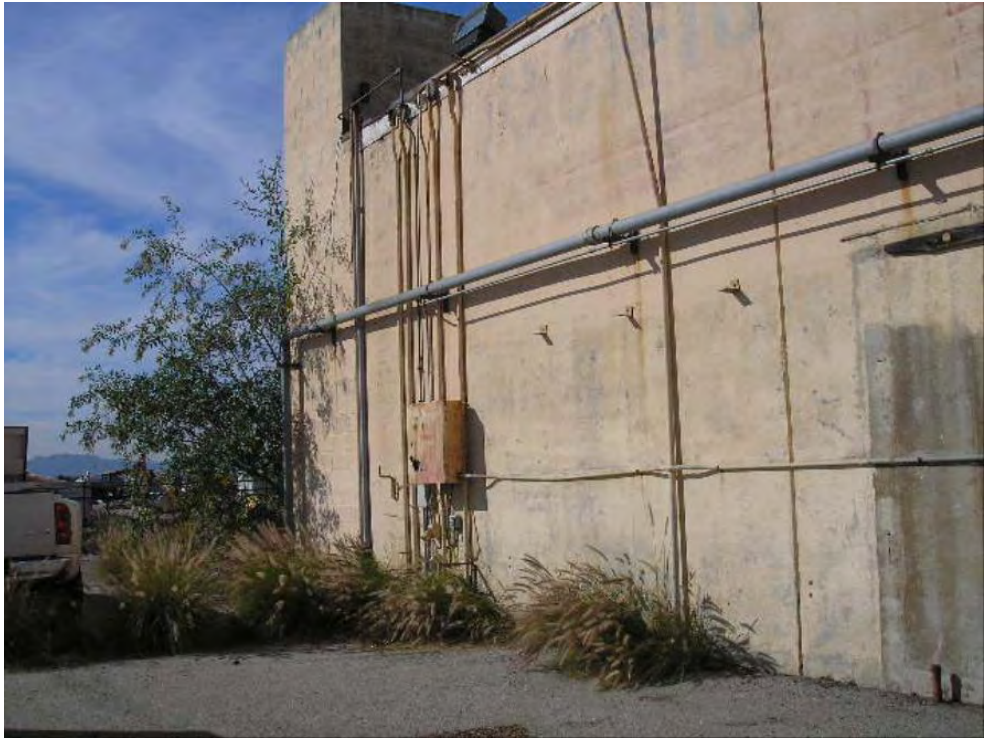
<p>Photograph ID: 75</p> <p>Photo Location: Outside of Test Cell No. 4</p> <p>Direction: SW</p> <p>Survey Date: 2/28/2011</p> <p>Comments: Exterior view of Test Cell No. 4.</p>

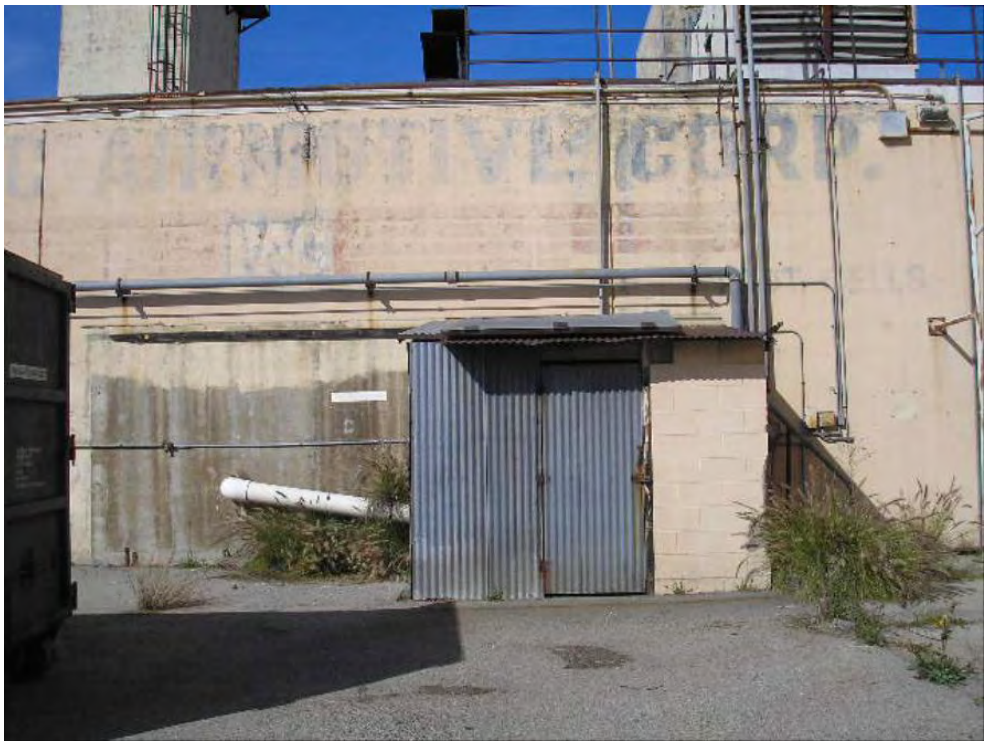
<p>Photograph ID: 76</p> <p>Photo Location: Outside of Test Cell No. 4</p> <p>Direction: W</p> <p>Survey Date: 2/28/2011</p> <p>Comments: Exterior view of sump location. Sump observed inside of a corrugated steel and cinderblock structure. Structure covered with corrugated steel.</p>

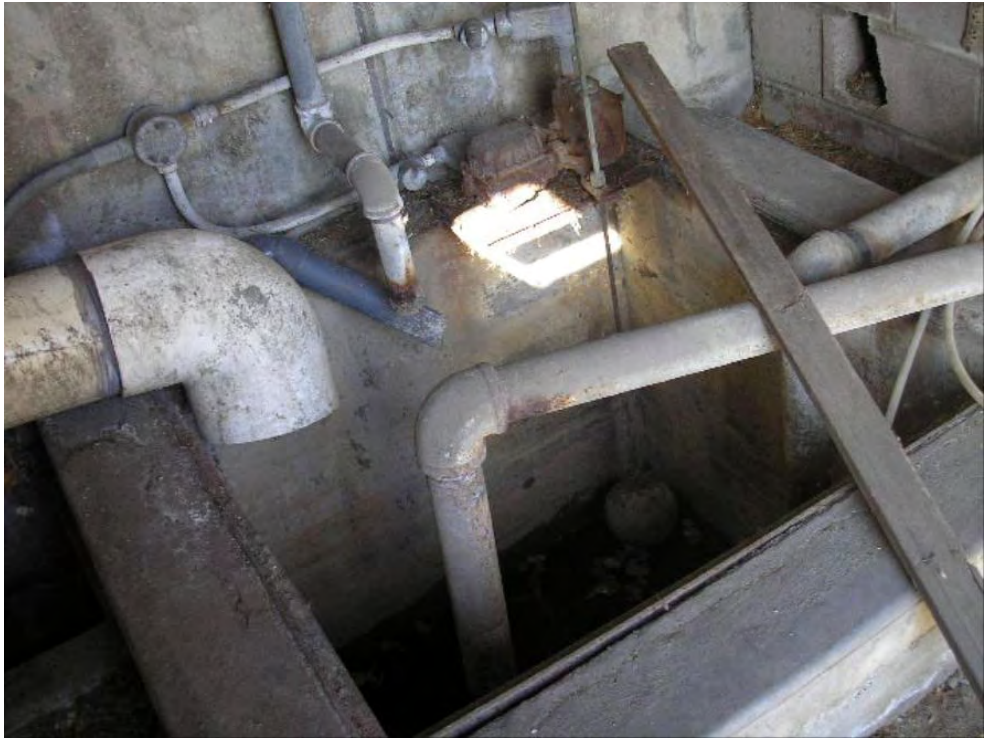
Photograph ID: 77

Photo Location: Outside of Test Cell No. 4	
Direction: Down	
Survey Date: 2/28/2011	
Comments: Sump outside of Test Cell No. 4.

Sump No. 6, located near the degreaser unit inside of Building No. 2, and sump No. 1 located near Test Cell No. 4, will be visually inspected for signs of deterioration. PAC will make arrangements to have the sumps emptied prior to our arrival onsite. Results of our inspection will be included in the Assessment Report described in Task 5 below. PAC will inspect sumps Nos. 1, 4, 5, and 6 yearly for cracks. The RWQCB will be notified prior to PAC conducting the yearly inspection.

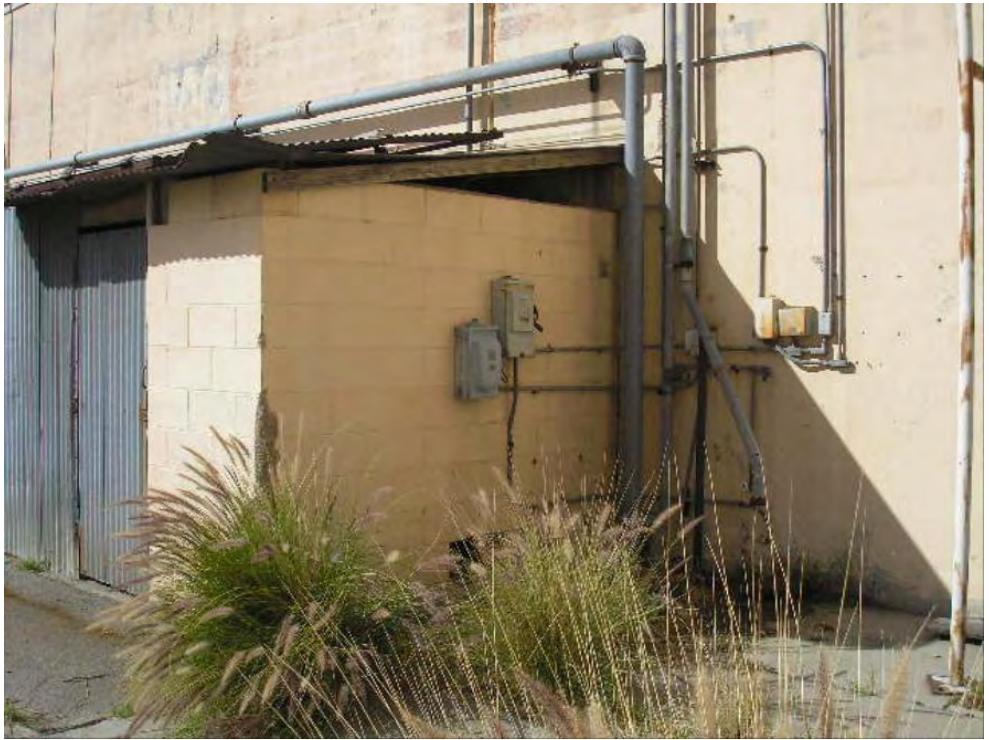
Photograph ID: 78

Photo Location: Outside of Test Cell No. 4	
Direction: SE	
Survey Date: 2/28/2011	
Comments: View of steel piping, panels, and electrical conduit.

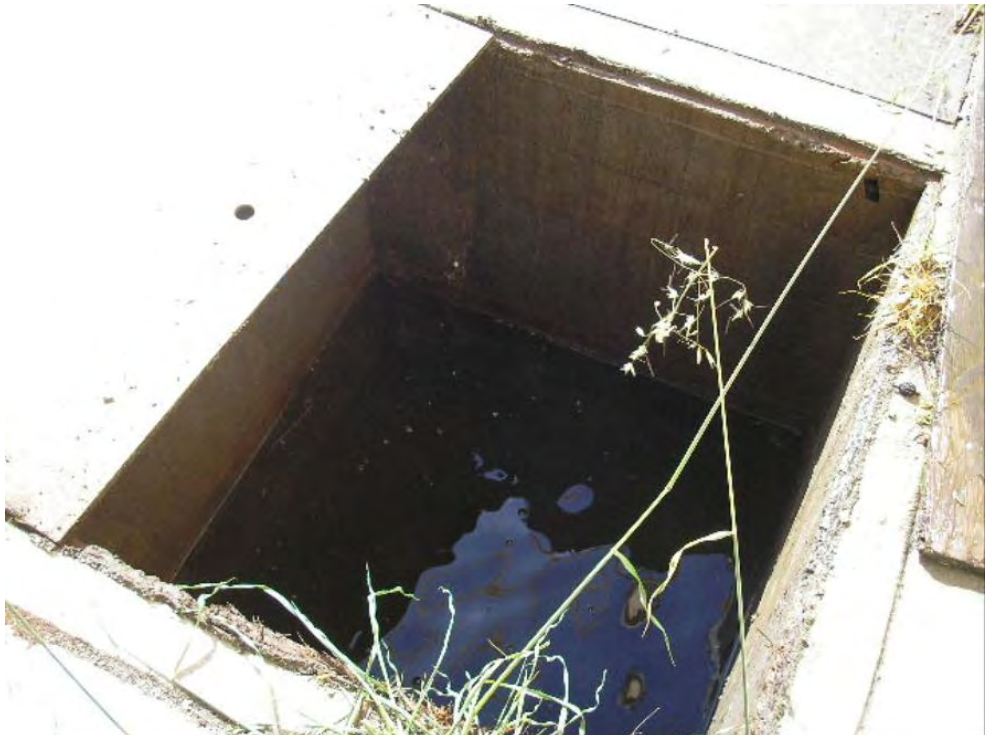
Photograph ID: 80

Photo Location: Loading Dock	
Direction: Down	
Survey Date: 2/28/2011	
Comments: Interior view of sump.

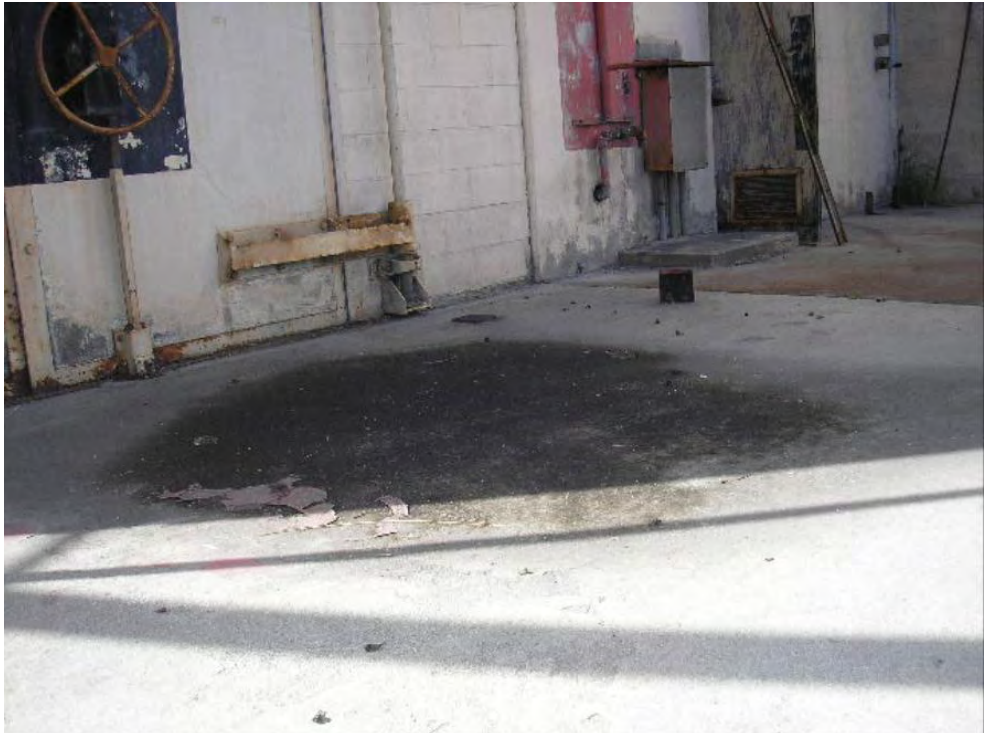
Photograph ID: 82

Photo Location: Loading Dock	
Direction: SW	
Survey Date: 2/28/2011	
Comments: View of 5 ft x 5 ft stain on Loading Dock.

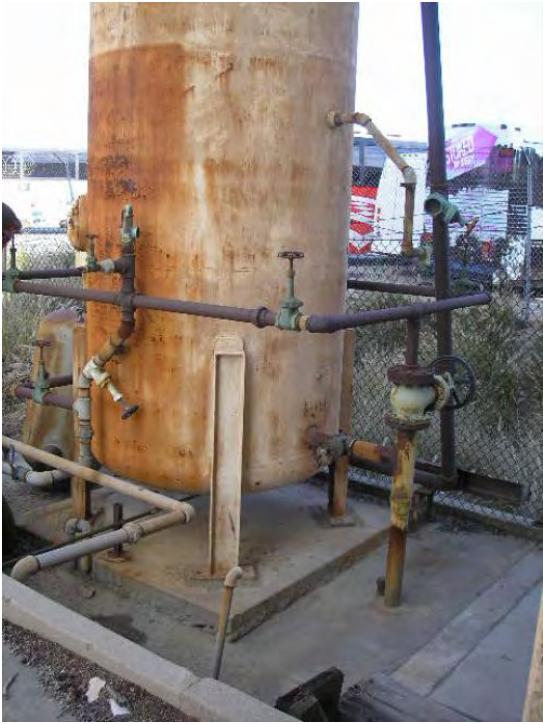
Photograph ID: 83

Photo Location: Loading Dock	
Direction: NW	
Survey Date: 2/28/2011	
Comments: View of rusted tank behind Loading Dock.

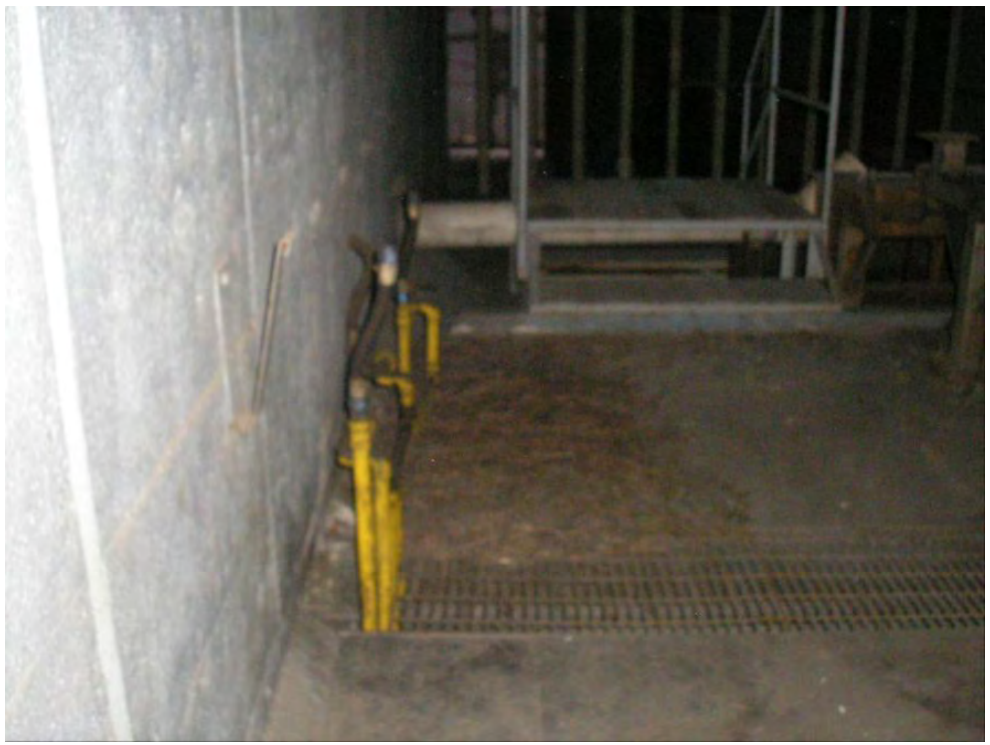
Photograph ID: 87

Photo Location: Test Cell No. 4	
Direction: SW	
Survey Date: 2/28/2011	
Comments: View of trench located in middle of Test Cell No. 4.

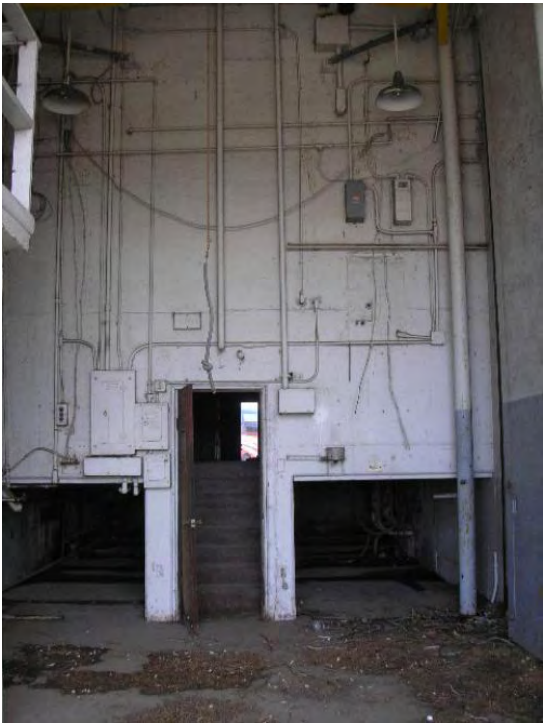
Photograph ID: 89

Photo Location: Control Room adjacent to Test Cell No. 4 (south half)	
Direction: N	
Survey Date: 2/28/2011	
Comments: View of panels and equipment on north wall. Floor is concrete. Branches and weeds were observed scattered on the floor.

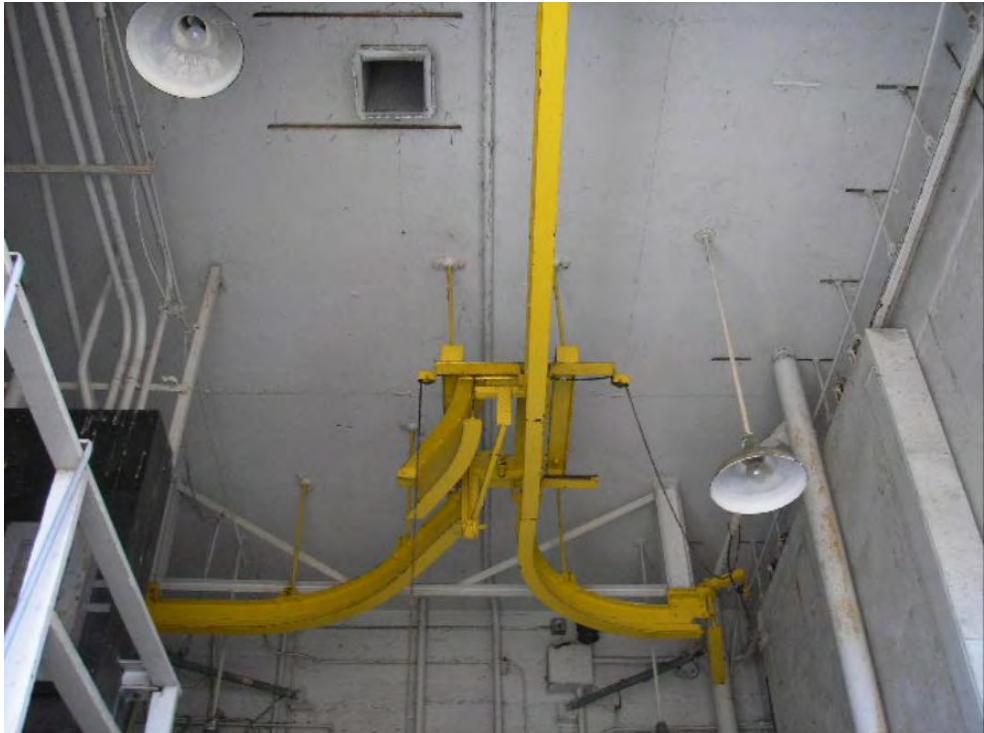
Photograph ID: 90

Photo Location: Control Room adjacent to Test Cell No. 4 (south half)	
Direction: Up	
Survey Date: 2/28/2011	
Comments: View of hoisting rack in Control Room.

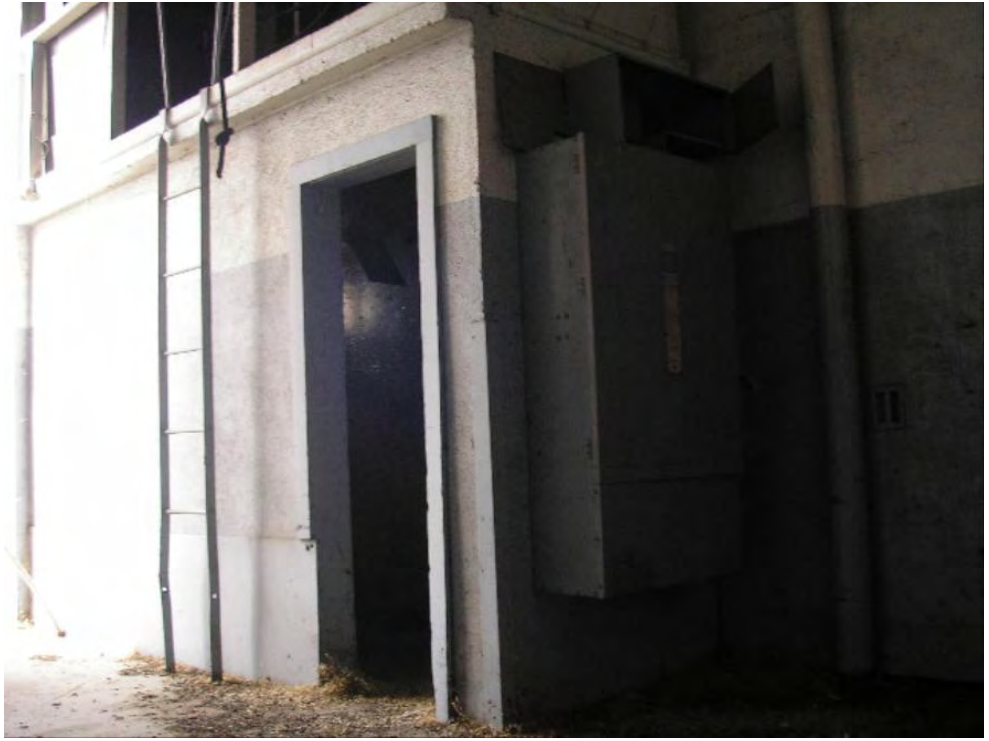
Photograph ID: 91

Photo Location: Control Room adjacent to Test Cell No. 4 (south half)	
Direction: SW	
Survey Date: 2/28/2011	
Comments: View of room in southwest corner of Control Room. Conduit and electrical panels were observed inside.

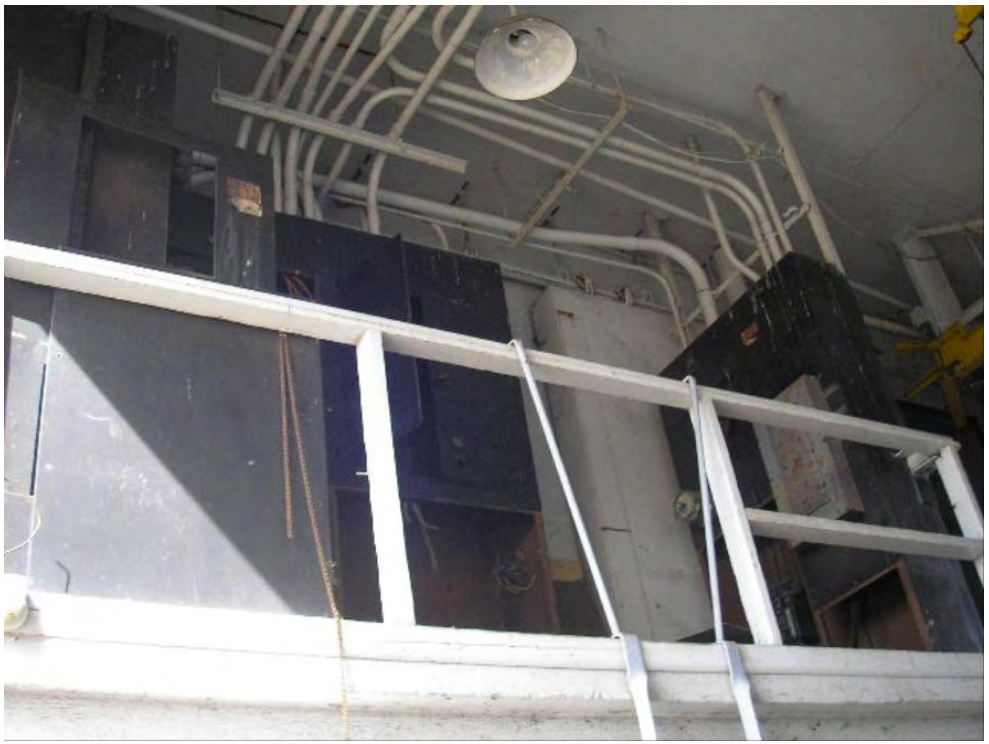
Photograph ID: 92

Photo Location: Control Room adjacent to Test Cell No. 4 (south half)	
Direction: Up	
Survey Date: 2/28/2011	
Comments: View of electrical equipment above room in southwest corner.

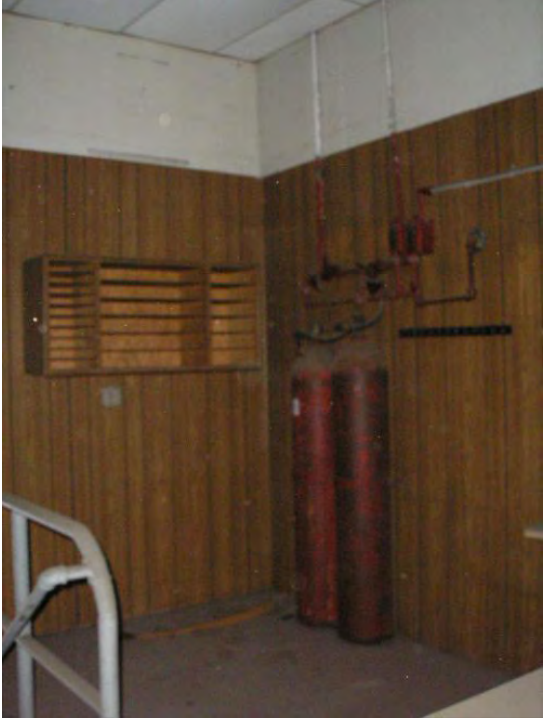
Photograph ID: 94

Photo Location: Control Room adjacent to Test Cell No. 4 (north half)	
Direction: SW	
Survey Date: 2/28/2011	
Comments: View of compressed gas bottles and shelves in southwest corner of room.

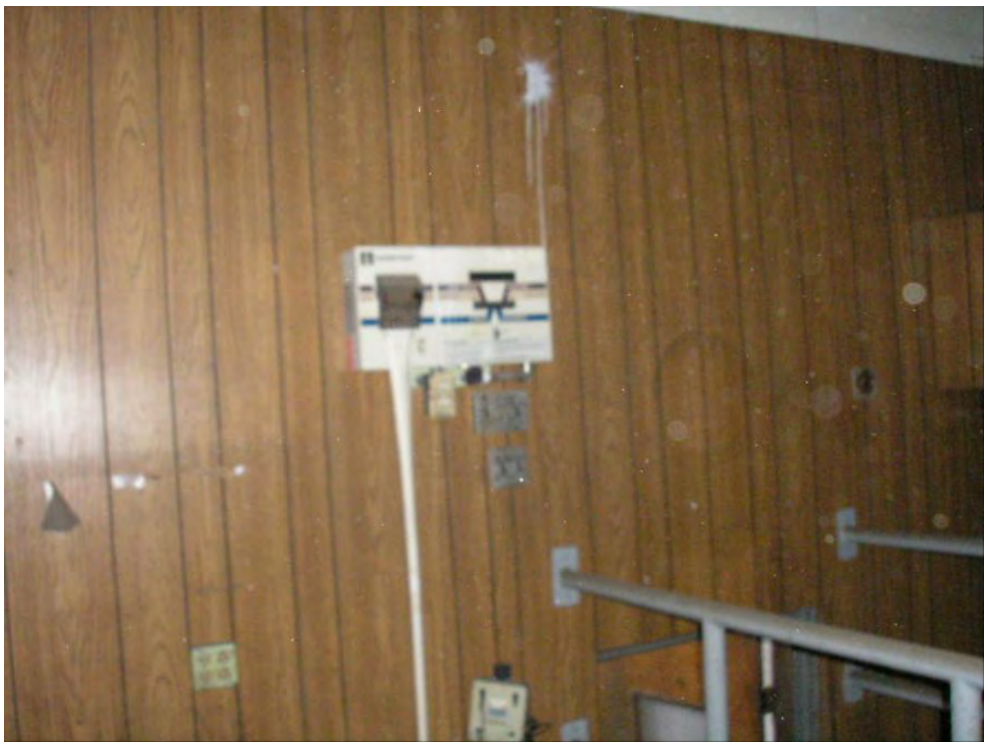
Photograph ID: 95

Photo Location: Control Room adjacent to Test Cell No. 4 (north half)	
Direction: SW	
Survey Date: 2/28/2011	
Comments: View of Veeder Root printout system mounted on wall.

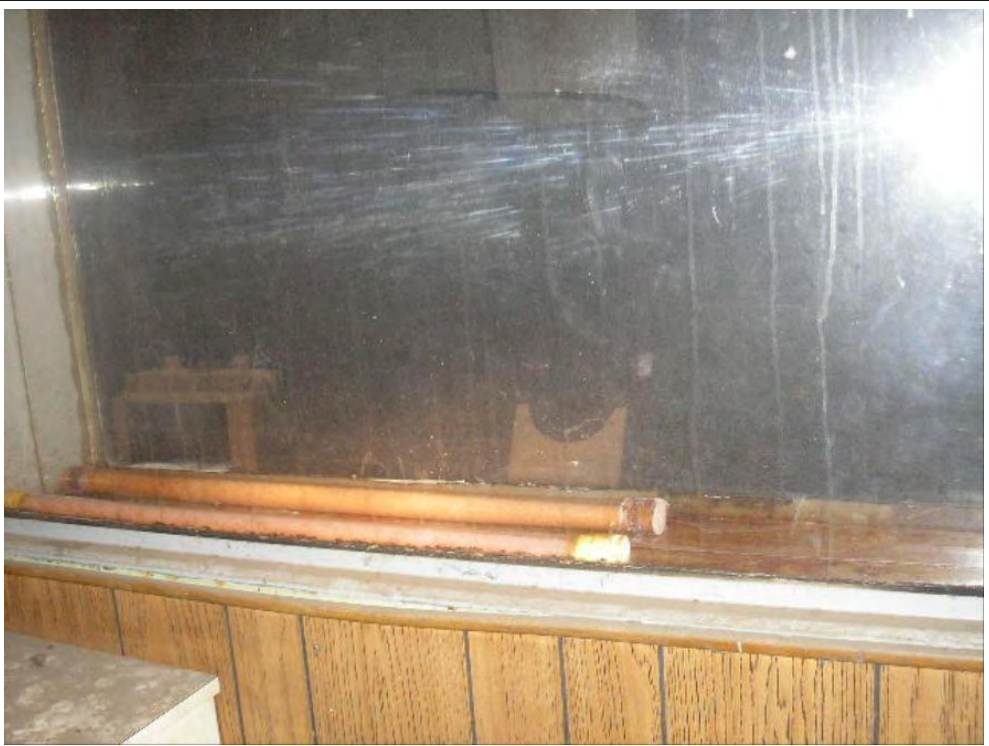
Photo Location: Control Room adjacent to Test Cell No. 4 (north half)	
Direction: NE	
Survey Date: 2/28/2011	
Comments: View of window in room. Tubes filled with crystallized rocks were observed inside the window. No labels on the tubes were observed.

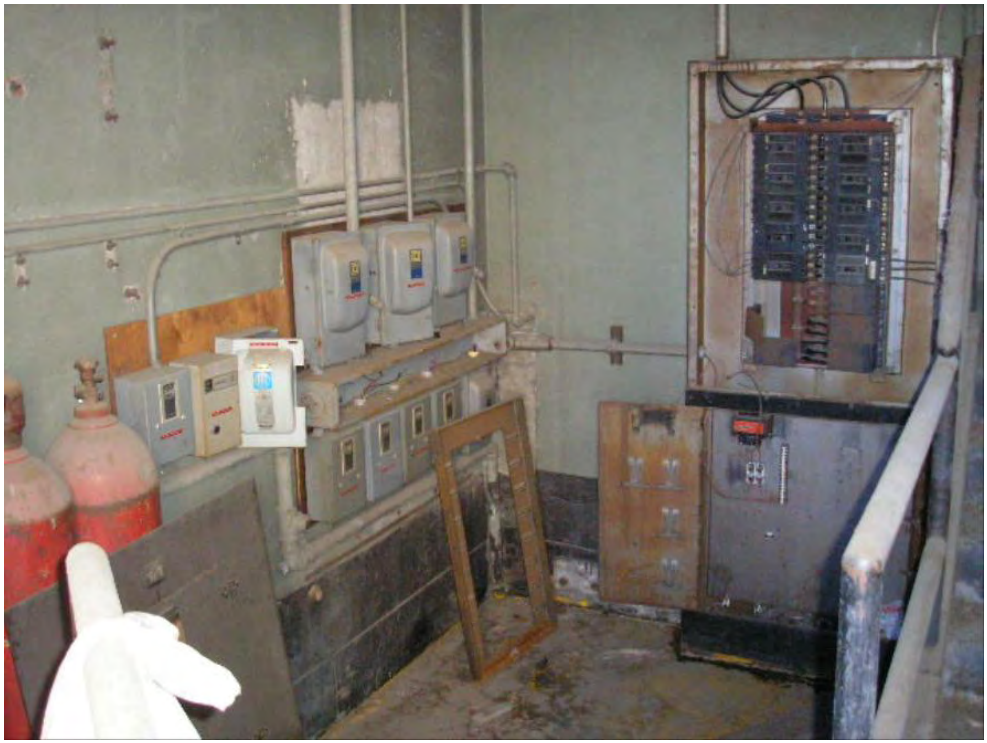
Photograph ID: 97

Photo Location: Control Room adjacent to Test Cell No. 4 (north half)	
Direction:	
Survey Date: 2/28/2011	
Comments: View of electrical equipment remaining on north side of Control Room.

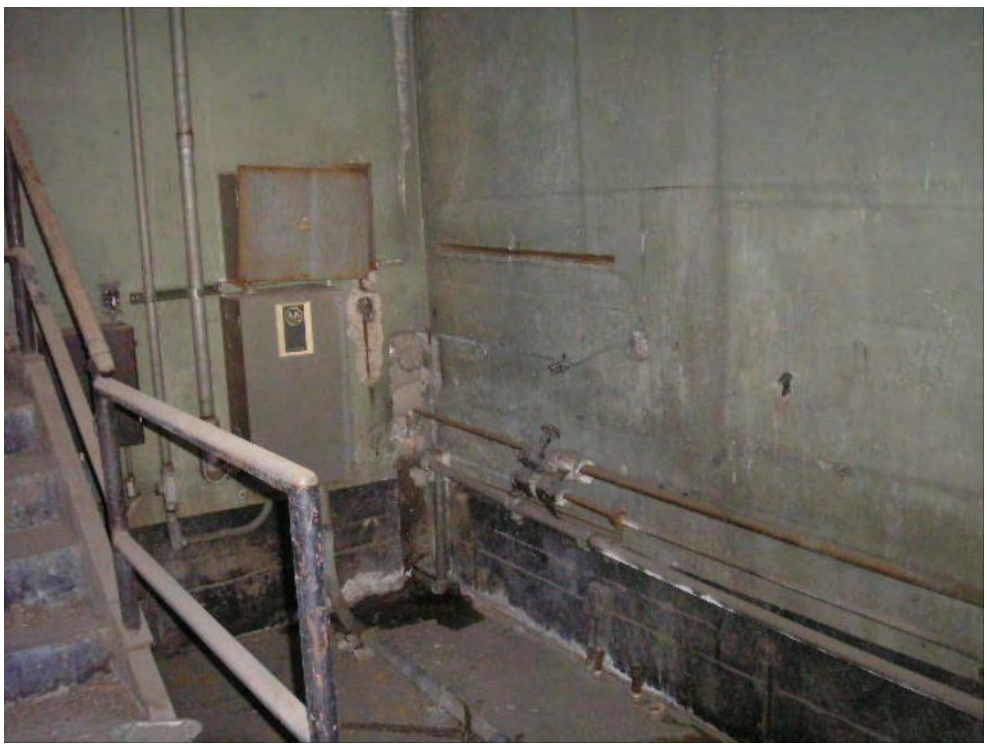
Photo Location: Control Room adjacent to Test Cell No. 4 (north half)	
Direction:	
Survey Date: 2/28/2011	
Comments: Staining observed below piping in southwest corner of room.
