Client:	GE Corporate Environmental Programs	Project:	Site Demolition Activities
Site Name:	Former Pacific Airmotive Facility	Site Location:	3003 N Hollywood Way, Burbank, California

Client:	GE Corporate Environmental Programs	Project:	Demolition Activities
Site Name:	Former Pacific Airmotive Facility	Site Location:	3003 N Hollywood Way, Burbank, California

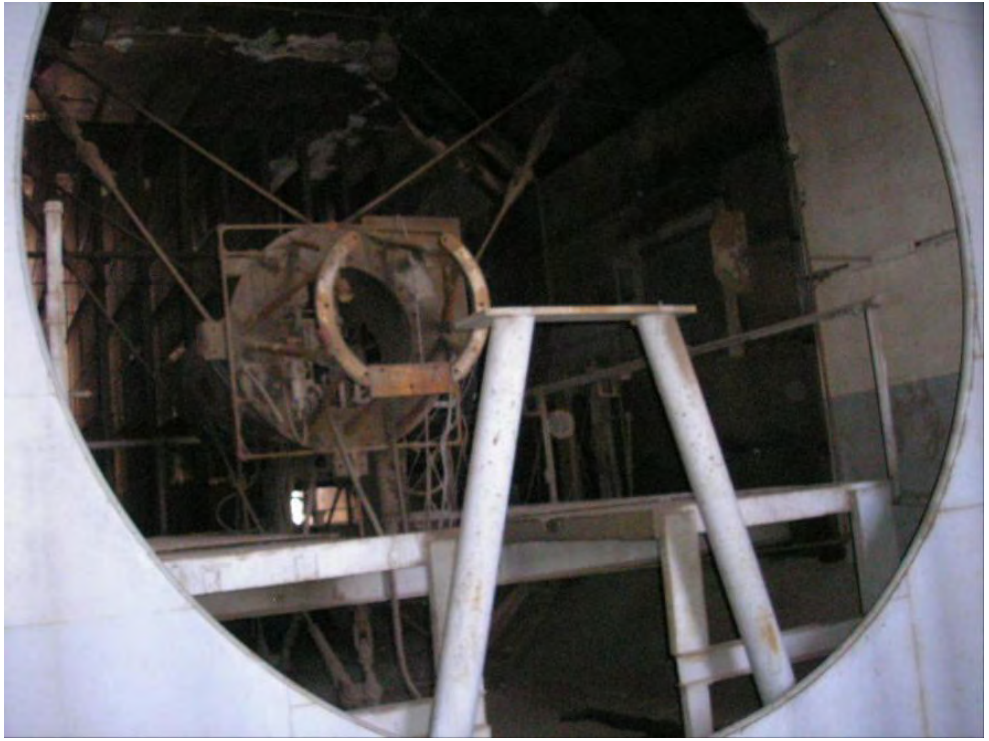
<p>Photograph ID: 99</p> <p>Photo Location: Test Cell No. 3</p> <p>Direction: NE</p> <p>Survey Date: 2/28/2011</p> <p>Comments: Interior view of Test Cell No. 3.</p>

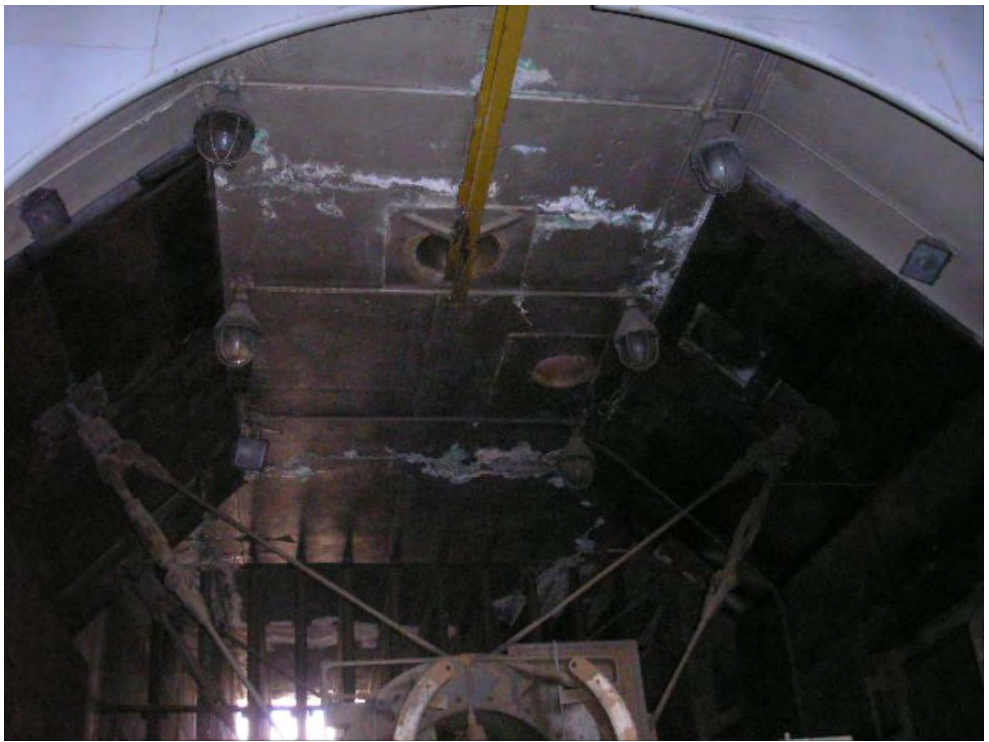
<p>Photograph ID: 100</p> <p>Photo Location: Test Cell No. 3</p> <p>Direction: Up</p> <p>Survey Date: 2/28/2011</p> <p>Comments: View of lights and test cell ceiling.</p>

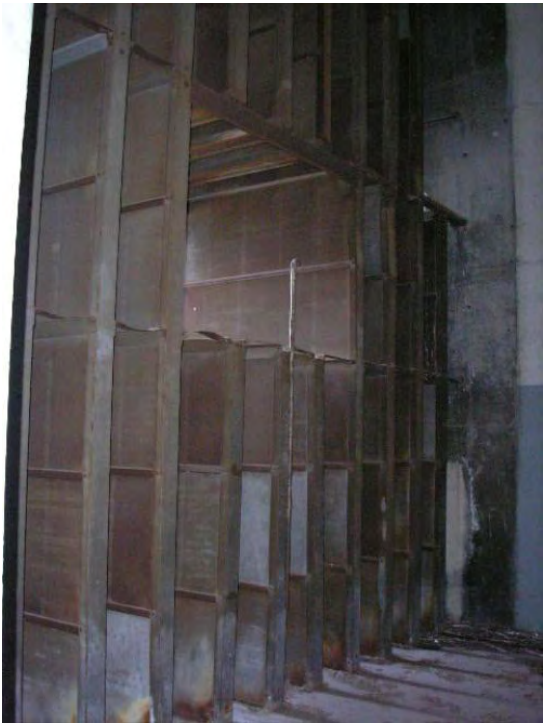
Photo Location: Test Cell No. 3	
Direction: SW	
Survey Date: 2/28/2011	
Comments: View of rusted air dispersers in Test Cell No. 3.

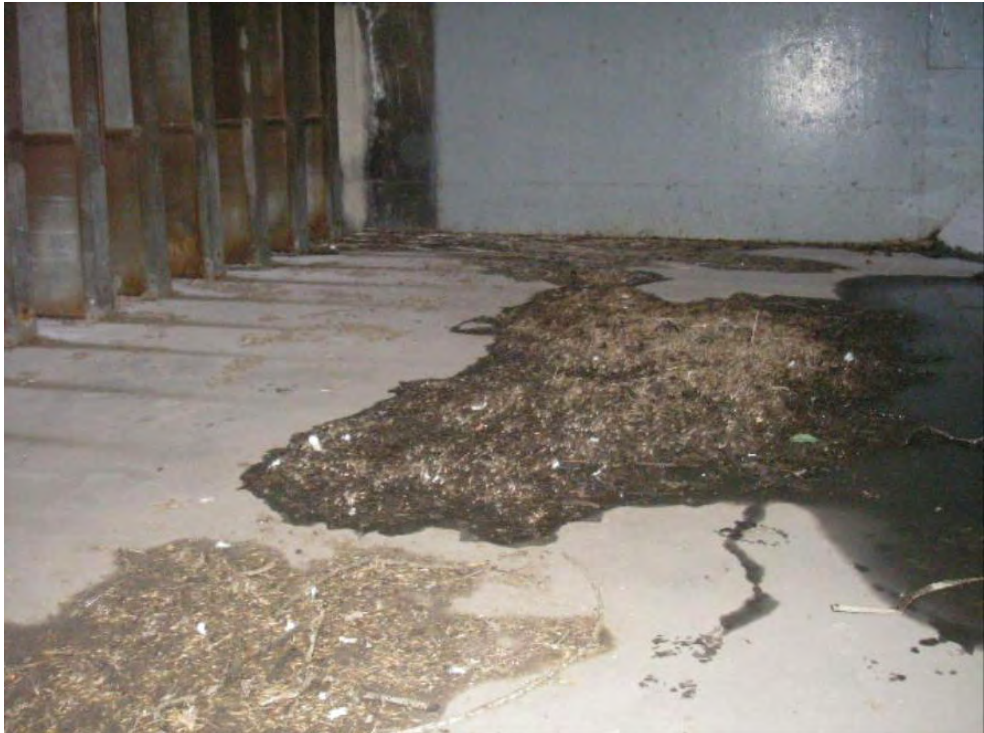
Photo Location: Test Cell No. 3	
Direction: Down	
Survey Date: 2/28/2011	
Comments: View of water and debris on floor of test cell.

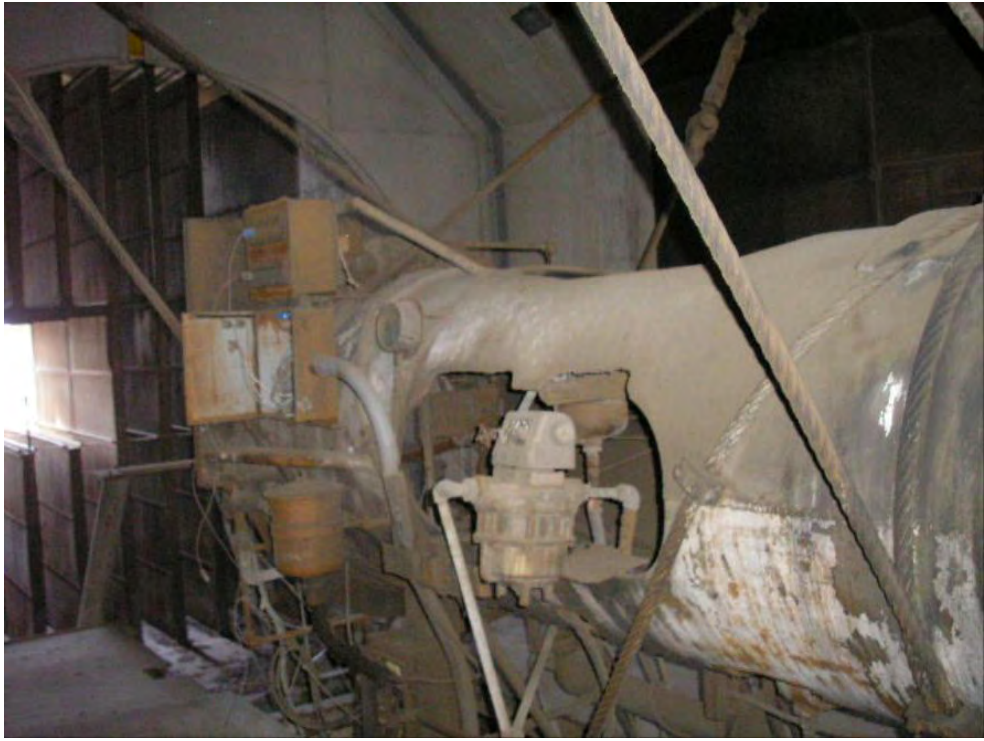
Photo Location: Test Cell No. 2	
Direction: SW	
Survey Date: 2/28/2011	
Comments: View of remaining test cell equipment.

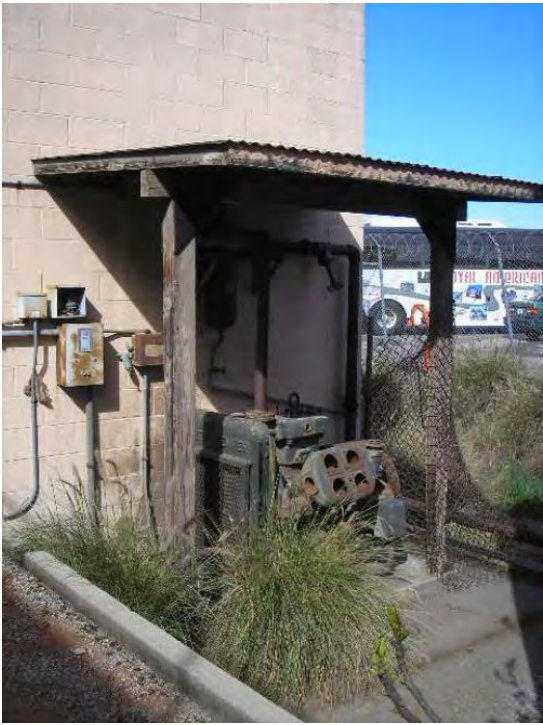
Photo Location: Loading Dock	
Direction: NW	
Survey Date: 2/28/2011	
Comments: View of Gardner Denver compressor adjacent to loading dock. Compressor was observed beneath a wooden and corrugated steel canopy and elevated on a concrete pad. No stains were observed around the pad.

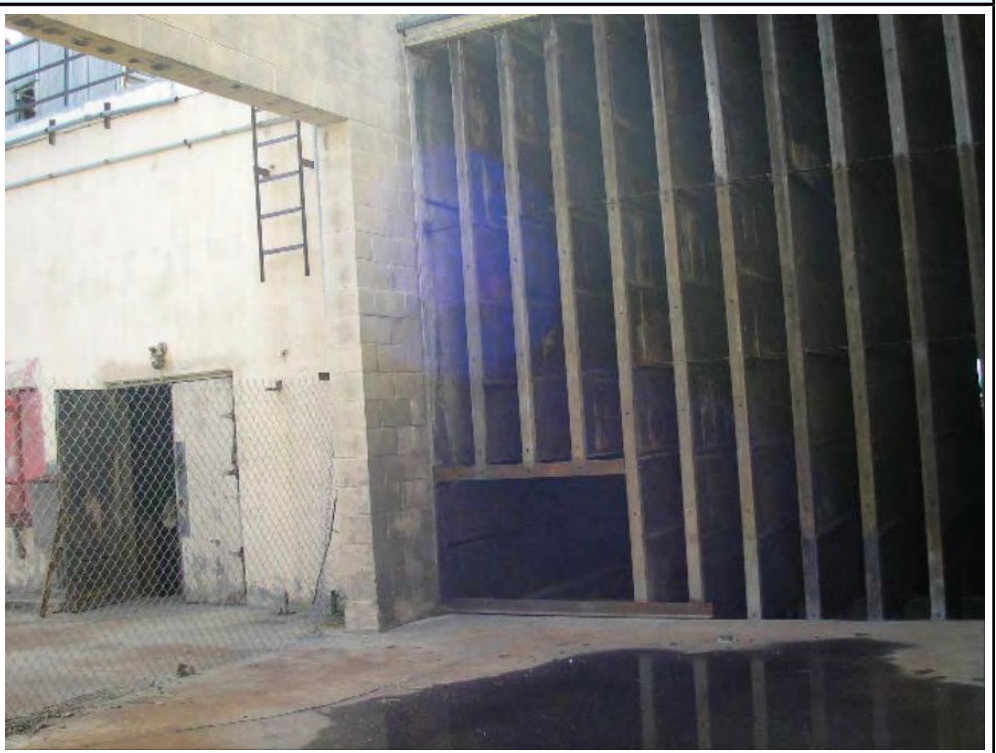
Photo Location: Outside of Test Cell No. 3	
Direction: SE	
Survey Date: 2/28/2011	
Comments: Back view of Test Cell No. 3. Puddles of water were observed in this area.

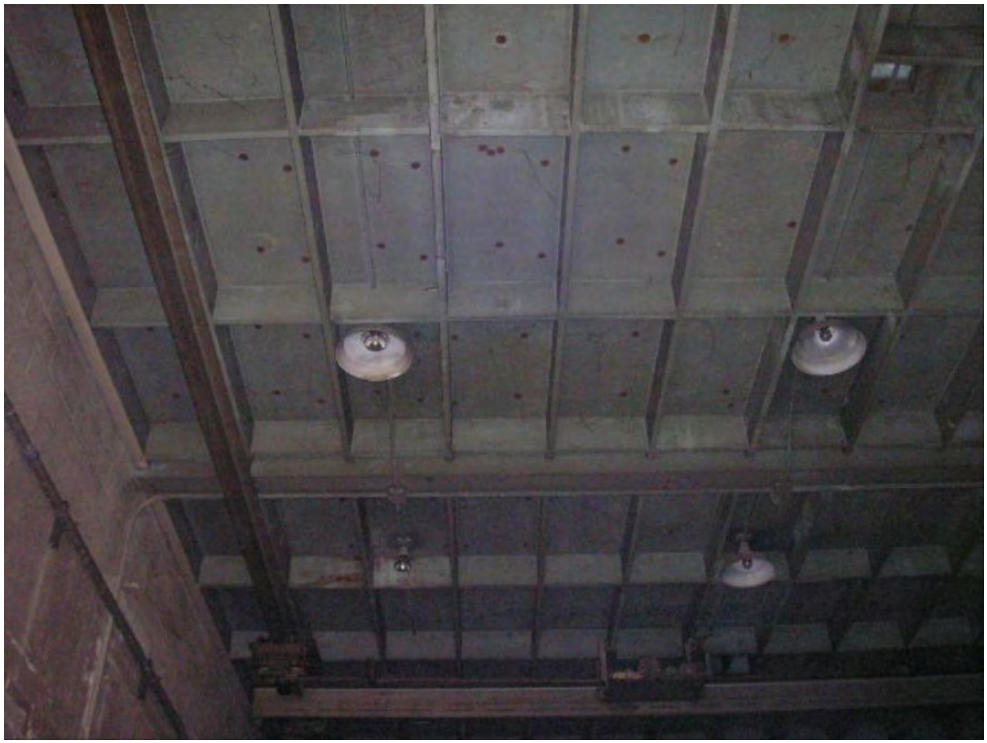
Photograph ID: 113

Photo Location: Area behind Test Cell No. 2 and adjacent Control Room.	
Direction: Up	
Survey Date: 2/28/2011	
Comments: View of ceiling and lamps in area.

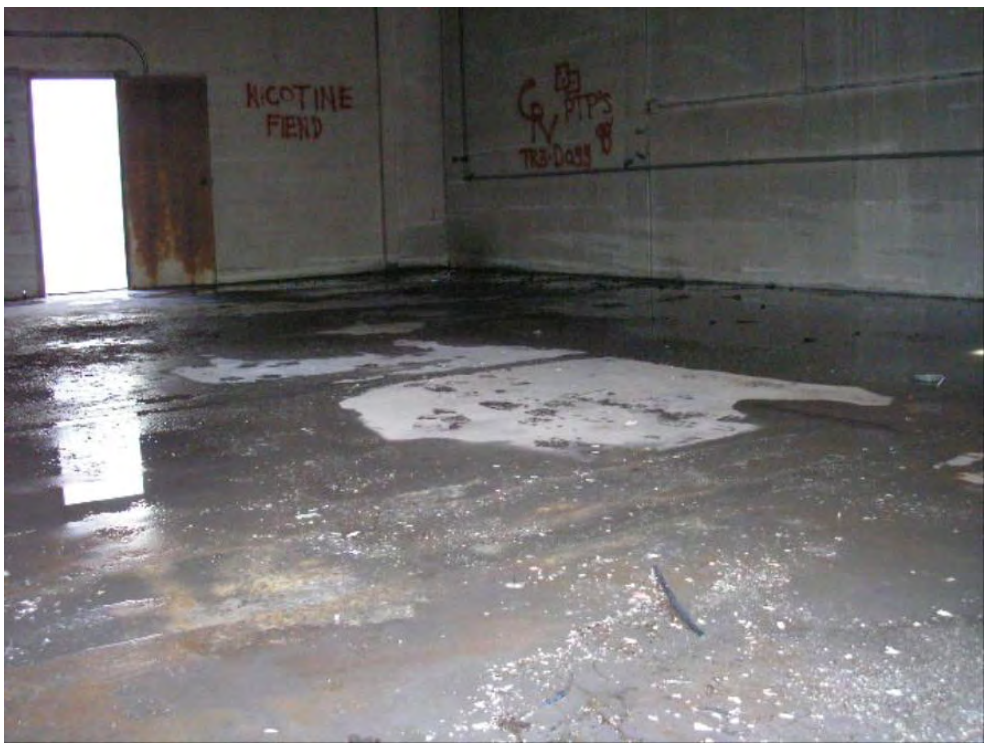
Photo Location: Area behind Test Cell No. 2 and adjacent Control Room.	
Direction: NW	
Survey Date: 2/28/2011	
Comments: View of concrete floor in area. Water and debris was observed on the floor at the time of the site visit.

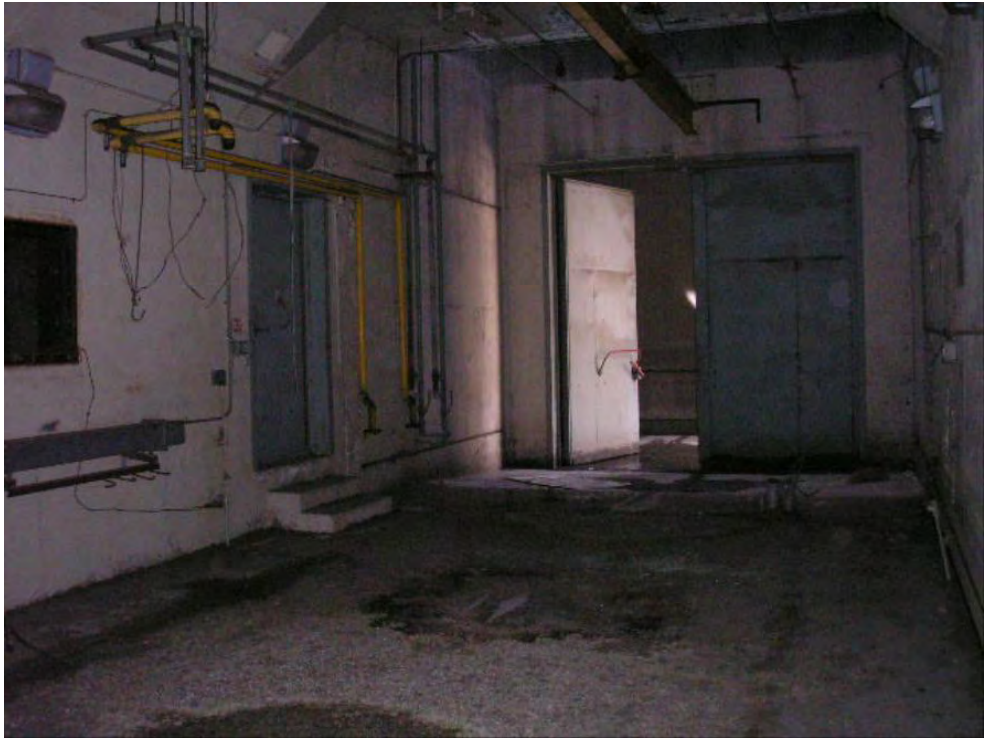
Photo Location: Test Cell No. 2	
Direction: N	
Survey Date: 2/28/2011	
Comments: Interior view of north side of test cell Oil staining observed on concrete floor.

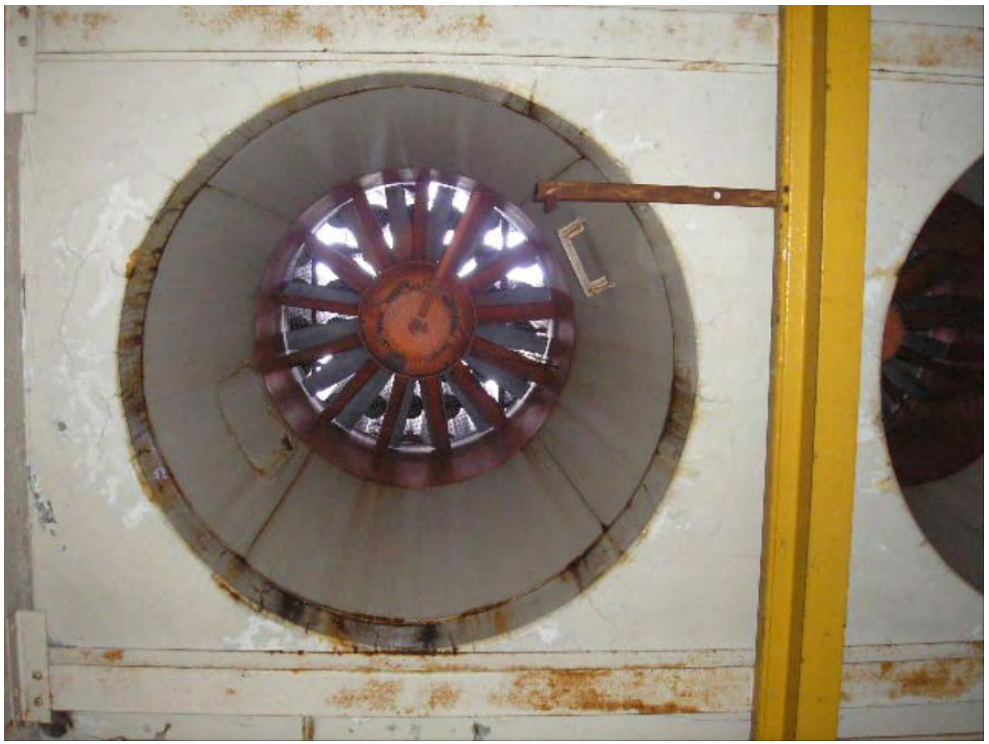
Photo Location: Test Cell No. 2	
Direction: Up	
Survey Date: 2/28/2011	
Comments: View of fan in ceiling of test cell.

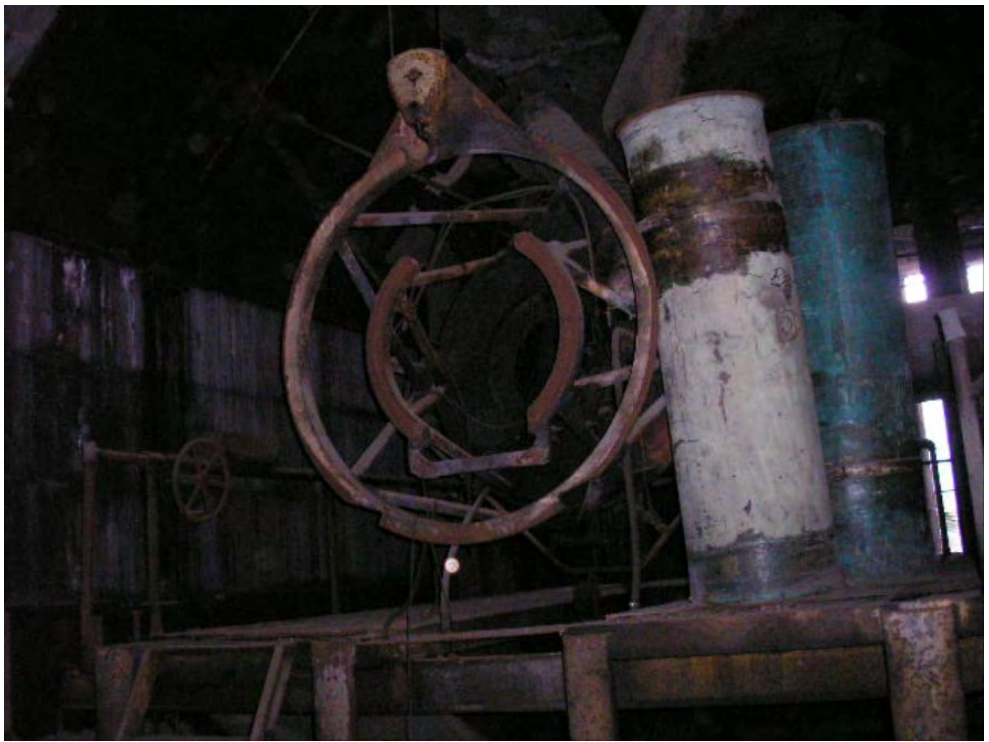
<p>Photograph ID: 120</p> <p>Photo Location: Test Cell No. 1</p> <p>Direction: NW</p> <p>Survey Date: 2/28/2011</p> <p>Comments: View of rack and remaining equipment in test cell.</p>

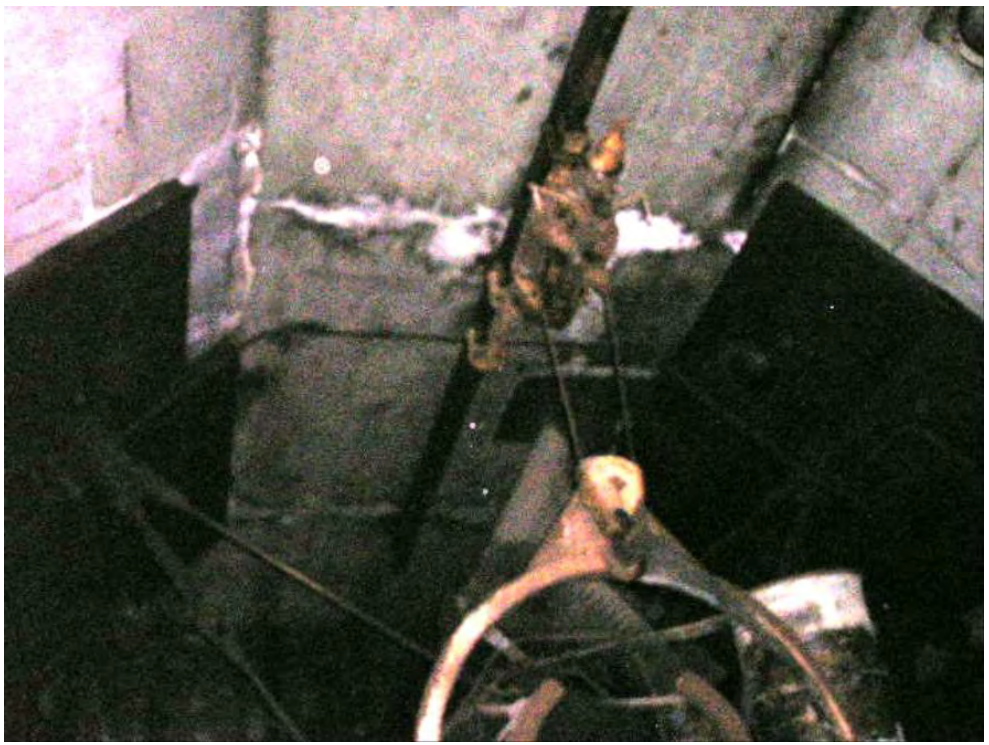
Photograph ID: 121

Photo Location: Test Cell No. 1	
Direction: Up	
Survey Date: 2/28/2011	
Comments: View of ceiling in test cell and hoisting rack.

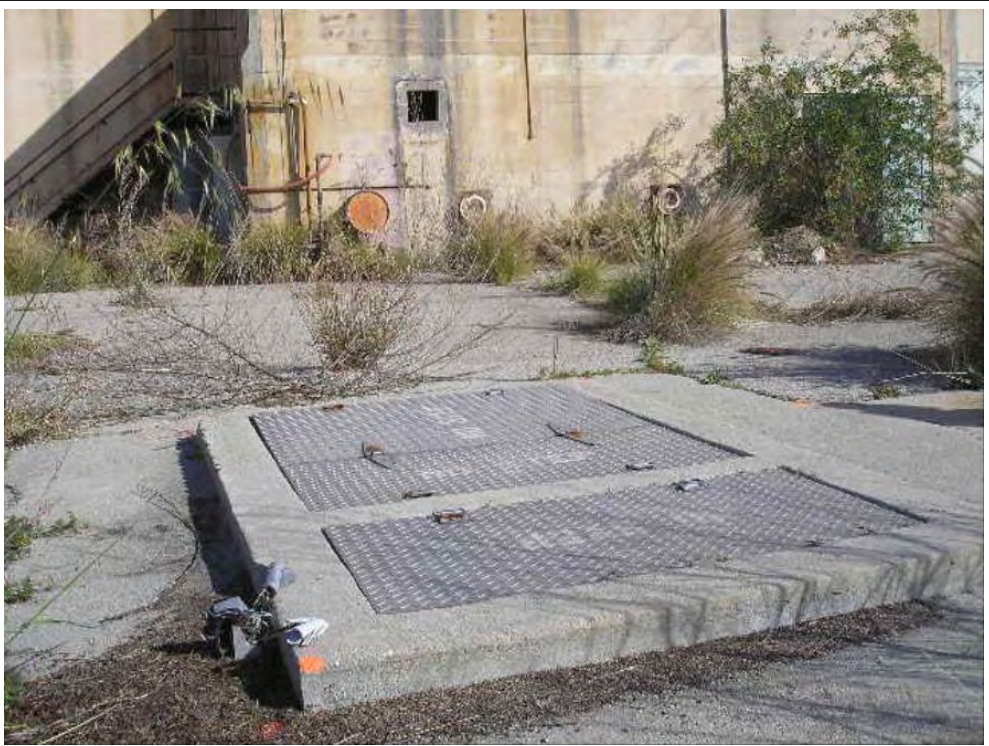
Photograph ID: 122

Photo Location: Southeast side of Site	
Direction: NE	
Survey Date: 2/28/2011	
Comments: View of clarifier and sump locations.

Clarifier No. 2 will be added to PAC's quarterly sampling program already being conducted for their RCRA facility permit. PAC will annually inspect clarifier Nos. 2 and 7 for cracks. The RWQCB will be notified prior to inspection of the clarifiers so that they may observe.

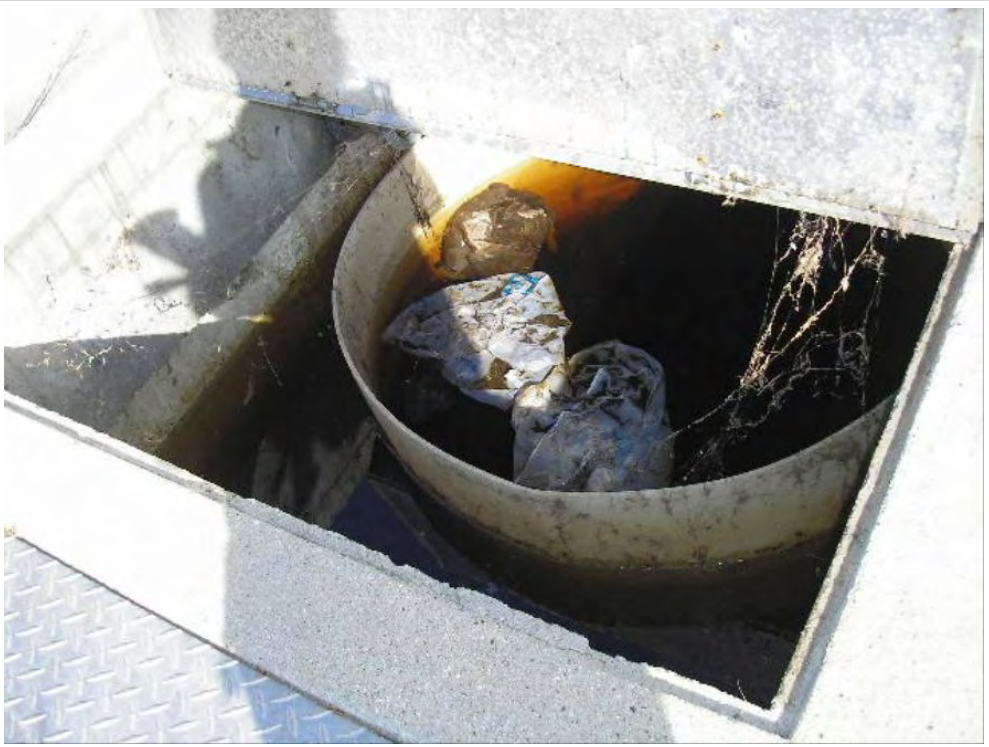
Photo Location: Southeast side of Site	
Direction: Down	
Survey Date: 2/28/2011	
Comments: Interior view of clarifier. Top of water observed approx. 6' below cover.

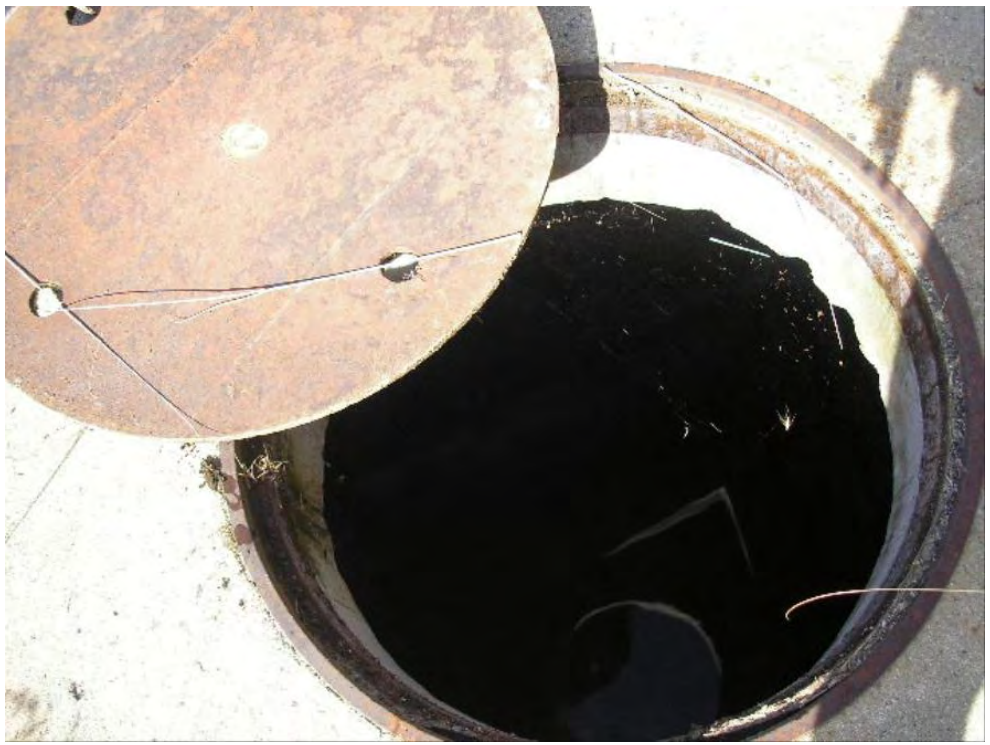
Photo Location: Southeast side of Site	
Direction: Down	
Survey Date: 2/28/2011	
Comments: Interior view of clarifier. Top of water observed approx. 6' below cover.

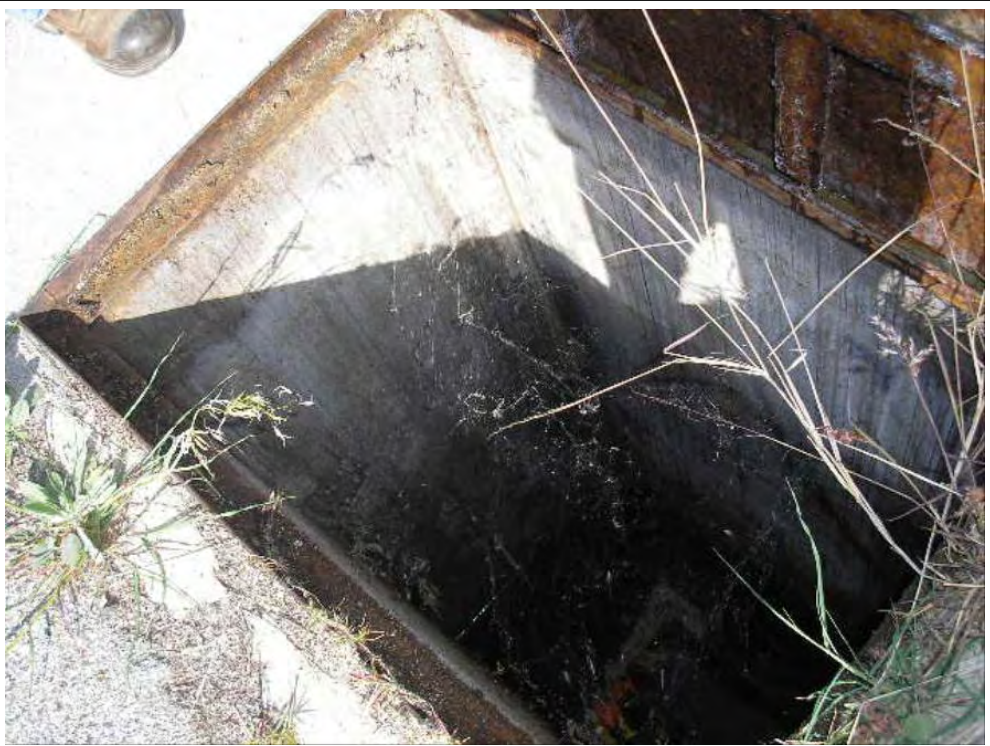
Photo Location: Southeast side of Site	
Direction: Down	
Survey Date: 2/28/2011	
Comments: Interior view of clarifier. Top of water observed approx. 6' below cover.

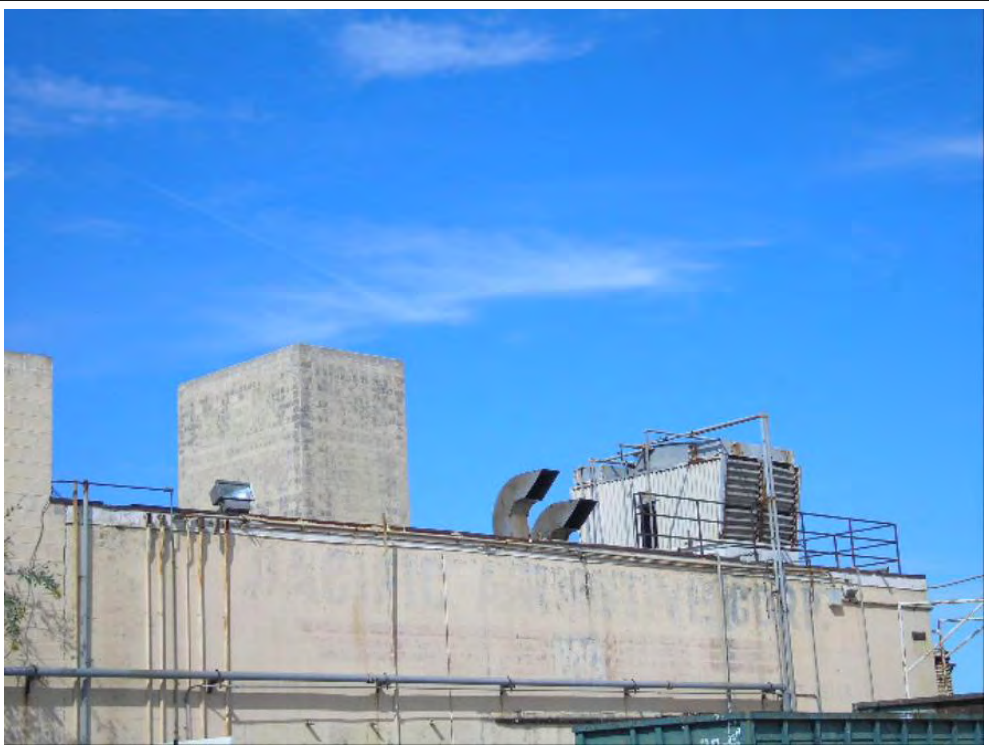
Photograph ID: 128

Photo Location: Parking area	
Direction: Up	
Survey Date: 2/28/2011	
Comments: View of old HVAC equipment on roof of Jet Engine Test Cell building.

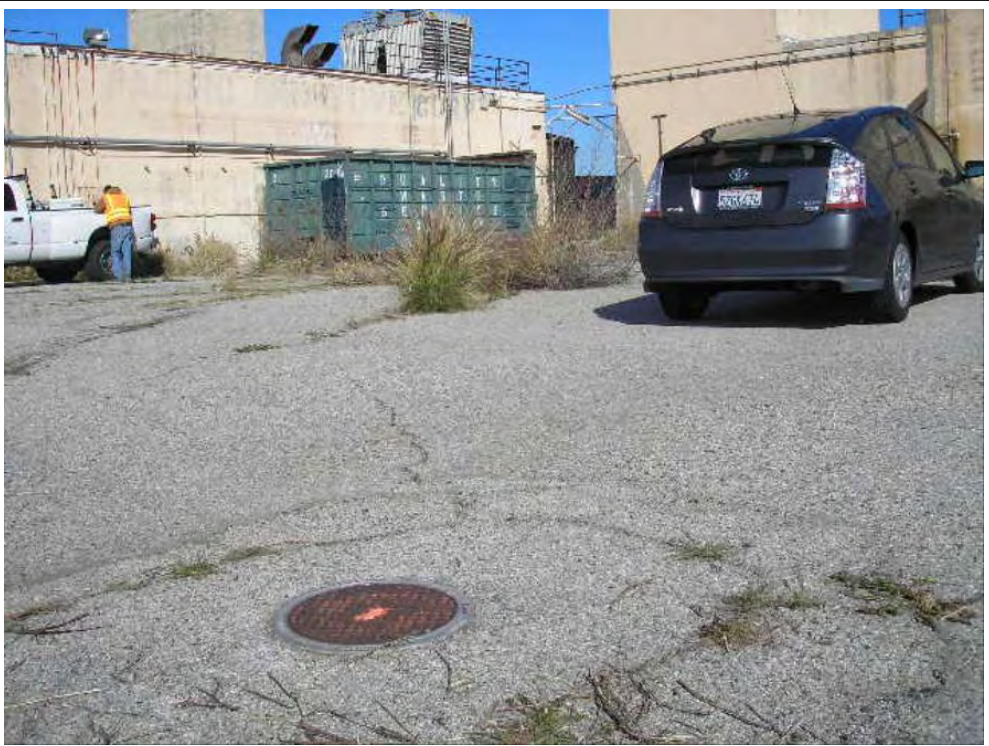
Photograph ID: 132

Photo Location: MW-1	
Direction: NW	
Survey Date: 2/28/2011	
Comments: View of location of MW-1.

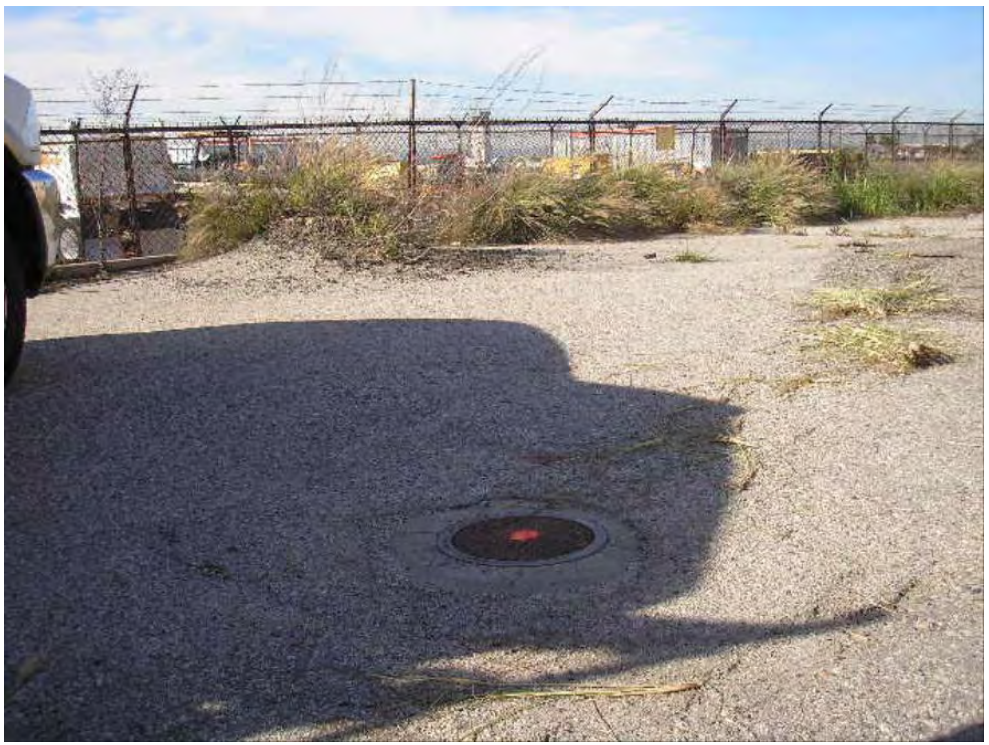
Photograph ID: 133

Photo Location: MW-2	
Direction: SW	
Survey Date: 2/28/2011	
Comments: View of MW-2. According to site contact, groundwater monitoring is conducted on an annual basis by another consultant.

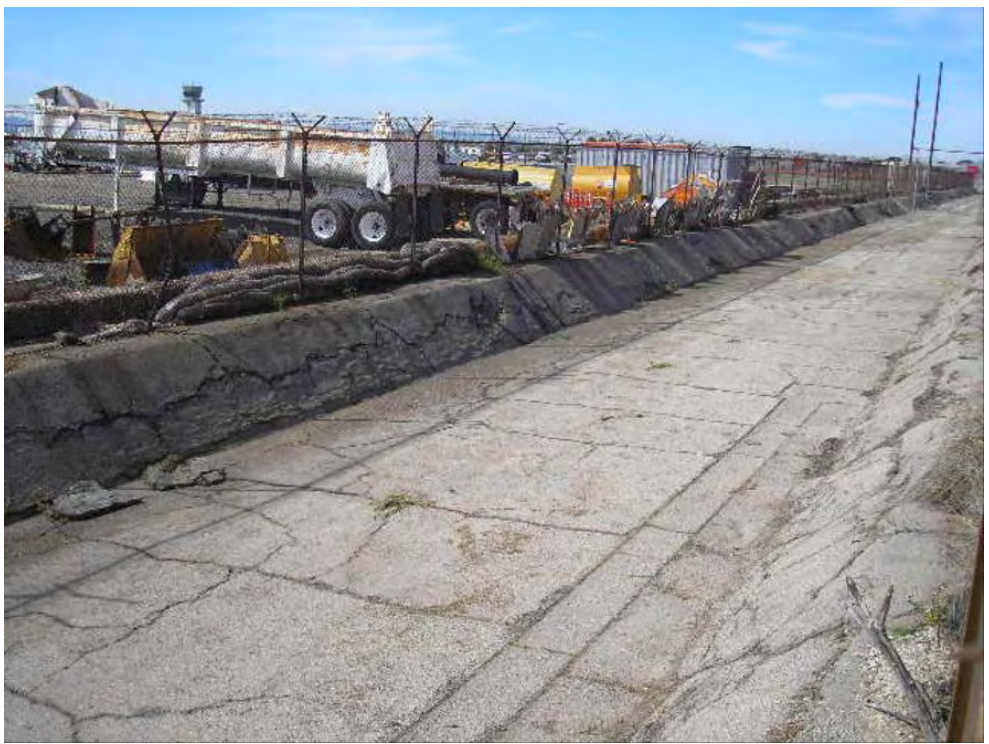
Photo Location: Fence	
Direction: NW	
Survey Date: 2/28/2011	
Comments: View of asphalt passageway between Site and Burbank Airport property to south. Cracked asphalt was observed in this area. Equipment, vehicles, and trailers were observed on the Burbank Airport property at the time of the site visit.

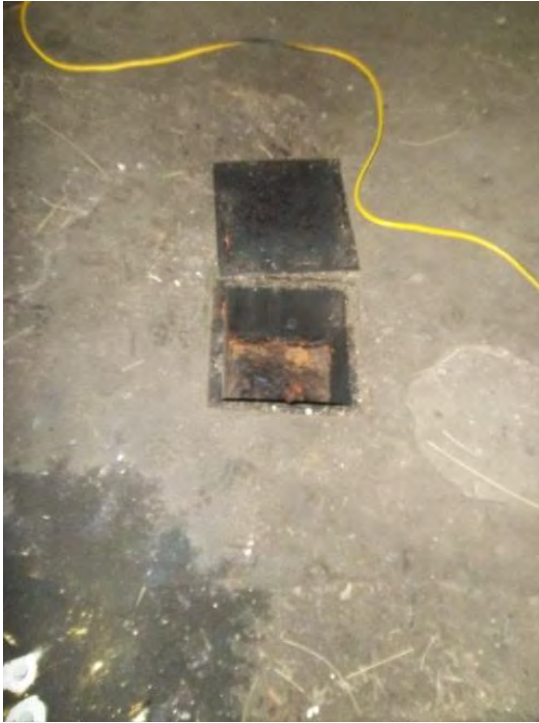
<p>Photograph ID: 2</p> <p>Photo Location: 3003 North Hollywood Way Property Engine Test Cell.</p> <p>Direction: Down</p> <p>Survey Date: 3/29/2011</p> <p>Comments: 2'x2'x2' Sump Below Exhaust Housing.</p>

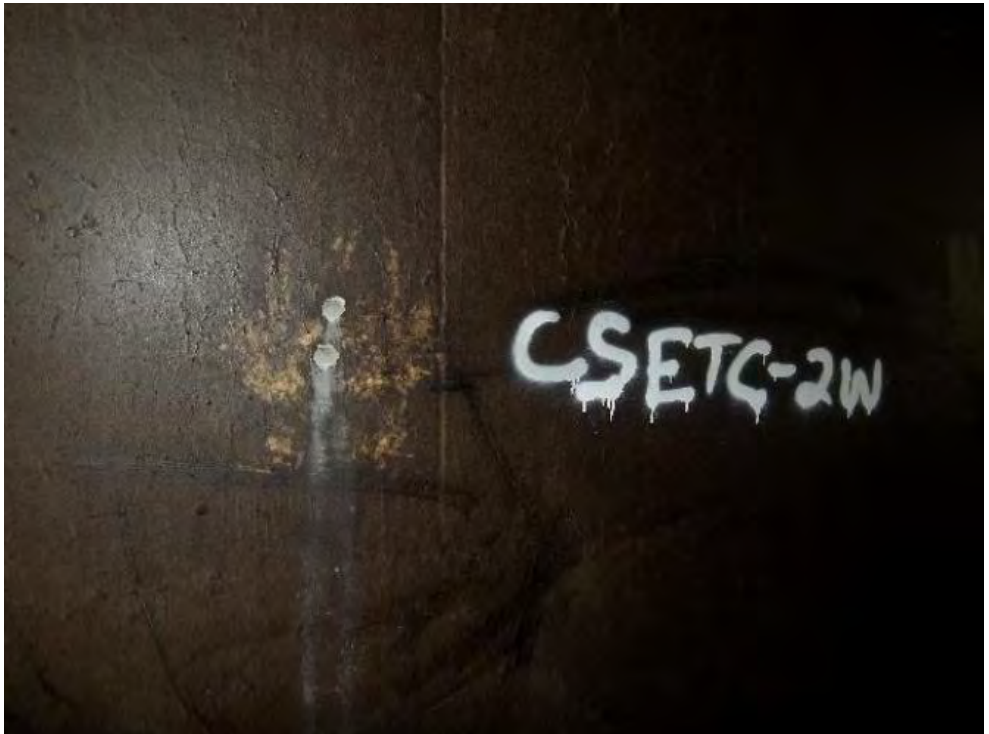
Photograph ID: 4

Photo Location: 3003 North Hollywood Way Property Engine Test Cell.	
Direction: North	
Survey Date: 3/29/2011	
Comments: Concrete Sampling Location on North Wall.

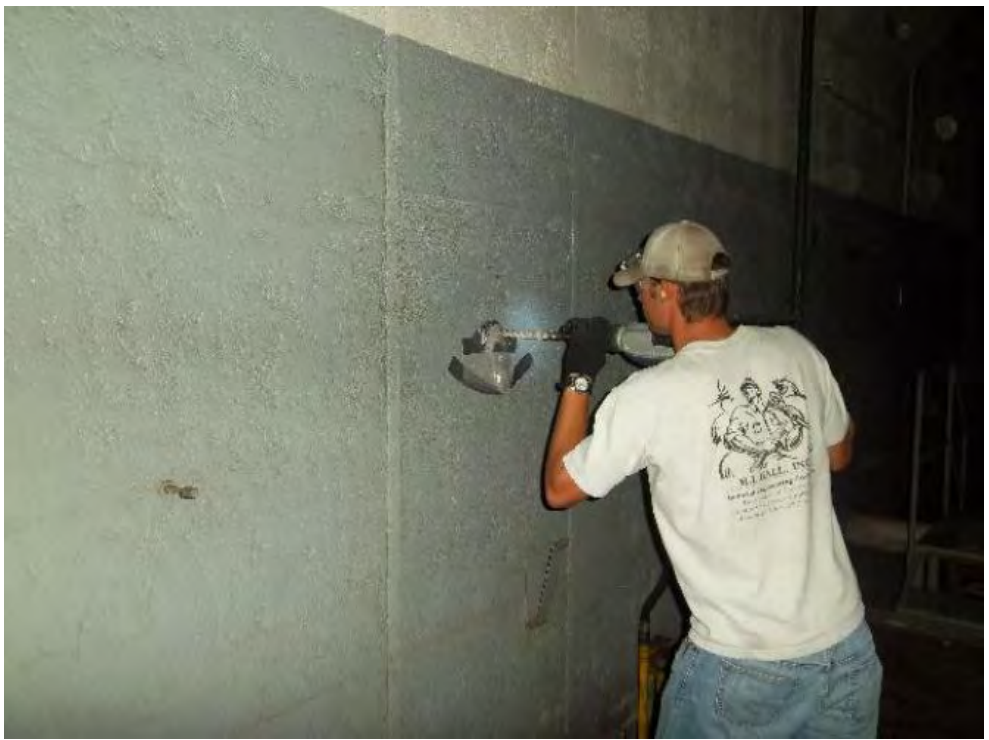
Photograph ID: 8

Photo Location: 3003 North Hollywood Way Property Test Cell #4.	
Direction: East	
Survey Date: 3/29/2011	
Comments: Concrete Drilling to Collect Sample.

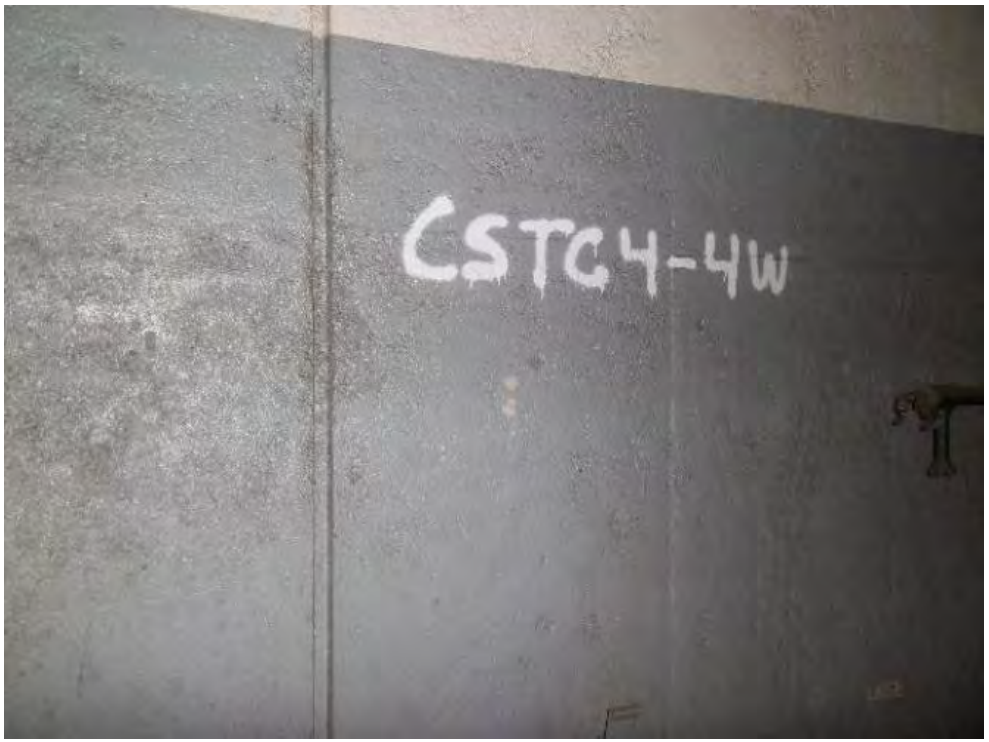
Photograph ID: 9

Photo Location: 3003 North Hollywood Way Property Test Cell #4.	
Direction: East	
Survey Date: 3/29/2011	
Comments: Concrete Sampling Location on East Wall.

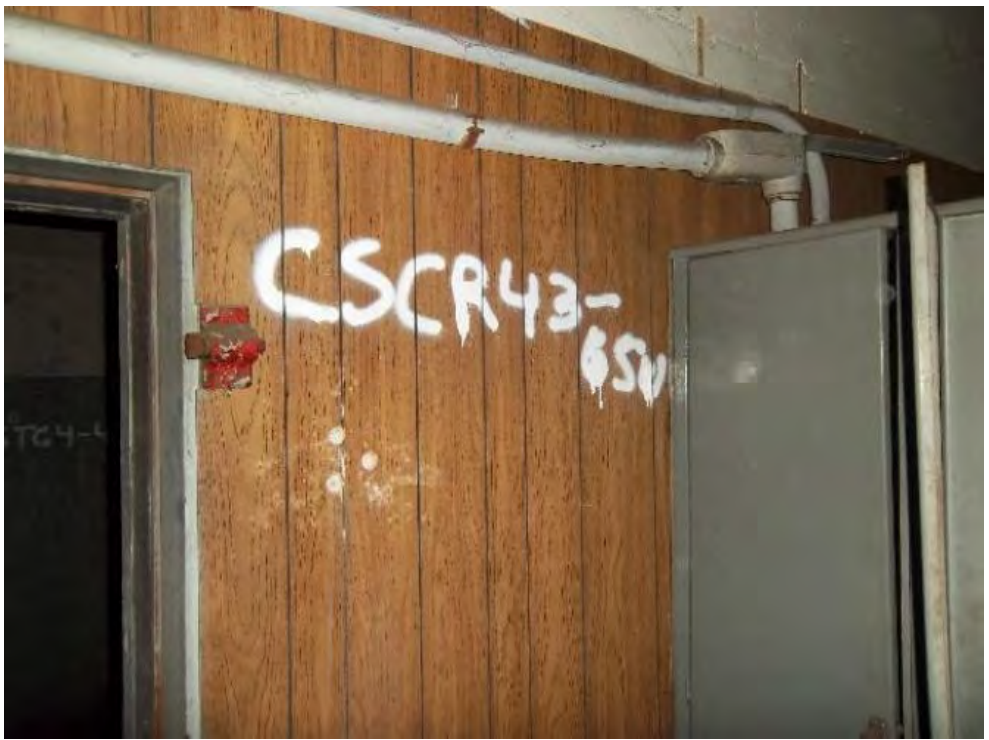
Photograph ID: 10

Photo Location: 3003 North Hollywood Way Property Control Room Between Test Cell #3 and Test Cell #4.	
Direction: East	
Survey Date: 3/29/2011	
Comments: Concrete Sampling Location on East Wall.

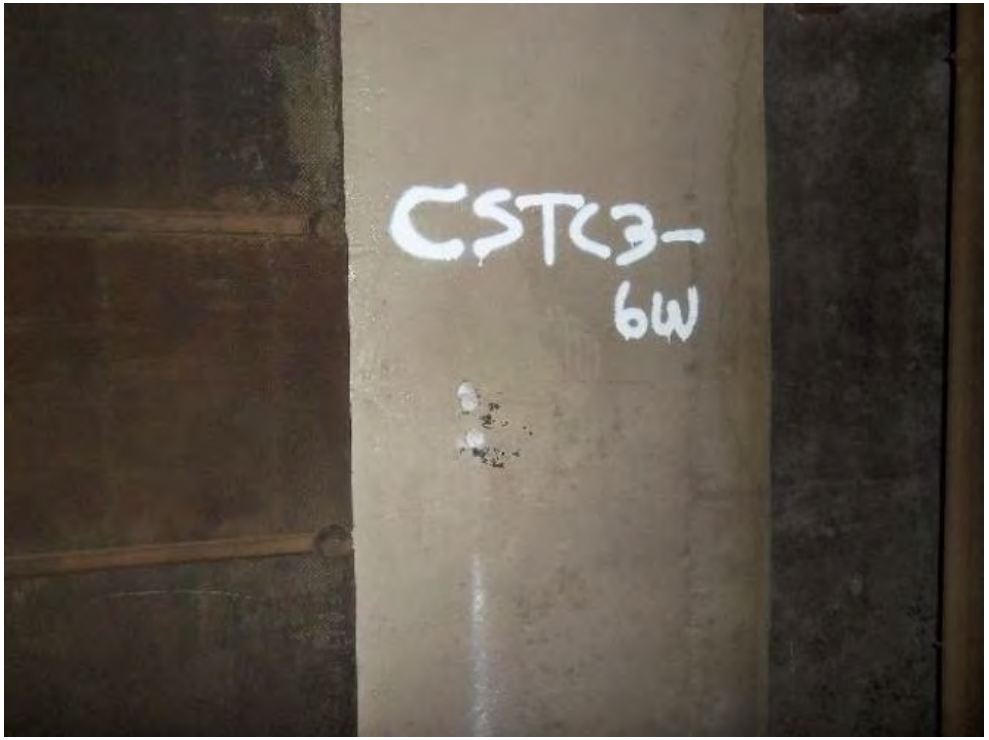
Photograph ID: 11

Photo Location: 3003 North Hollywood Way Property Test Cell #3	
Direction: West	
Survey Date: 3/29/2011	
Comments: Concrete Sampling Location on West Wall

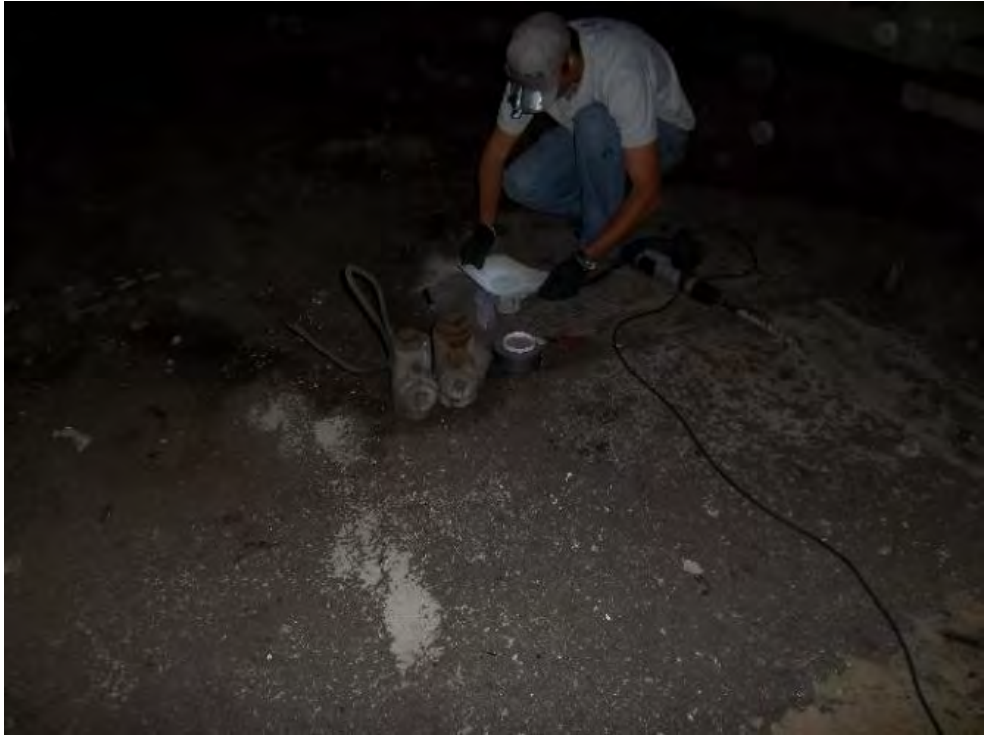
Photograph ID: 13

Photo Location: 3003 North Hollywood Way Property Test Cell #2.	
Direction: East	
Survey Date: 3/29/2011	
Comments: Concrete Sampling.

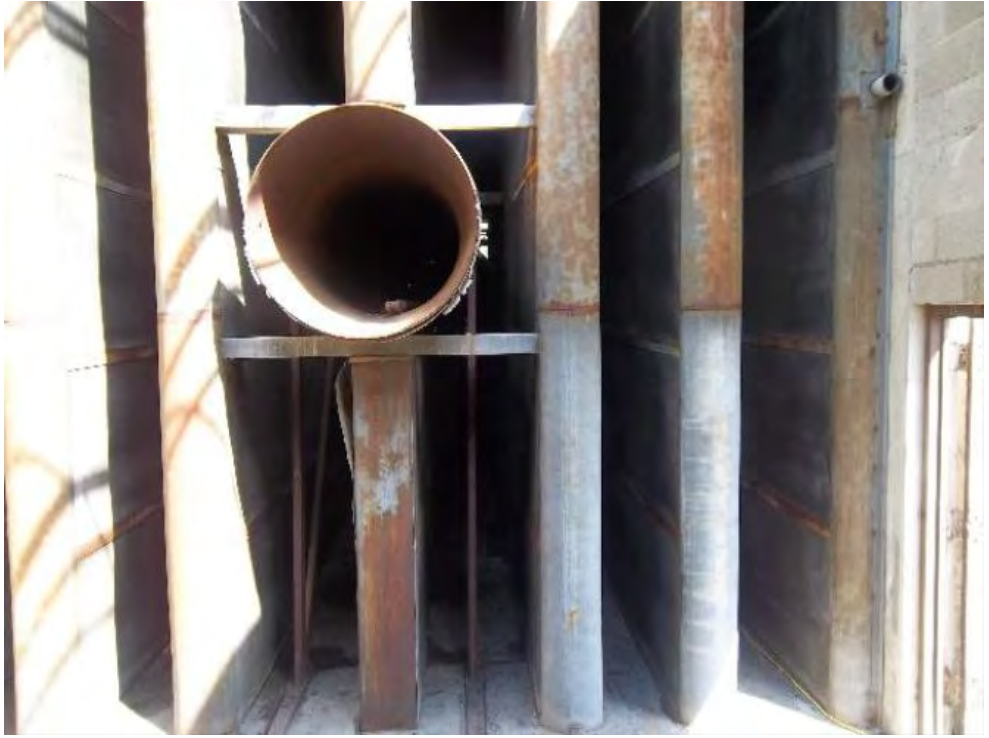
Photograph ID: 17

Photo Location: 3003 North Hollywood Way Property Test Cell #1.	
Direction: North	
Survey Date: 3/29/2011	
Comments: Sound Damper Baffles in Test Cell #1.

- Noise suppression baffle material – Baffle material was sampled and analyzed for hazardous waste characteristics. The TCLP lead concentrations exceeded the hazardous waste limits and therefore this material was classified as a hazardous waste.
- Suspected ACM materials – Potential ACM materials that were not previously characterized were sampled. Materials identified as ACM were designated for abatement.
- Concrete - Concrete core samples were collected from throughout the facility and analyzed for total petroleum hydrocarbons (TPH). TPH analytical results from the concrete core sampling are presented on **Figure 3**. Based on the TPH results, concrete material was segregated based on the TPH limits for different disposal/recycling facilities.

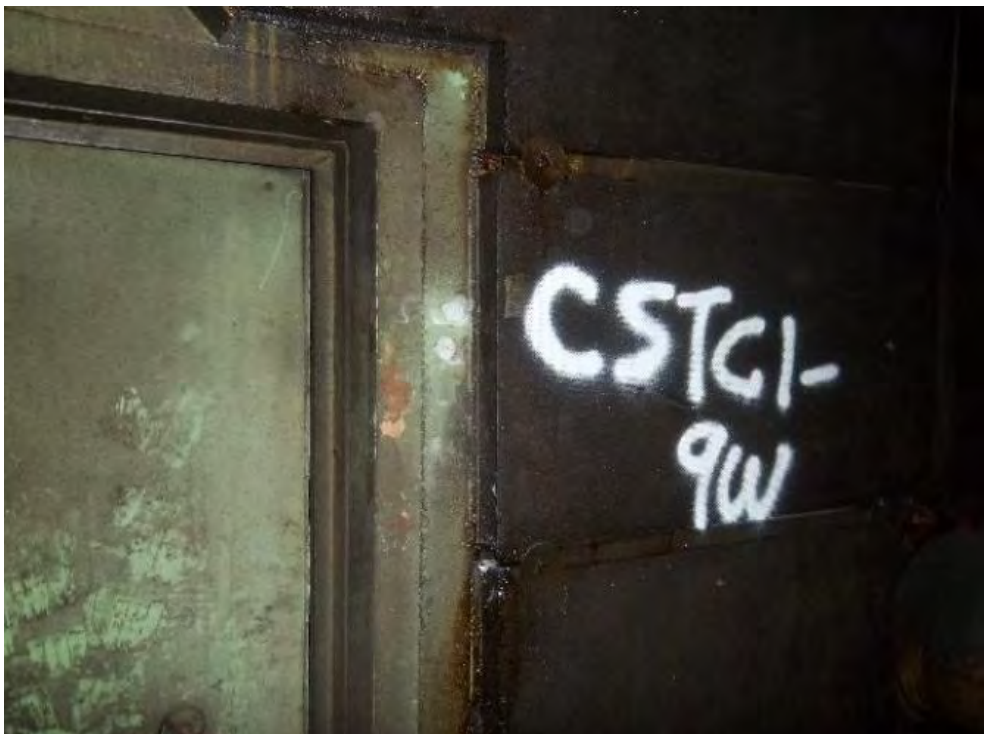
Photograph ID: 18

Photo Location: 3003 North Hollywood Way Property Test Cell #1.	
Direction: East	
Survey Date: 3/29/2011	
Comments: Concrete Sampling Location on East Wall.
