Client:	GE Corporate Environmental Programs	Project:	Site Demolition Activities
Site Name:	Former Pacific Airmotive Facility	Site Location:	3003 N Hollywood Way, Burbank, California

Client:	GE Corporate Environmental Programs	Project:	Demolition Activities
Site Name:	Former Pacific Airmotive Facility	Site Location:	3003 N Hollywood Way, Burbank, California

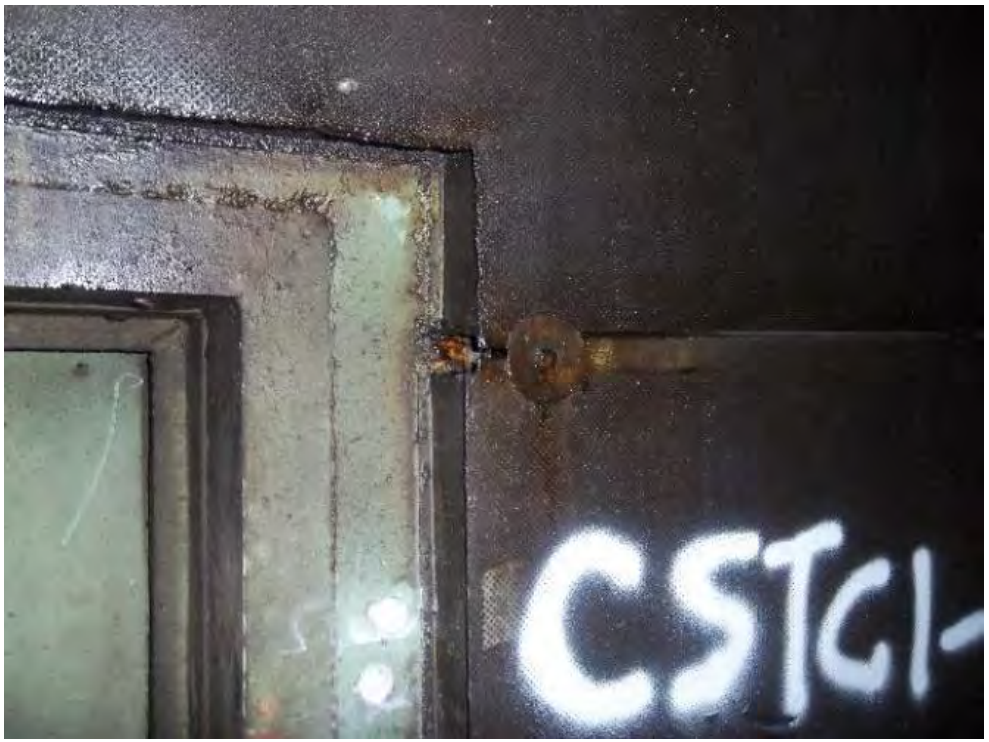
Photo Location: 3003 North Hollywood Way Property Test Cell #1.	
Direction: East	
Survey Date: 3/29/2011	
Comments: Concrete Sampling Location on East Wall. Note Oil Stains.

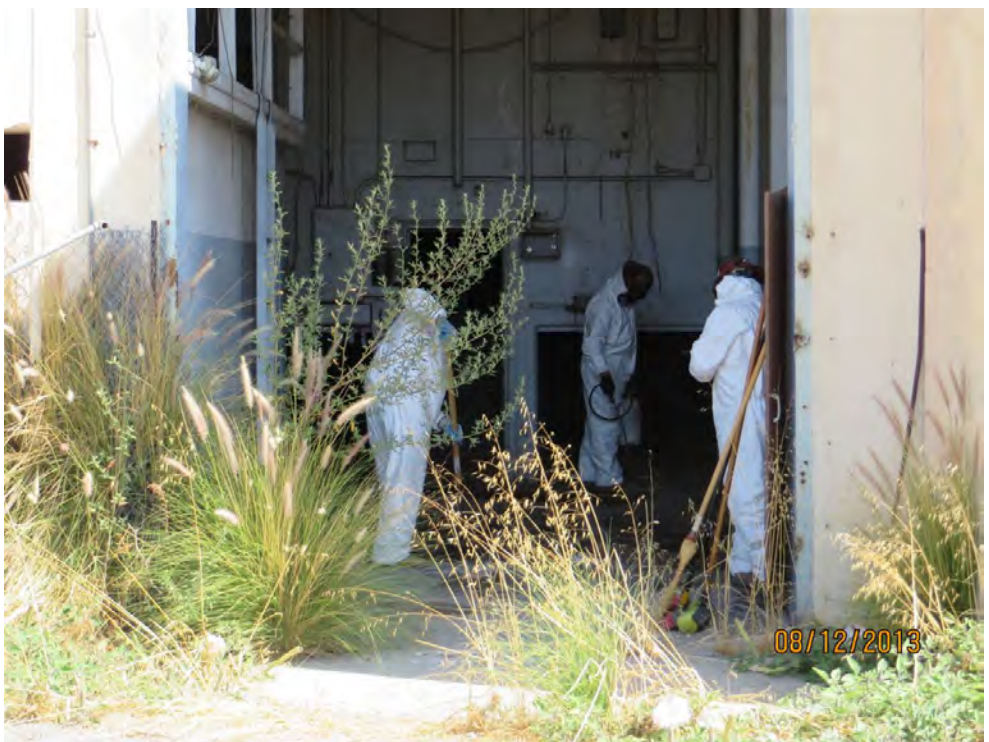
<p>Photograph ID: 10</p> <p>Photo Location: Engine Prep Room # 2</p> <p>Direction: North</p> <p>Survey Date: 8/12/2013</p> <p>Comments: View of pigeon droppings clean-up activities.</p>

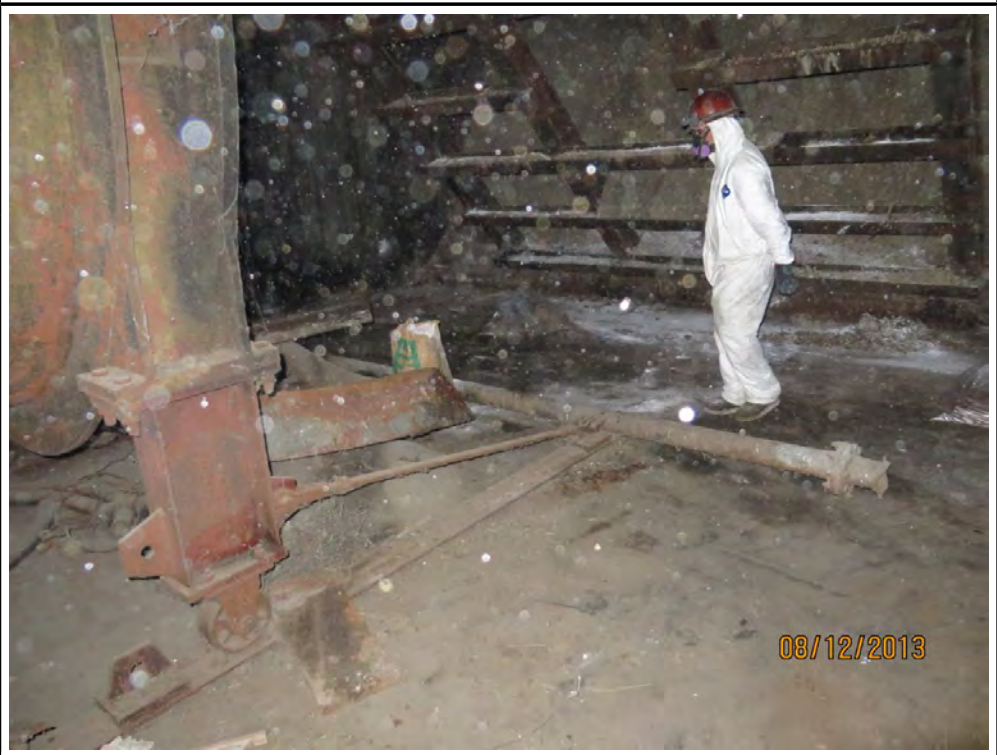
Photograph ID: 14

Photo Location:
Test Cell 5 - Exhaust Area

Comments:
View of pigeon droppings clean-up activities.

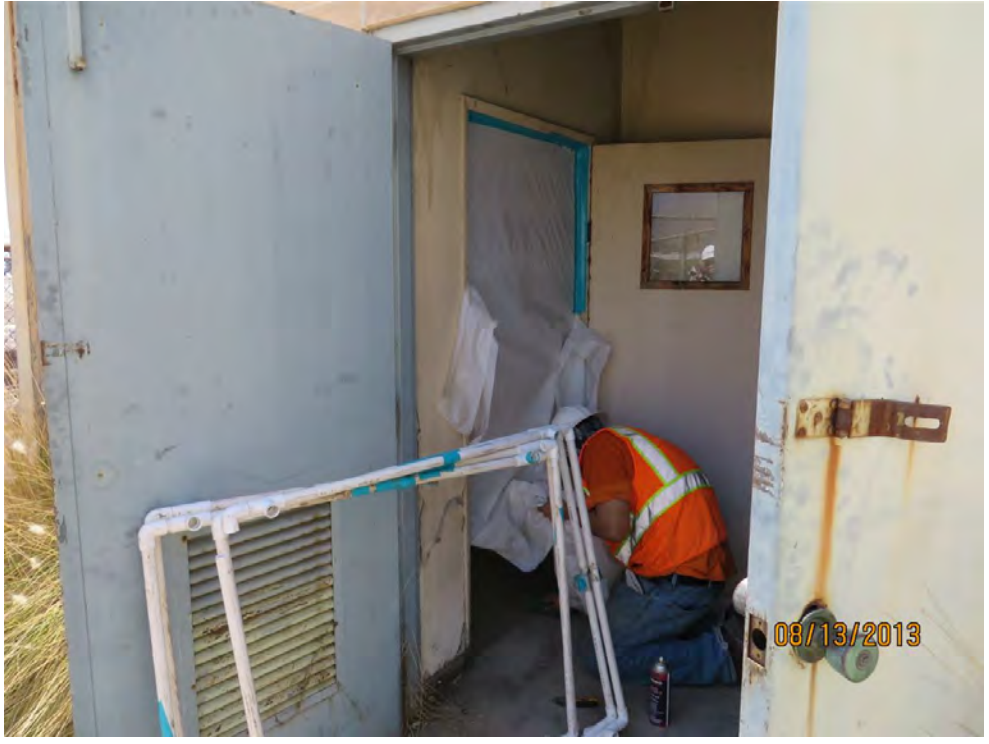
Photograph ID: 11

Photo Location: Office	
Direction: West	
Survey Date: 8/13/2013	
Comments: View of preparation of ACM containment area.

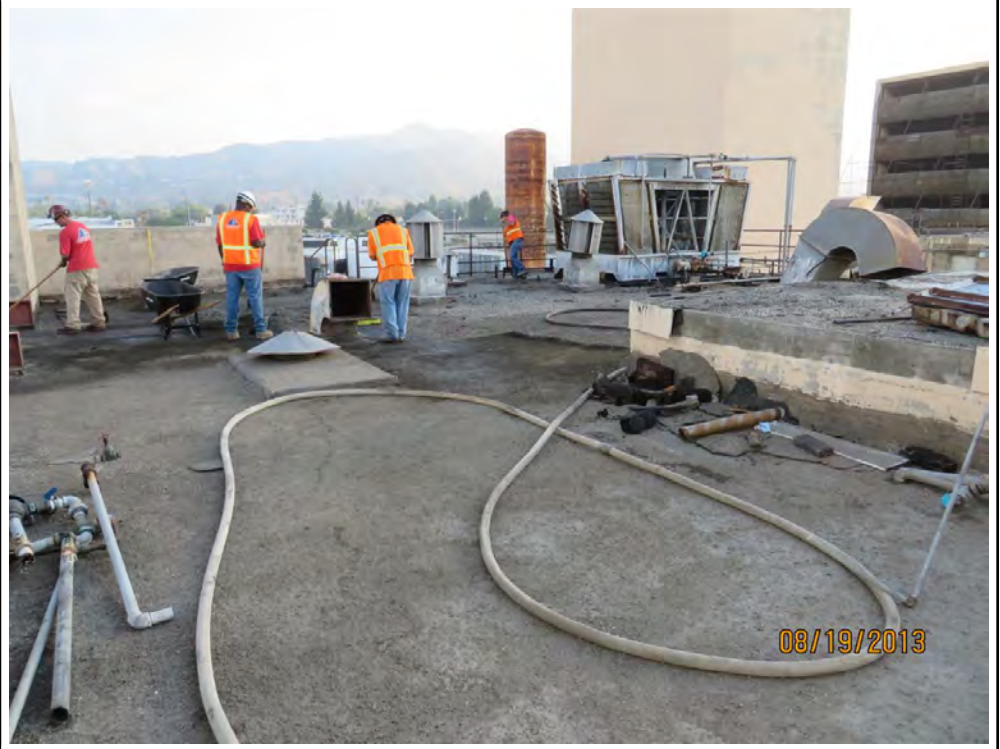
Photograph ID: 2

Photo Location:
Building C Rooftop (Test Cell 1 and 2)

Comments:
A view of roofing material (tar paper and gravel) and metal piping removal activities. Water hose is used during pipe cutting.

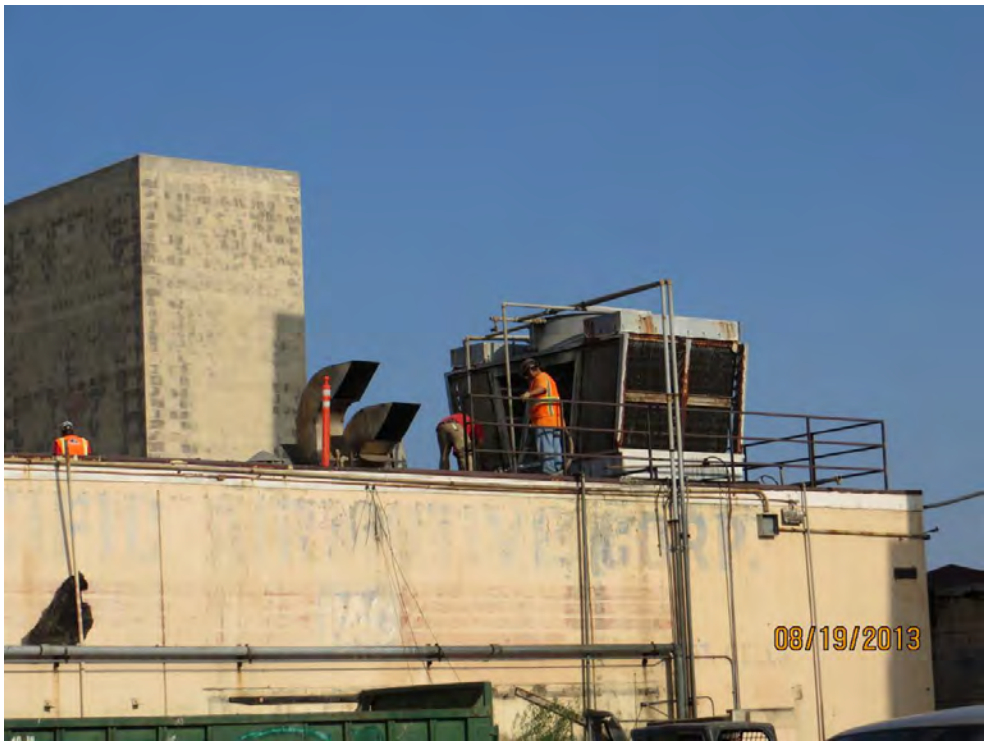
<p>Photograph ID: 3</p> <p>Photo Location: Building C Rooftop (Test Cell 1 and 2)</p> <p>Direction: West</p> <p>Survey Date: 8/19/2013</p> <p>Comments: View of metal cutting on the roof. Spark shield and water hose implemented during this activity.</p>

- 1 Daily safety tailgate conducted.
- 2 An incident occurred today during the soft demomtion activities on the roof above Test Stand # 1. The incident was a brush fire. The fire was started due to sparks emanating from pipe-cutting and landing on dry brush located on the ground. The affected area was on Burbank Airport property adjacent to Test Cell #1..Burbank Airport Fire Department personnel responded to the fire. The affected area was approximately 900 sq. ft. There was one specific root cause to this incident. The operator of the chop saw was facing a direction which sent sparks flying off the roof and down onto the ground. The adjacent work area on the roof and the affected area had been hosed down with water prior to starting operations. The corrective actions consist of the following; 1)better positioning of chop saw use, and 2) inplement using a spark shield to knock down the sparks immediately. After the incident was handled, the Aman crewand MWH stood-down all work activities for a Health and Safety meeting to discuss the incident and its countermeasures.

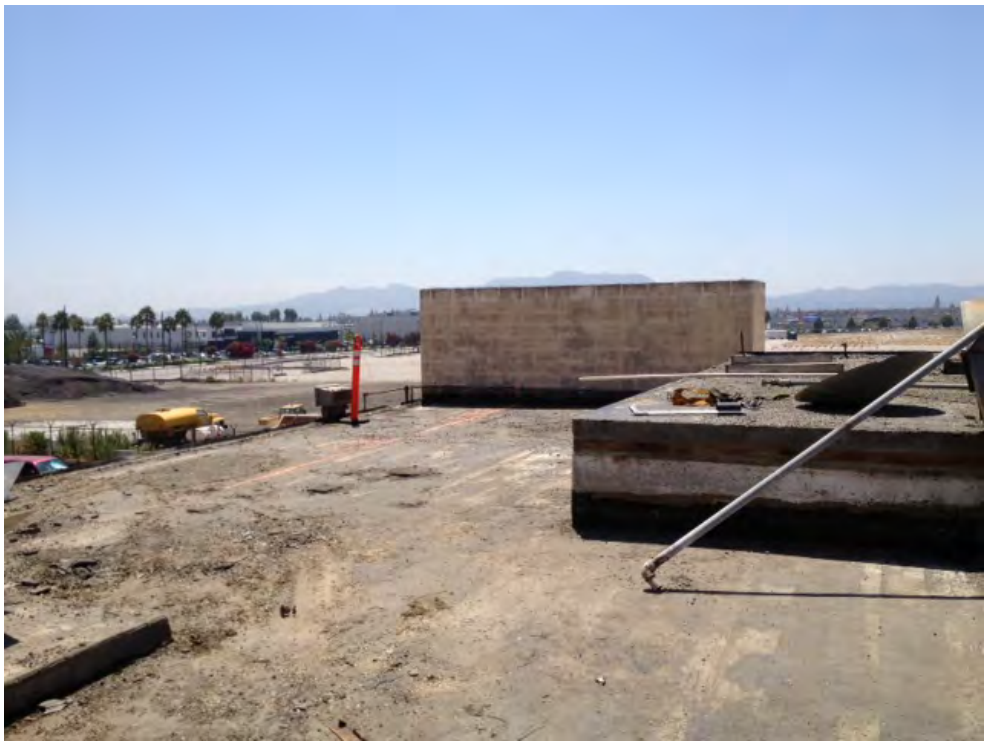
Photograph ID: 5

Photo Location: Roof	
Direction: South	
Survey Date: 8/20/2013	
Comments: A view of roof after roofing material removed.

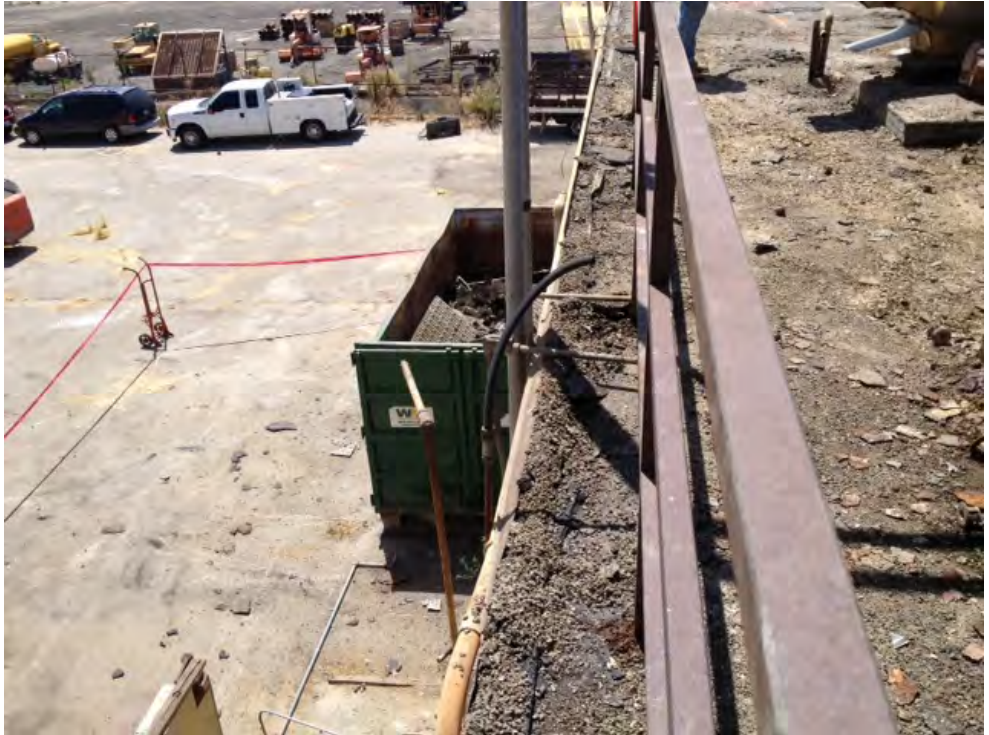
Photograph ID: 6

Photo Location: Roof	
Direction: South	
Survey Date: 8/20/2013	
Comments: A view of the roof along the eastern edge. A guard rail surrounds the cooling tower.

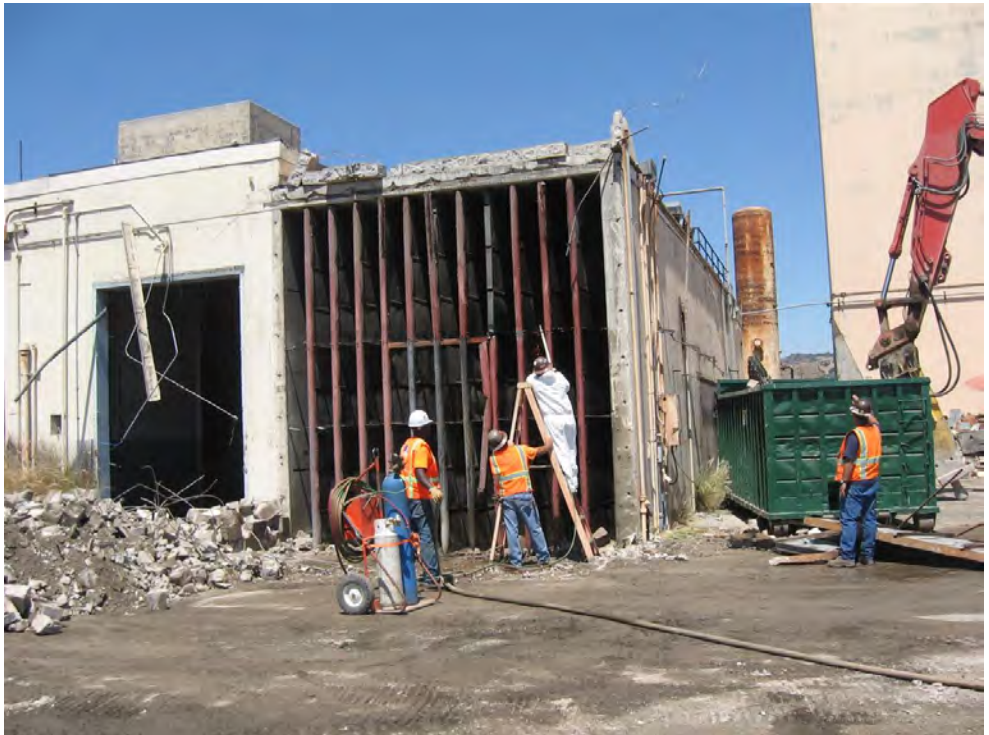
Photograph ID: 6

Photo Location: Test Cell #4	
Direction: North	
Survey Date: 8/21/2013	
Comments: A view of workers cutting metal baffling frame with a weld torch.

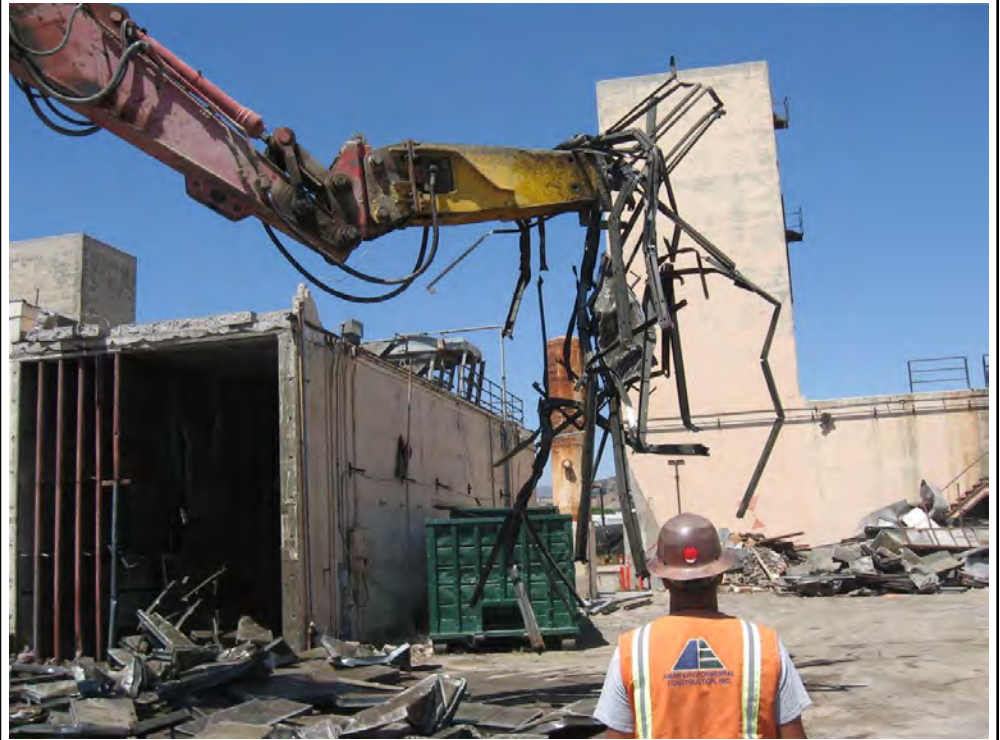
Comments:
A view of metal debris being segregated.

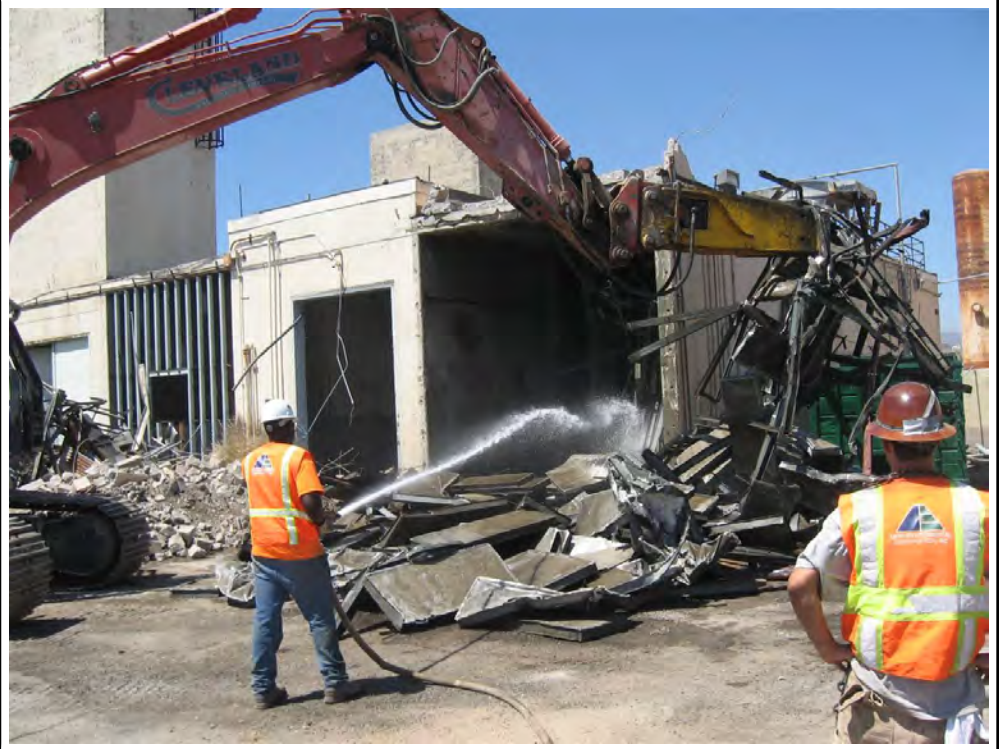
Photograph ID: 8

Comments:
A view of baffling material being removed from Test Cell #4.

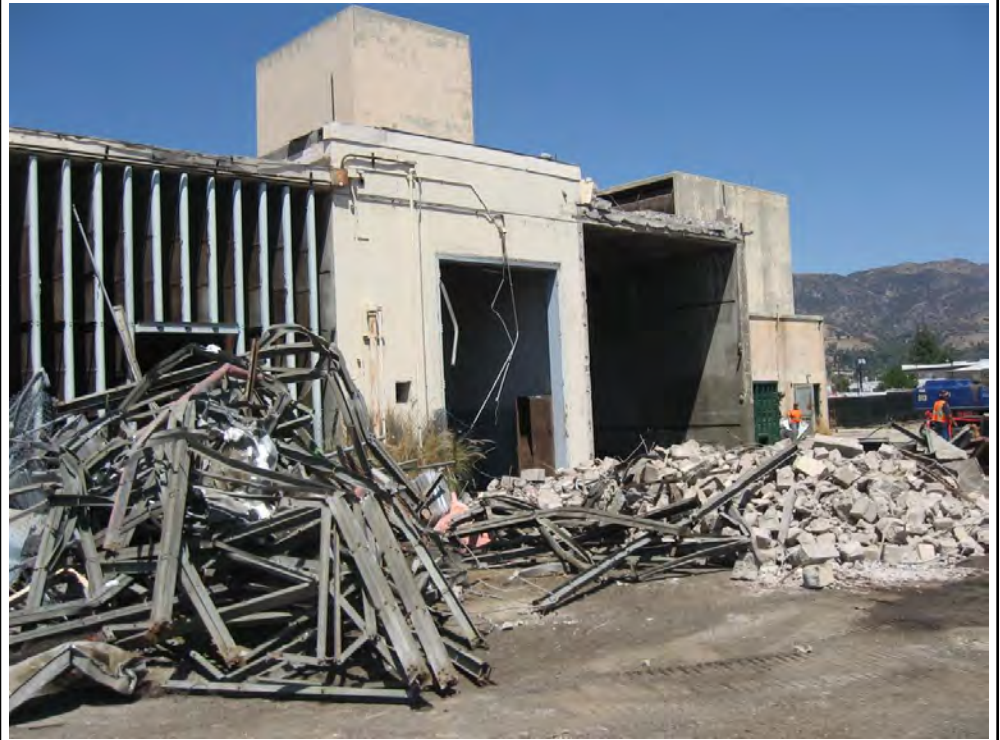
Photograph ID: 9

Comments:
A view of waste material stockpiles.

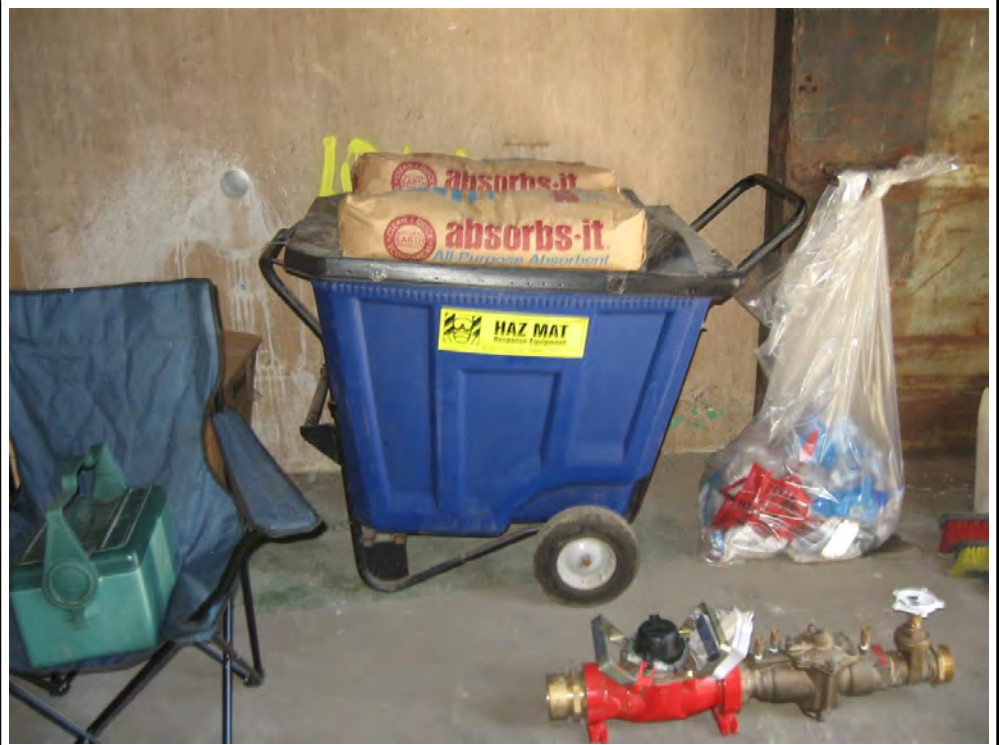
Photograph ID: 10

Comments:
A view of hazardous materials clean-up kit located in Test Cell #5.

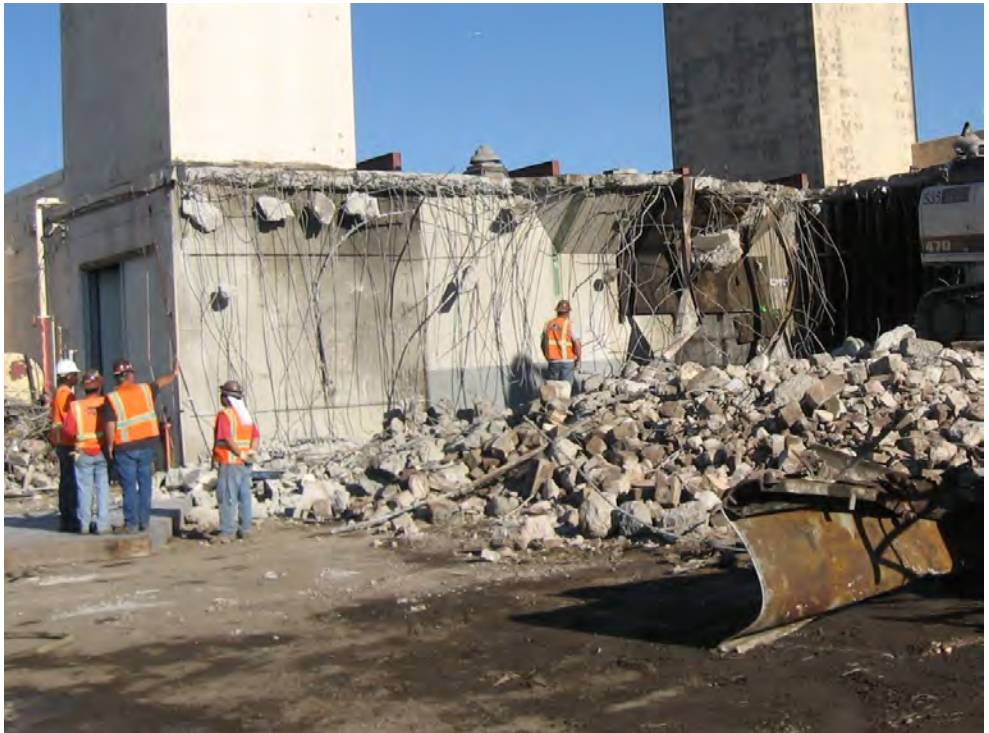
Photograph ID: 4

Photo Location: Test Cell #3	
Direction: Northwest	
Survey Date: 8/23/2013	
Comments: A view of Aman crew during a meeting to discuss segregation of TPH impacted concrete on the western wall (exposed wall shown) of Test Cell #3.

- 1 Demolition of Test Cell #2, Loading Dock roof and Test Cell #1 and #2 exhaust towers.
- 2 Segregating concrete metal and baffle waste. TPH impacted concrete waste marked with paint and left in-place to segregate at a later date.
- 3 Additional suspected ACM (approx. 72 ft) found within Test Cell #2 door material.

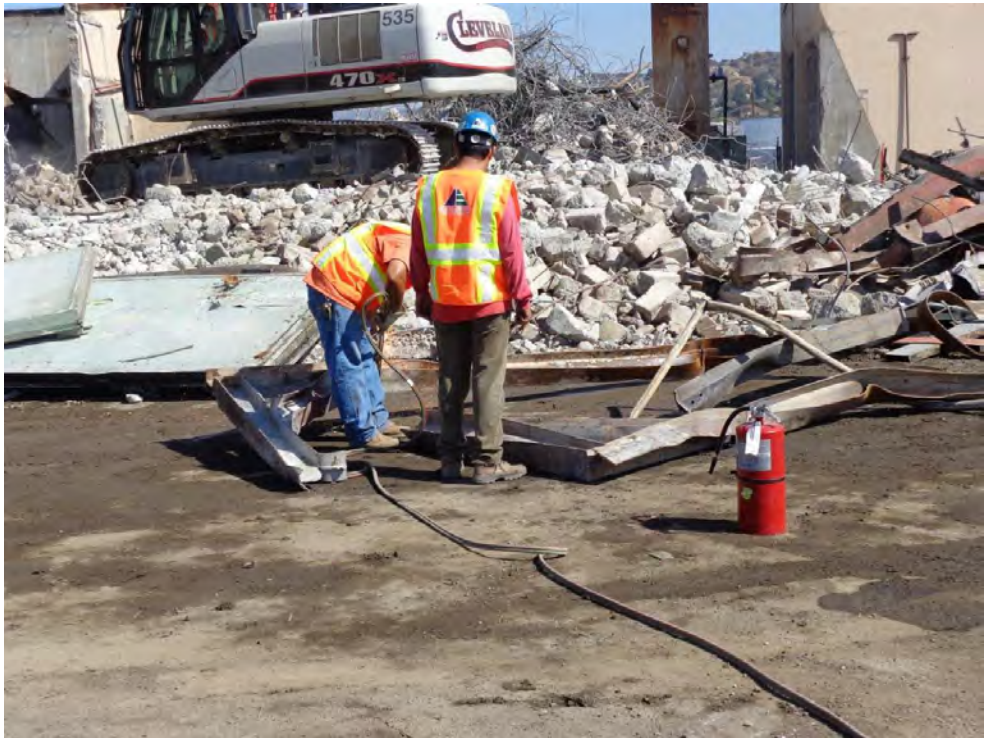
<p>Photograph ID: 5</p> <p>Photo Location: Parking Area</p> <p>Direction: North</p> <p>Survey Date: 8/26/2013</p> <p>Comments: A view of Aman crew torch cutting metal to reduce size. Fire extinguisher and additional crew member available during all torch cutting operations for fire prevention.</p>

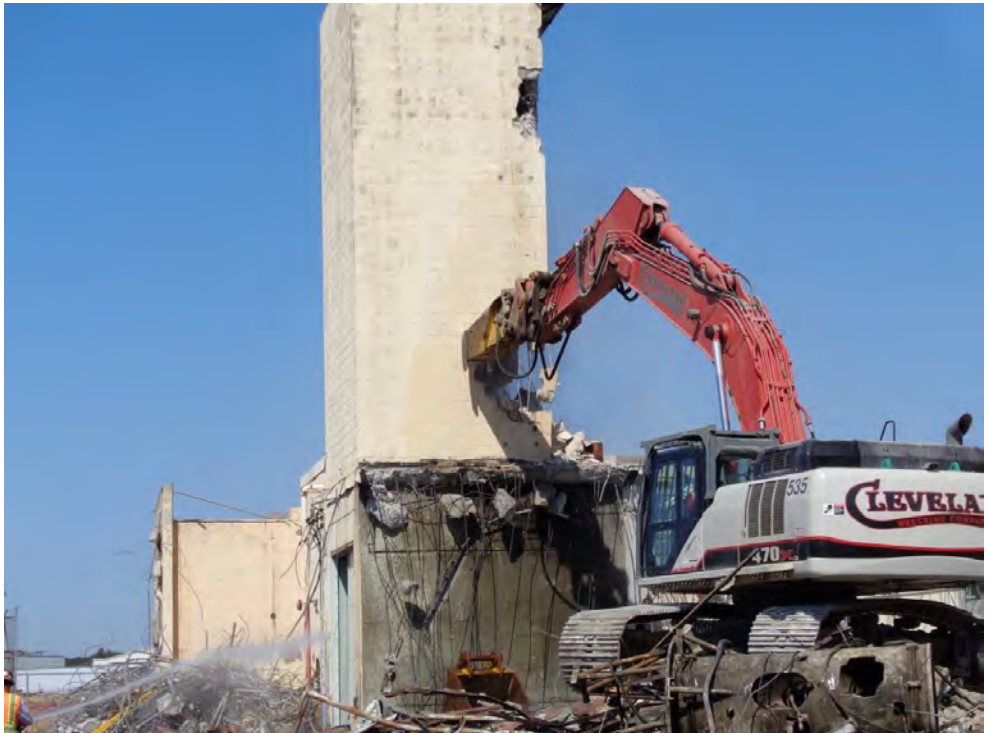
<p>Photograph ID: 6</p> <p>Photo Location: Test Cell #2 Exhaust Tower</p> <p>Direction: West</p> <p>Survey Date: 8/26/2013</p> <p>Comments: A view of Test Cell #2 exhaust tower demolition.</p>

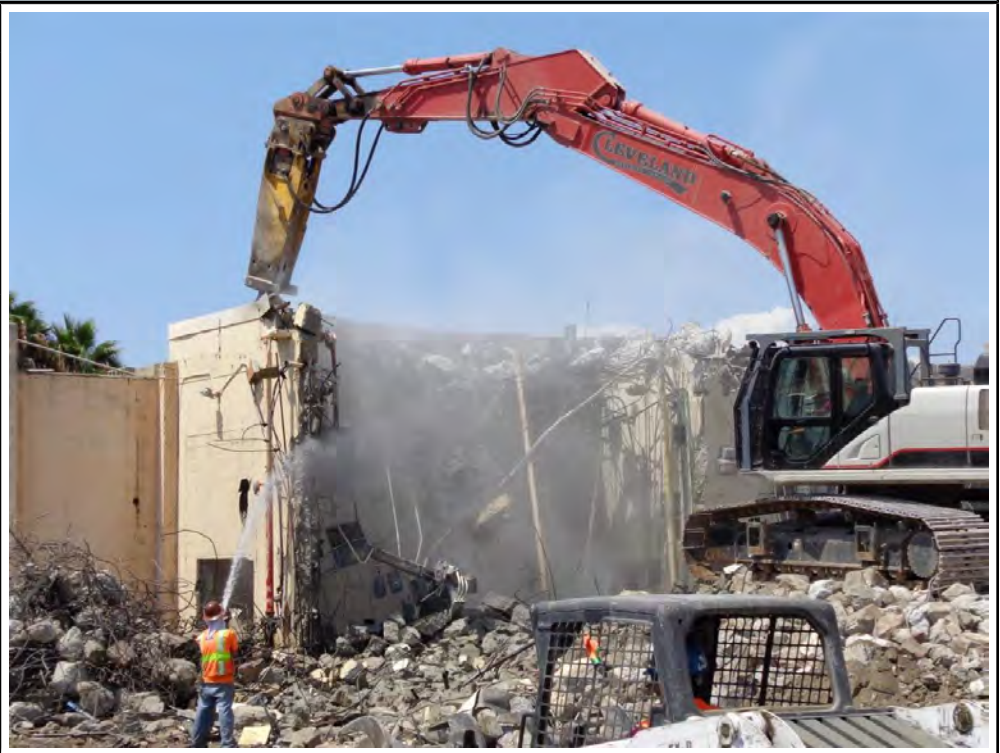
Photograph ID: 11
Photo Location: Engine Room #1
Direction: Northwest
Survey Date: 8/26/2013
Comments: A view of Engine Prep Room #1 demolition.

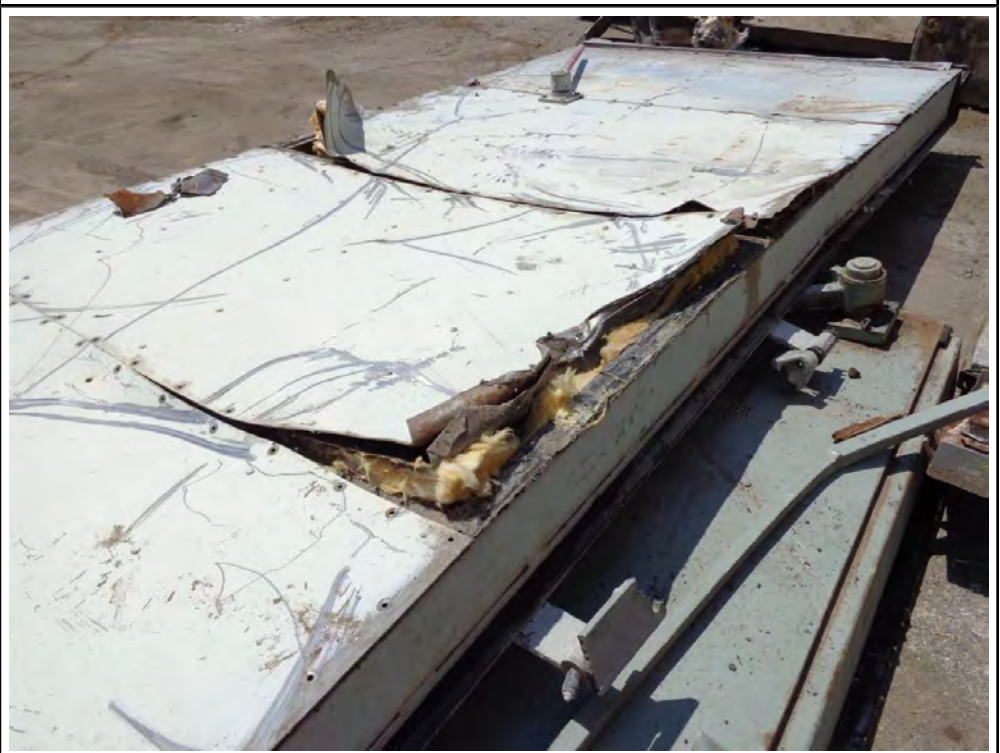
Photograph ID: 12
Photo Location: Test Cell #2 Doors
Direction: North
Survey Date: 8/26/2013
Comments: A view of Test Cell #2 Doors. Additional suspected ACM identified within the interior door structure.

- 14 Additional suspected ACM (approx. 72 sq ft) found within Test Cell #2 door material, analysis pending.
- 15 PPE and plastic sheeting containerized in contractor-sized garbage bags.

- 15 Additional ACM found within Test Cell #2 door material removed and sealed in 4 double poly bags.
- 16 PPE and plastic sheeting containerized in contractor-sized garbage bags.

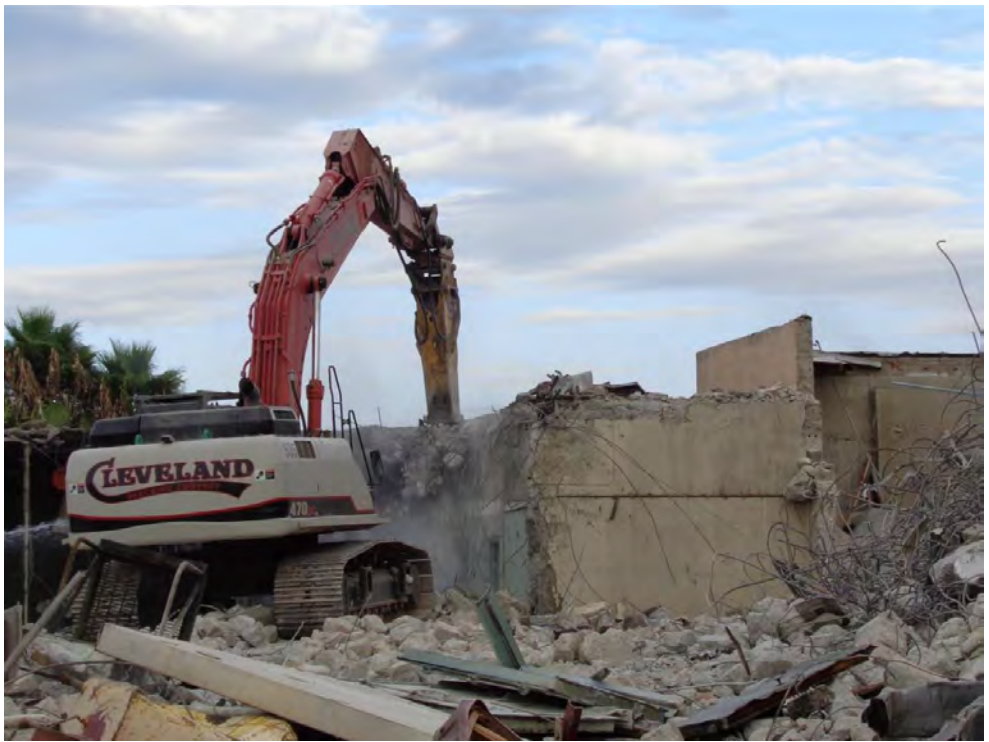
Photograph ID: 1

Photo Location: Test Cell #1 and Storage Room #1	
Direction: West	
Survey Date: 8/27/2013	
Comments: A view of Test Cell #1 demolition.

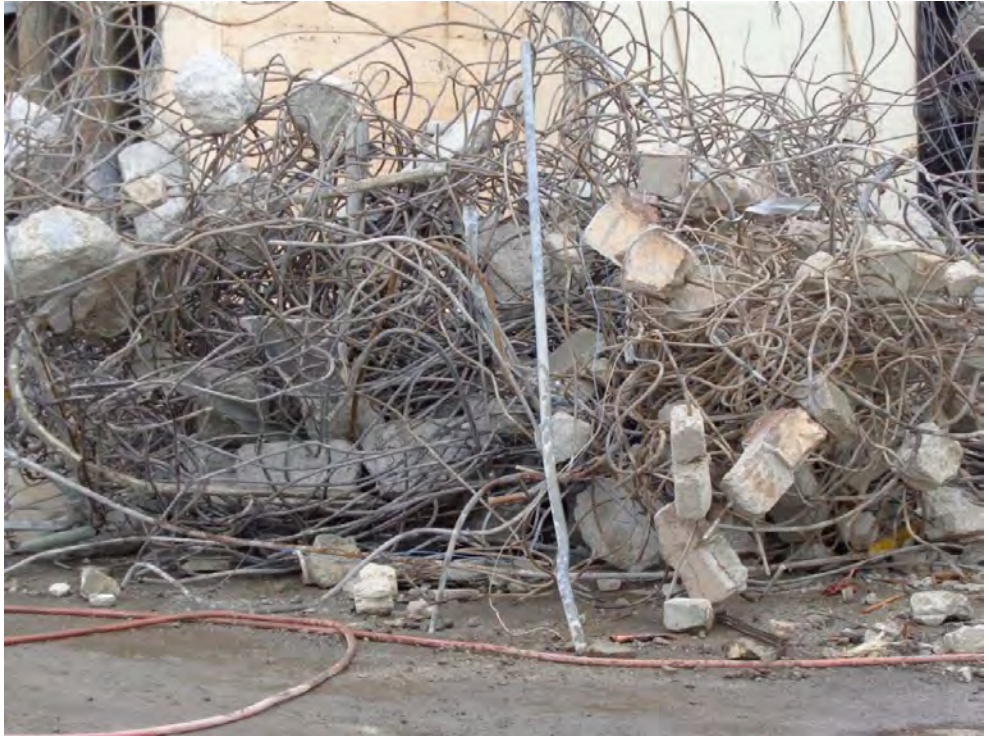
Photograph ID: 3

Photo Location: Test Cell #1	
Direction: North	
Survey Date: 8/27/2013	
Comments: A view of rebar stockpile with concrete.

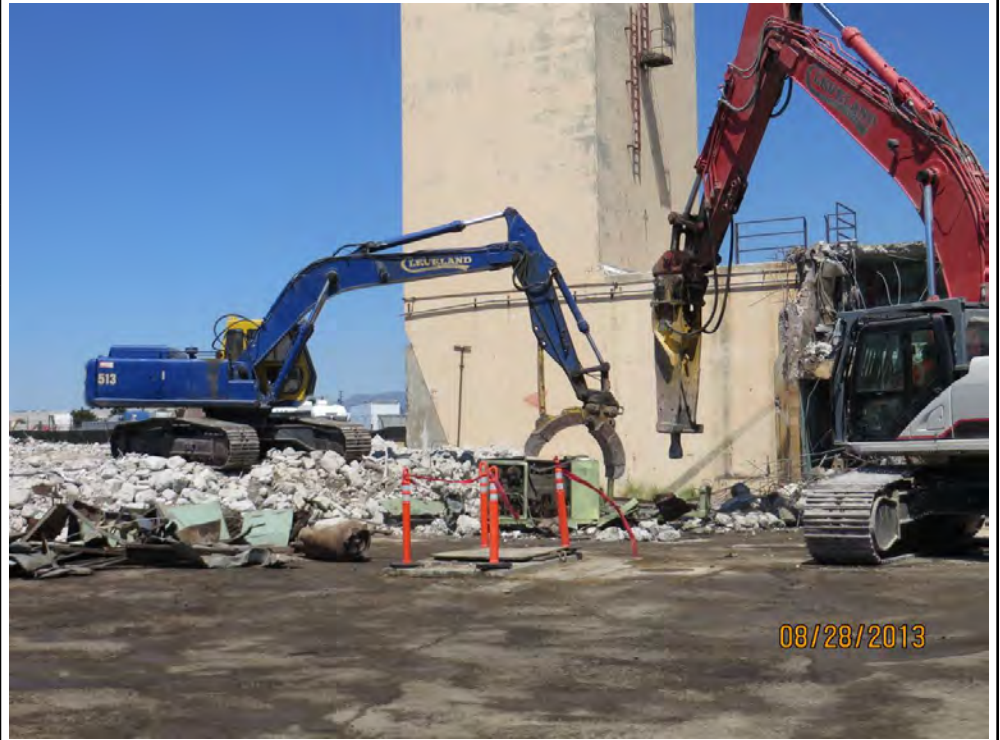
Comments:
A view of the Control Room #5 equipment being pulled out, segregated and striped for metal recycling.

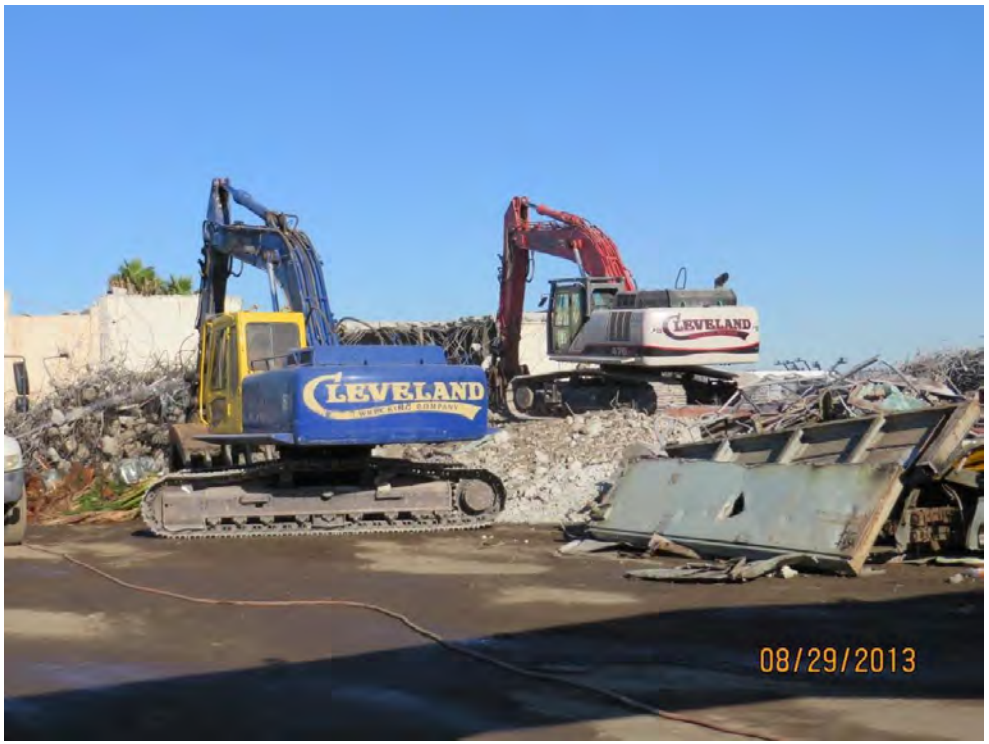
Photograph ID: 3

Photo Location: Parking Area	
Direction: West	
Survey Date: 8/29/2013	
Comments: A view of the excavators processing general waste (non-hazardous wood) shown on the left and rebar with concrete shown on the right.

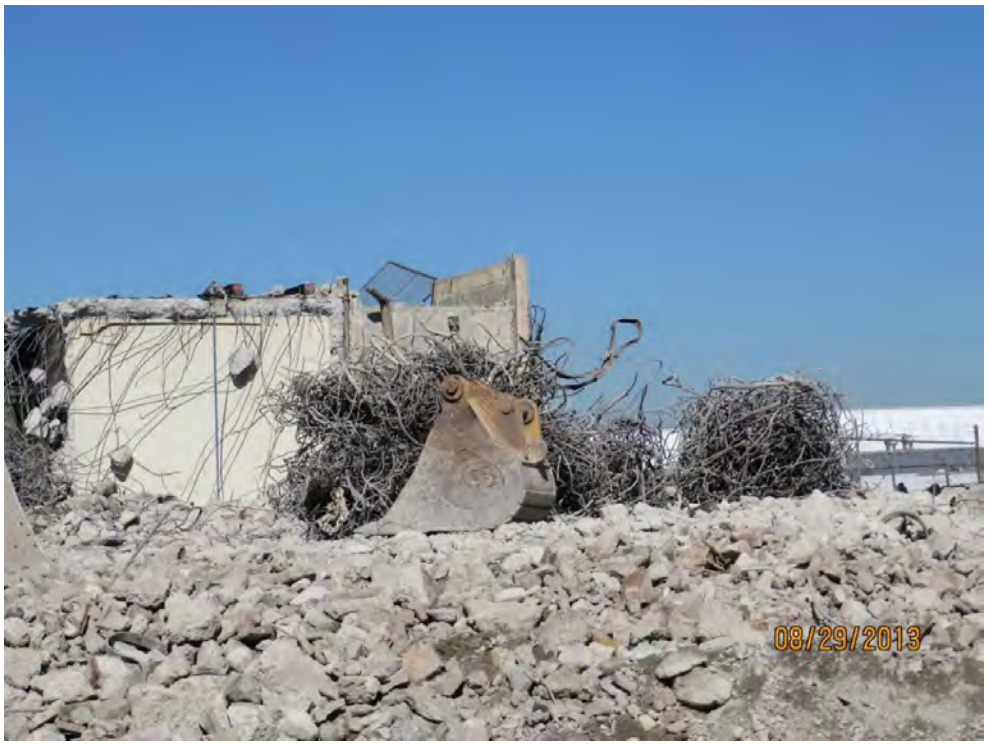
Photograph ID: 5

Photo Location: Parking Area	
Direction: West	
Survey Date: 8/29/2013	
Comments: A view of the processed rebar that is balled together to facilitate future loading.

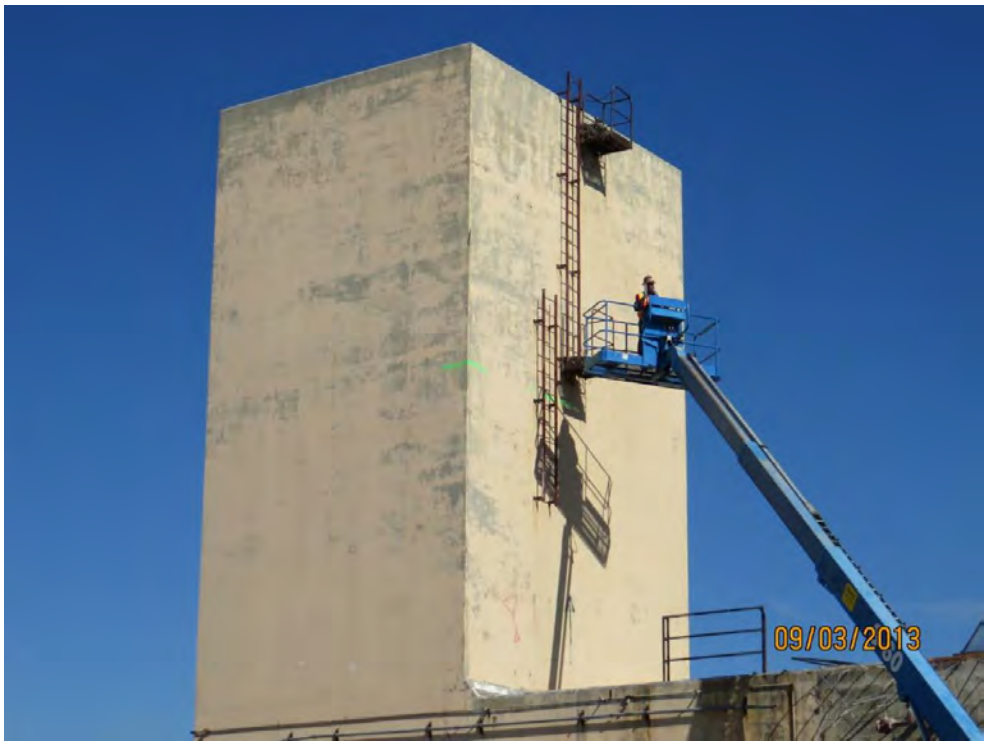
Photograph ID: 3

Photo Location: Tower Structure #3	
Direction: North	
Survey Date: 9/3/2013	
Comments: A view of an Aman crew member in the boom lift (with fall protection equipment installed) marking the tower structure #3 on the south and east walls 20 feet below the top of wall.

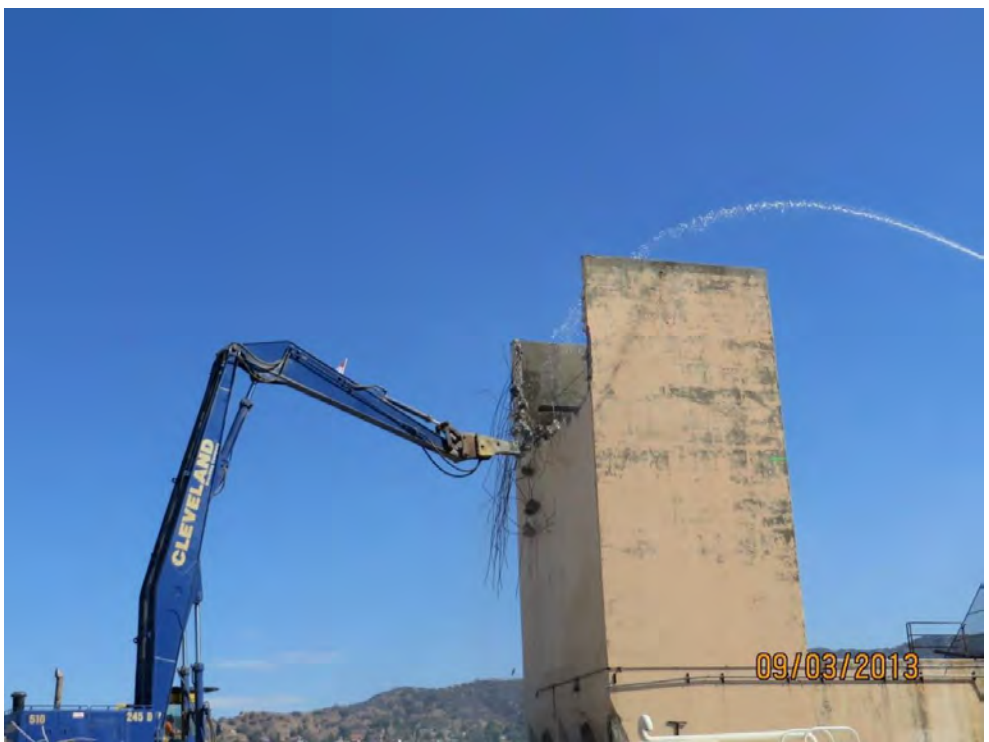
<p>Photograph ID: 6</p> <p>Photo Location: Tower Structure #3</p> <p>Direction: North</p> <p>Survey Date: 9/3/2013</p> <p>Comments: A view of the western structure wall being broken from the top down in approximately 4 feet by 4 feet sections to an elevation of approximately 20 feet below the top.</p>

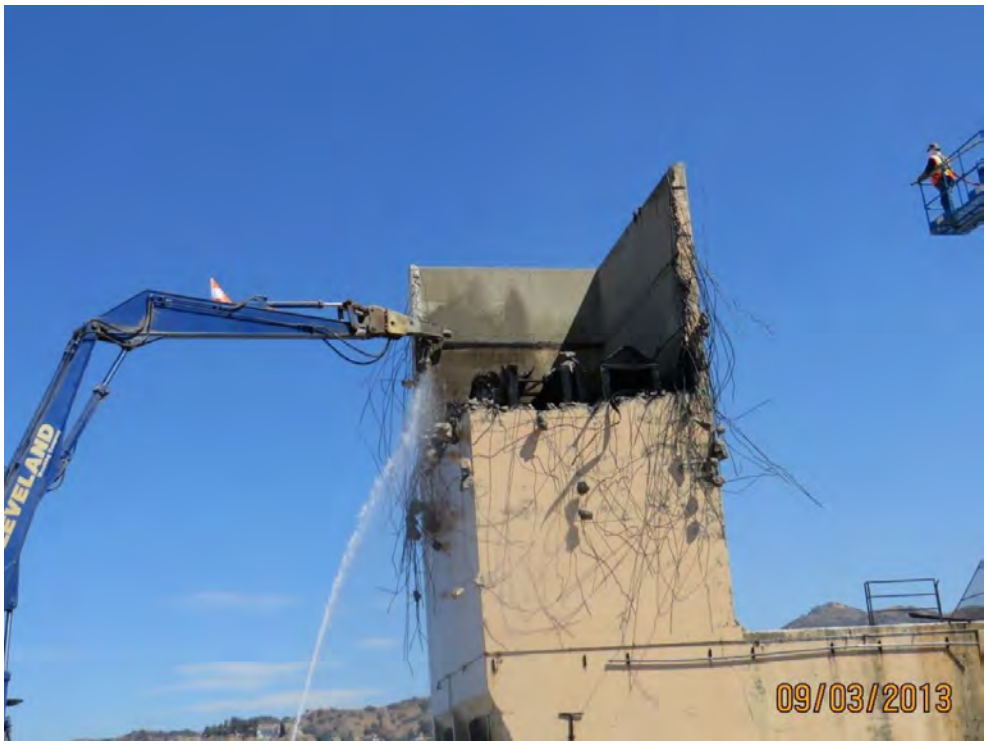
Photograph ID: 7

Photo Location: Tower Structure #3	
Direction: North	
Survey Date: 9/3/2013	
Comments: A view of the southern wall after demolition to approximately 20 feet below the top.

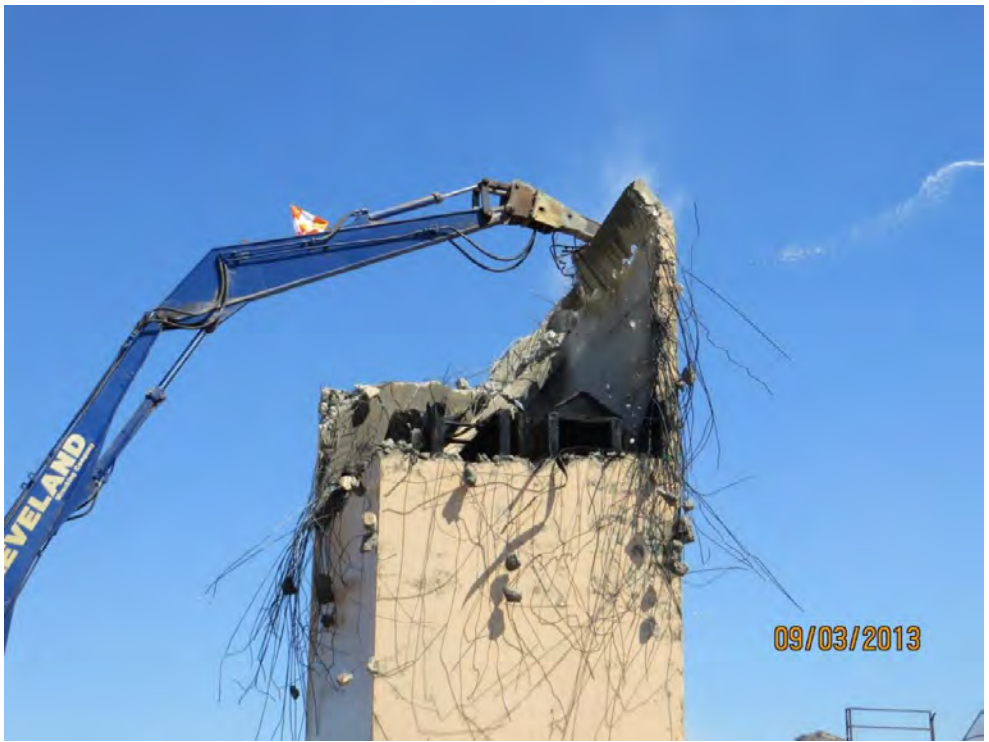
<p>Photograph ID: 9</p> <p>Photo Location: Tower Structure #3</p> <p>Direction: North</p> <p>Survey Date: 9/3/2013</p> <p>Comments: A view of the excavator breaker running a chase cut (approximately 4 feet tall) horizontally across the eastern wall face to provide a crease and then folding the section inward.</p>

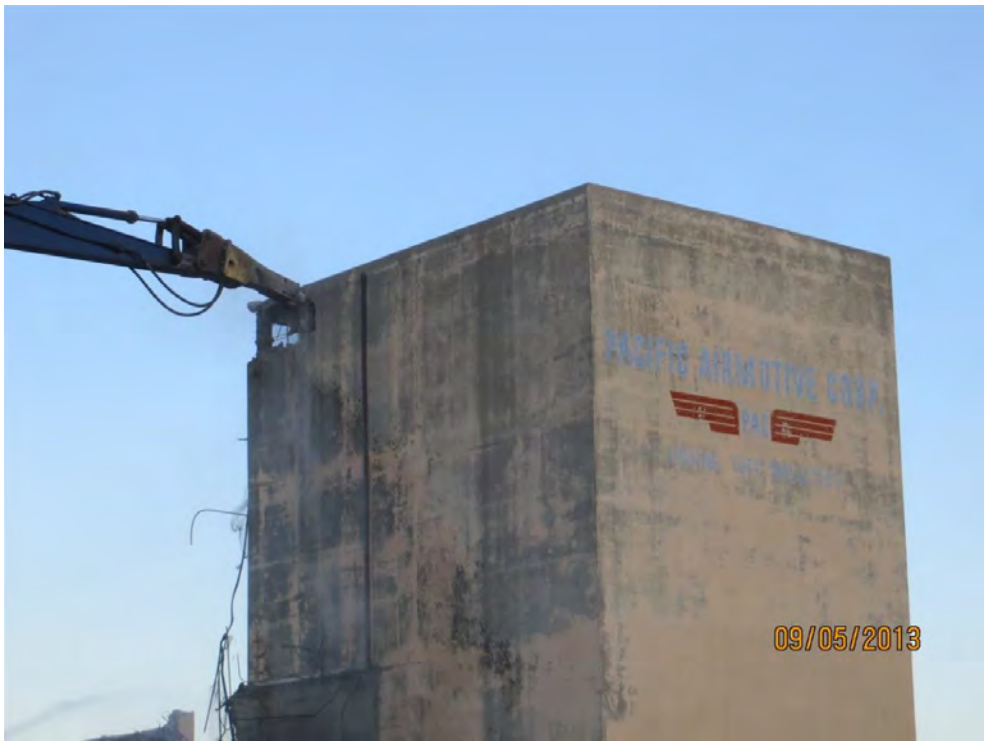
Photograph ID: 1

Photo Location: Tower Structure #4	
Direction: Northwest	
Survey Date: 9/5/2013	
Comments: Begin demolition of Tower Structure #4.
