Client:	GE Corporate Environmental Programs	Project:	Site Demolition Activities
Site Name:	Former Pacific Airmotive Facility	Site Location:	3003 N Hollywood Way, Burbank, California

Client:	GE Corporate Environmental Programs	Project:	Demolition Activities
Site Name:	Former Pacific Airmotive Facility	Site Location:	3003 N Hollywood Way, Burbank, California

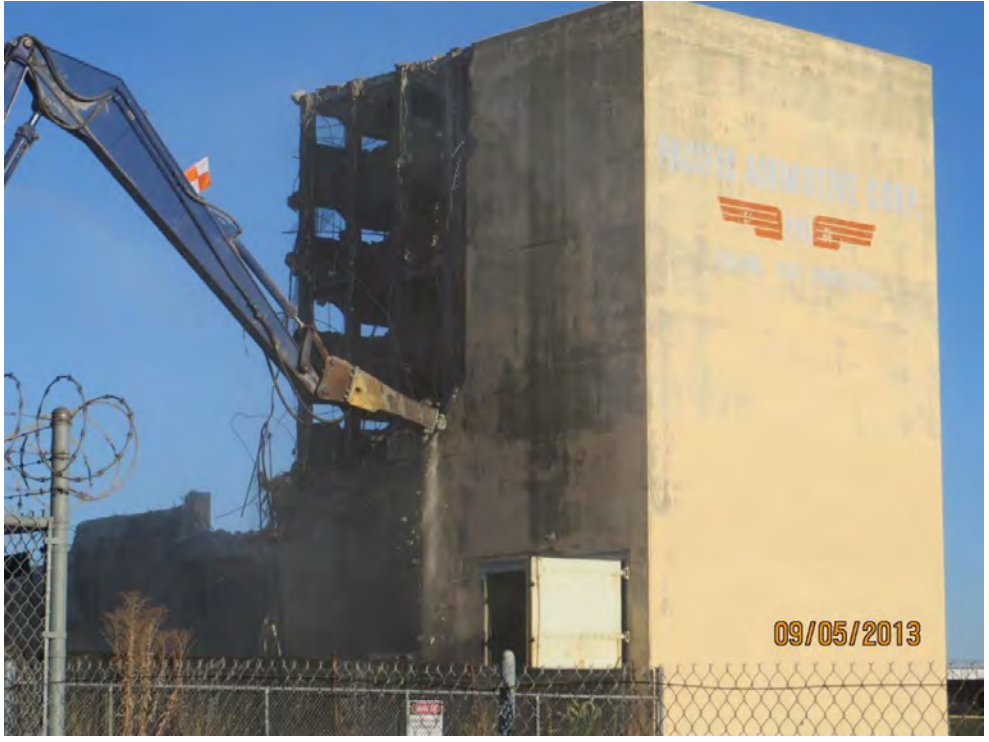
Photograph ID: 2

Photo Location: Tower Structure #4	
Direction: Northwest	
Survey Date: 9/5/2013	
Comments: A view of the four steel vertical support columns exposed on the southern wall of the tower structure.

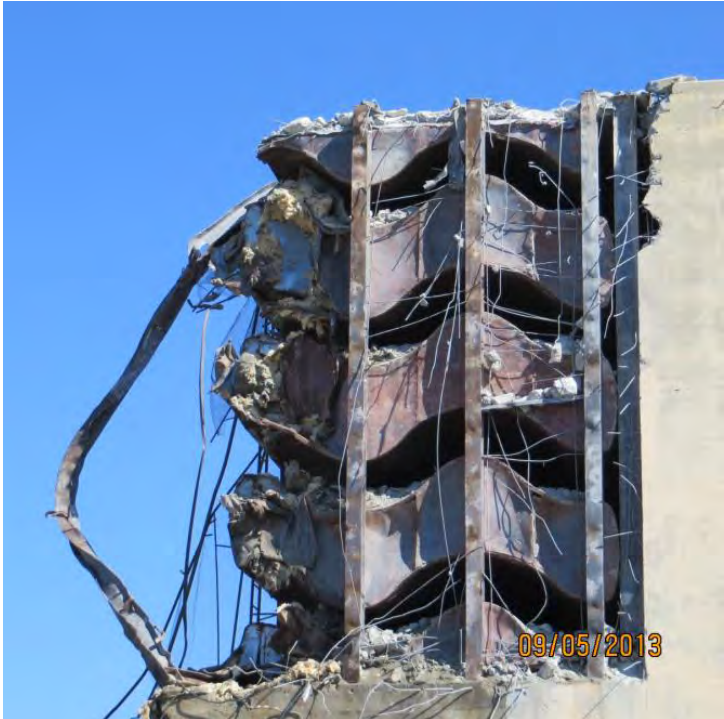
<p>Photograph ID: 4</p> <p>Photo Location: Tower Structure #4</p> <p>Direction: North</p> <p>Survey Date: 9/5/2013</p> <p>Comments: A view of the western steel vertical support column bent outward to access the baffle material.</p>

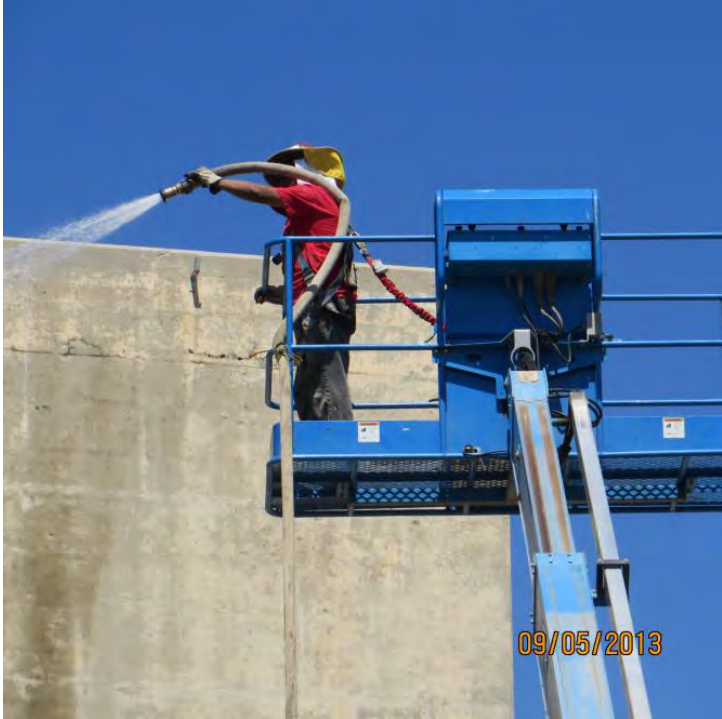
Photograph ID: 5

Photo Location: Tower Structure #4	
Direction: North	
Survey Date: 9/5/2013	
Comments: A view of an Aman crew member in a boom lift (with fall protection) applying water for dust suppression to the demolition area.

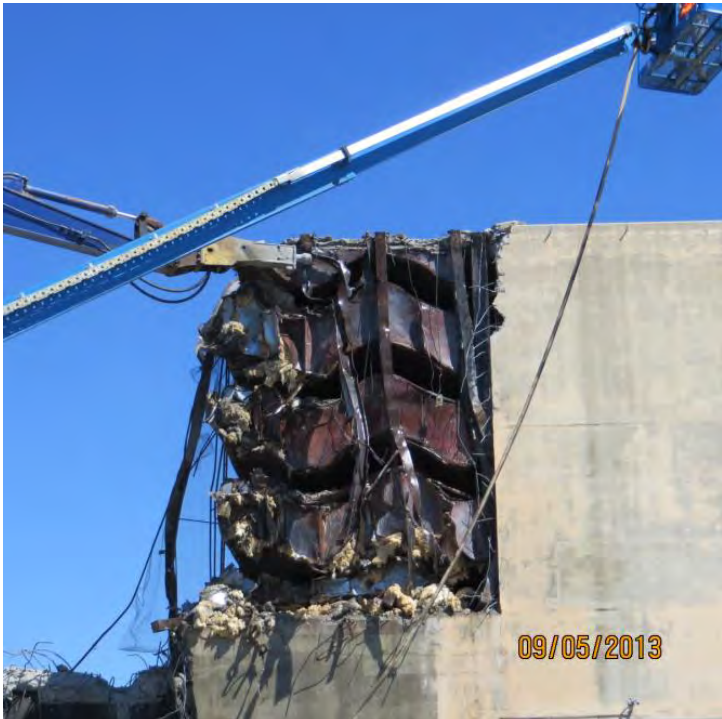
Photograph ID: 6

Photo Location: Tower Structure #4	
Direction: North	
Survey Date: 9/5/2013	
Comments: A view of the remaining vertical support columns being removed to gain access to the baffle material.

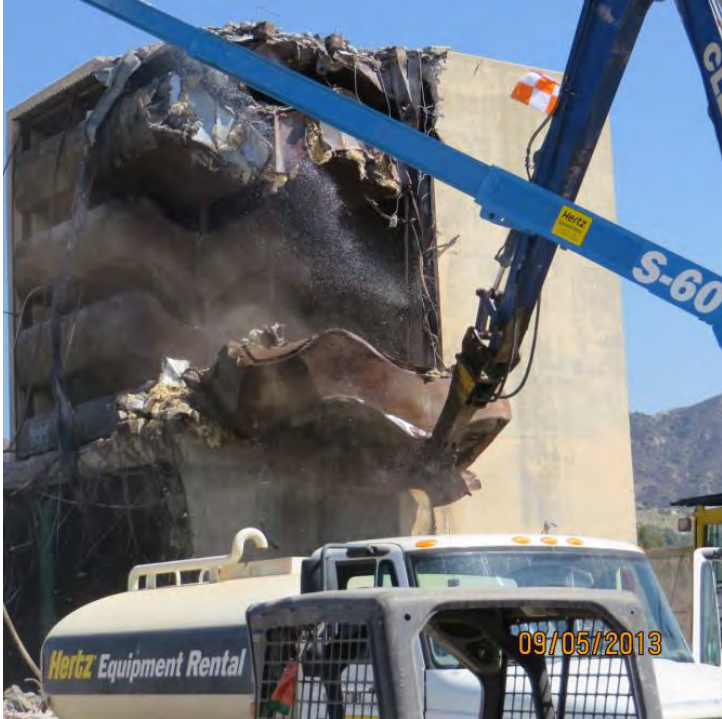
Photograph ID: 7

Photo Location: Tower Structure #4	
Direction: Northeast	
Survey Date: 9/5/2013	
Comments: A view of the baffle material being removed from Tower Structure #4.

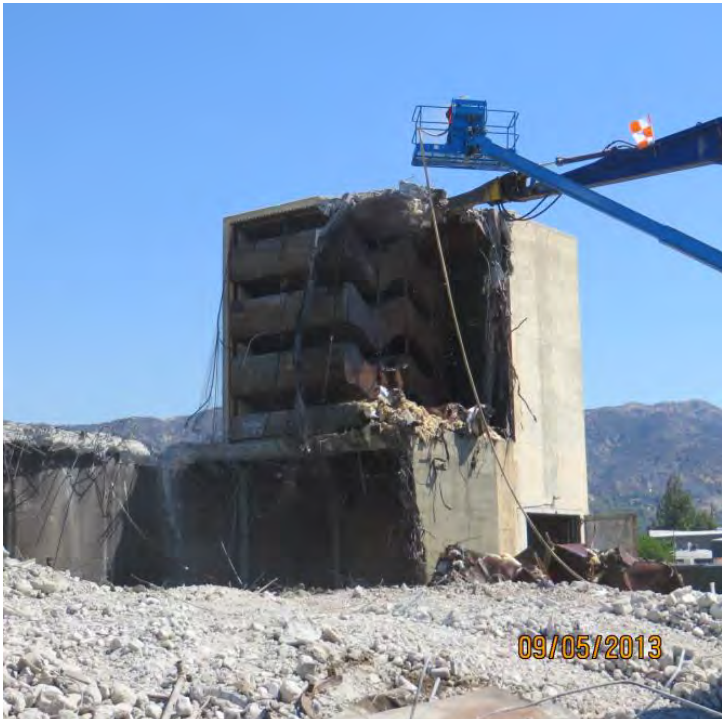
Photograph ID: 8

Photo Location: Tower Structure #4	
Direction: Northwest	
Survey Date: 9/5/2013	
Comments: Additional view of the baffle material being removed from Tower Structure #4.

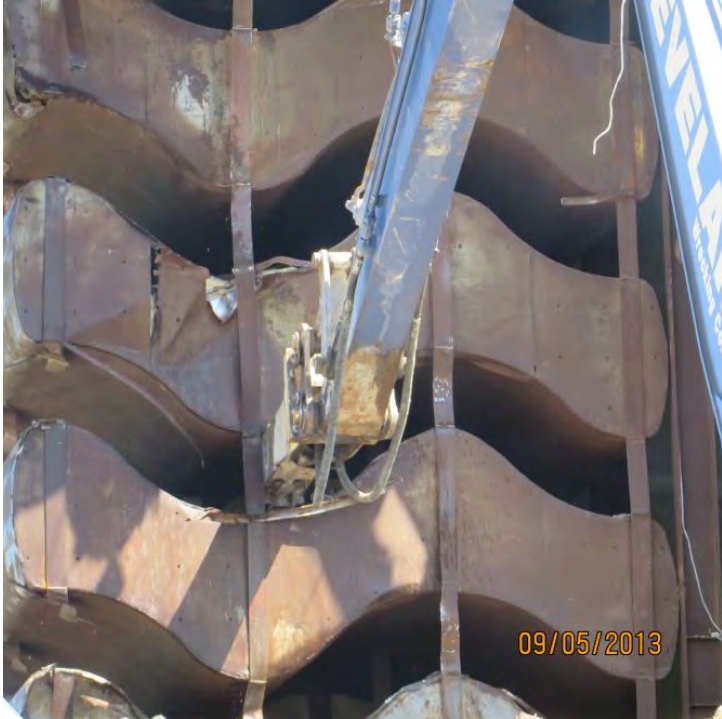
Photograph ID: 9

Photo Location: Tower Structure #4	
Direction: North	
Survey Date: 9/5/2013	
Comments: A close-up view of Tower Structure #4 baffle material.

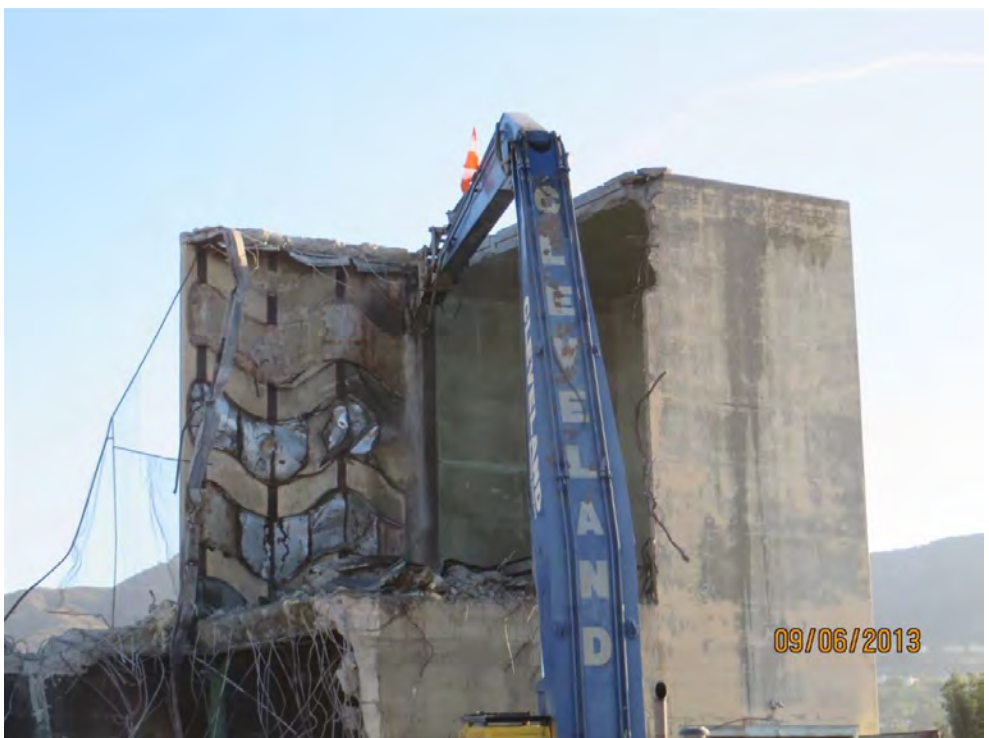
Photo Location: Tower Structure #4	
Direction: North	
Survey Date: 9/6/2013	
Comments: A view of the northern structure wall being broken from the top down in approximately 4 feet by 4 feet sections to an elevation of approximately 20 feet below the top.

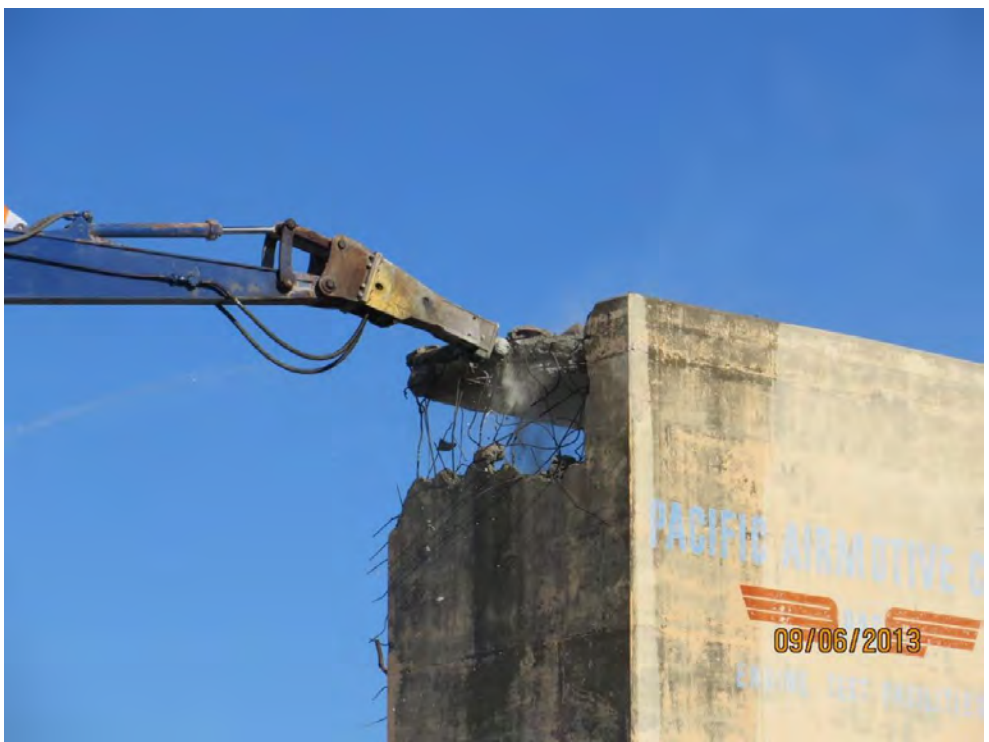
Photograph ID: 4

Photo Location: Tower Structure #4	
Direction: Northwest	
Survey Date: 9/6/2013	
Comments: A view of the long reach excavator breaking out the roof and southern wall of Structure #4, allowing the concrete pieces to fall into the interior structure footprint.

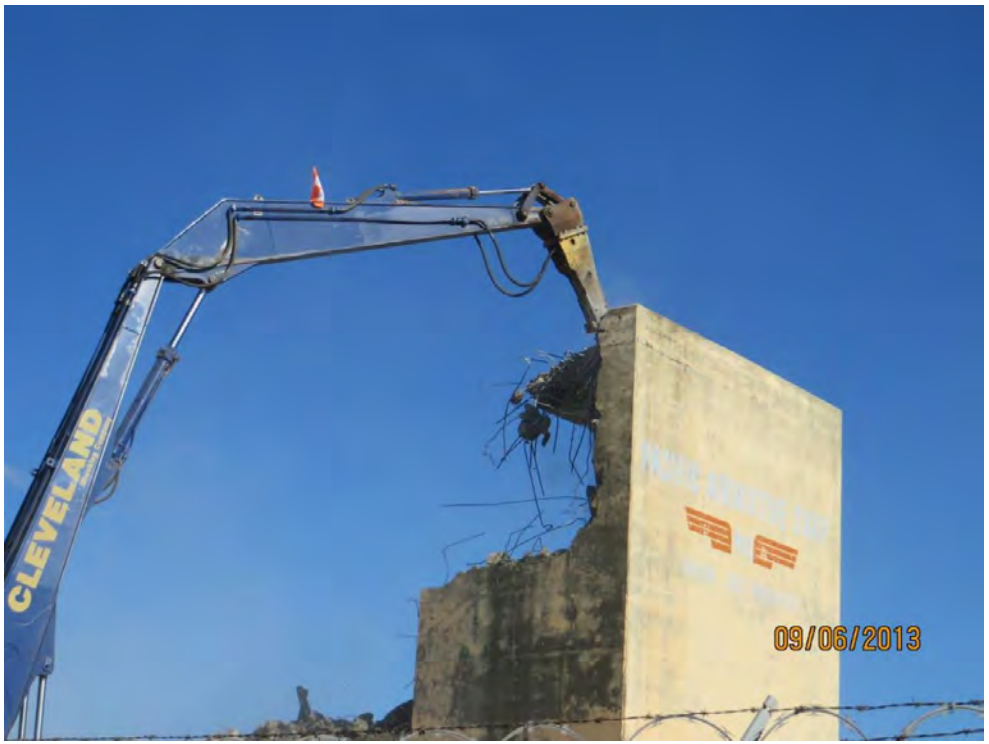
Photo Location: Tower Structure #4	
Direction: North	
Survey Date: 9/6/2013	
Comments: Additional view of the long reach excavator breaking out the roof and southern wall of Structure #4.

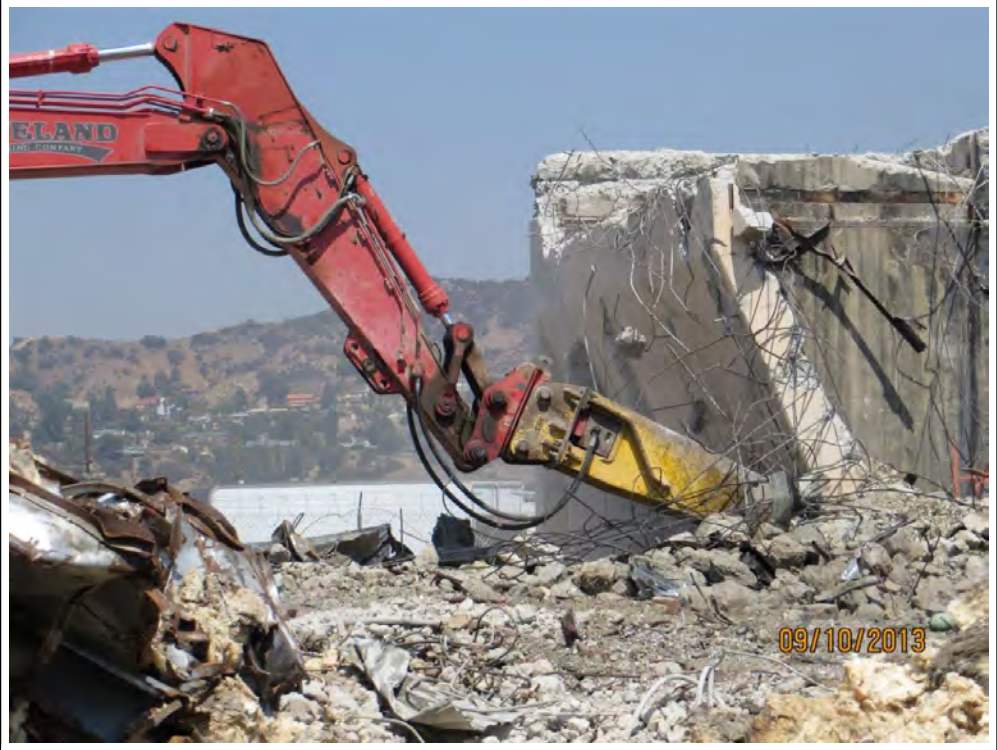
Comments:
A view of Test Cell #5 (western wall) demolition.

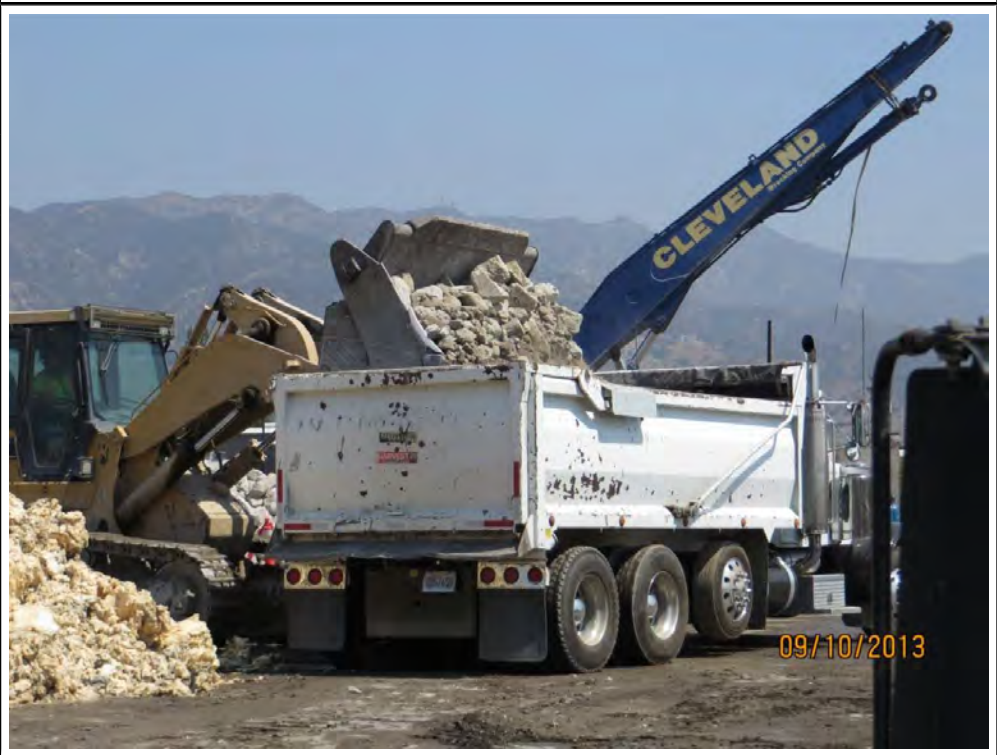
Photograph ID: 6

Comments:
A view of the track loader loading a truck with non-TPH impacted concrete for transportation off-site.

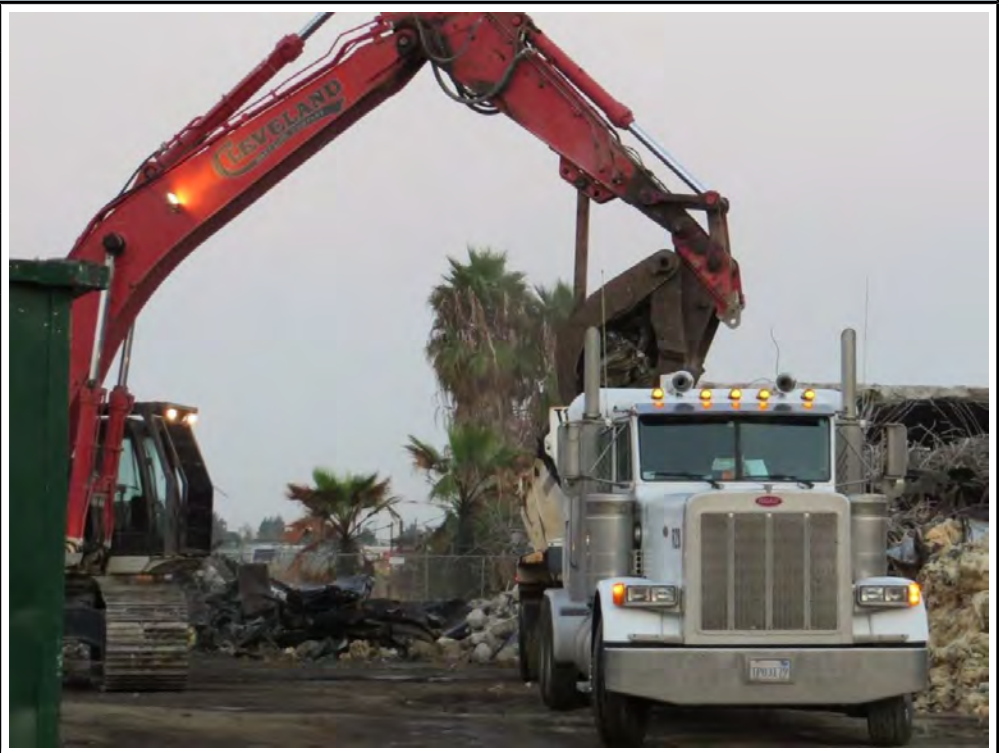
Comments:
A view of the excavator loading a truck with baffle waste (Non RCRA hazardous, lead) for transportation off-site.

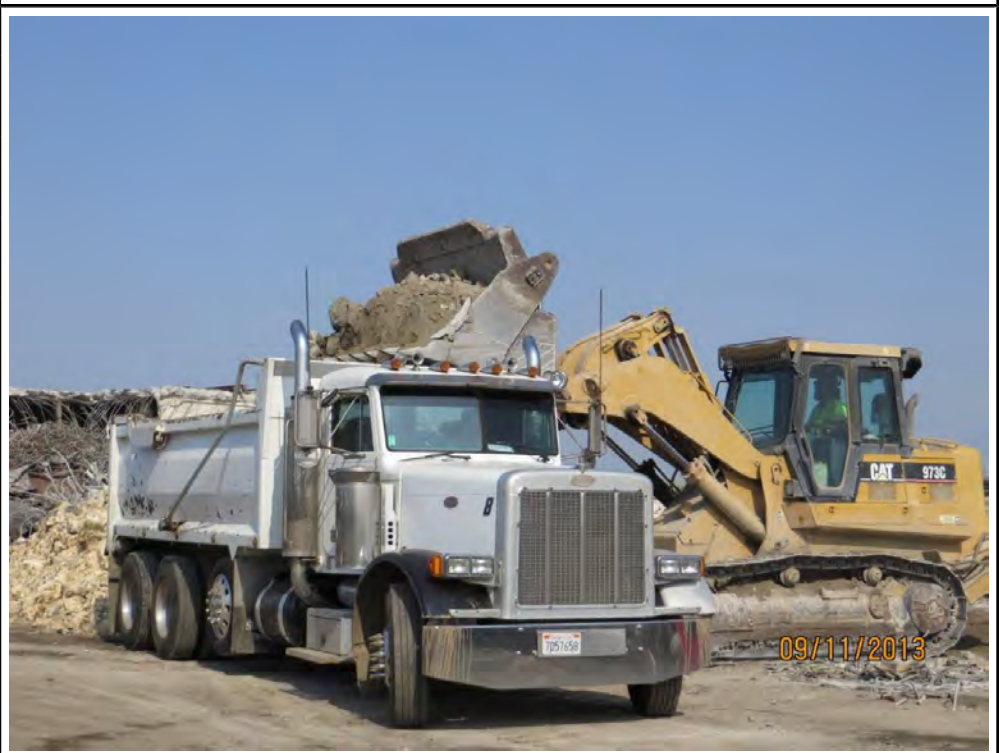
Photograph ID: 2

Comments:
A view of the track loader loading a truck with non-TPH impacted concrete for transportation off-site.

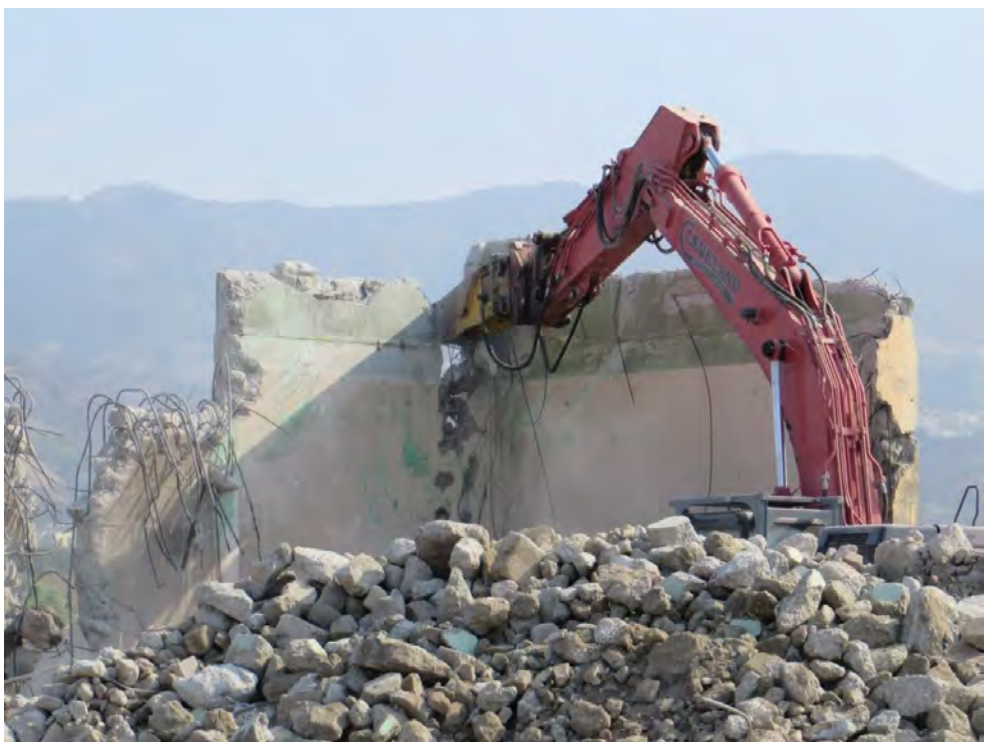
Photograph ID: 4

Photo Location: Test Cell #5	
Direction: North	
Survey Date: 9/11/2013	
Comments: Additional view of Test Cell #5 (northeast corner) demolition.

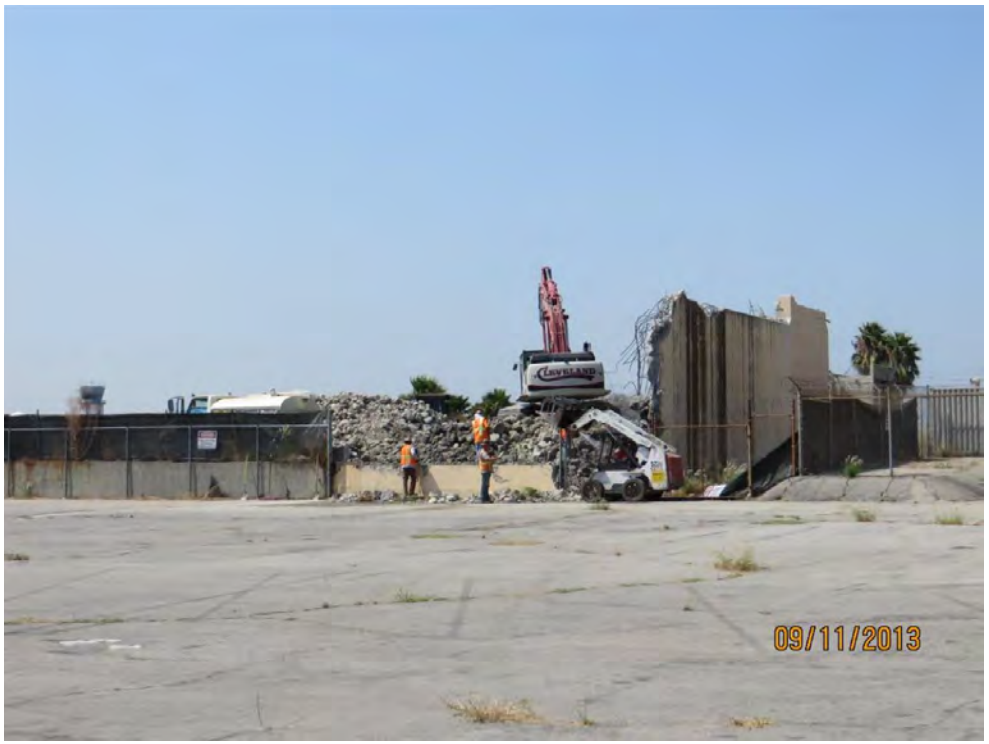
Photograph ID: 5

Photo Location: Eastern Adjacent Parking Lot	
Direction: West	
Survey Date: 9/11/2013	
Comments: A view of Aman crew members cleaning up the eastern adjacent parking lot.

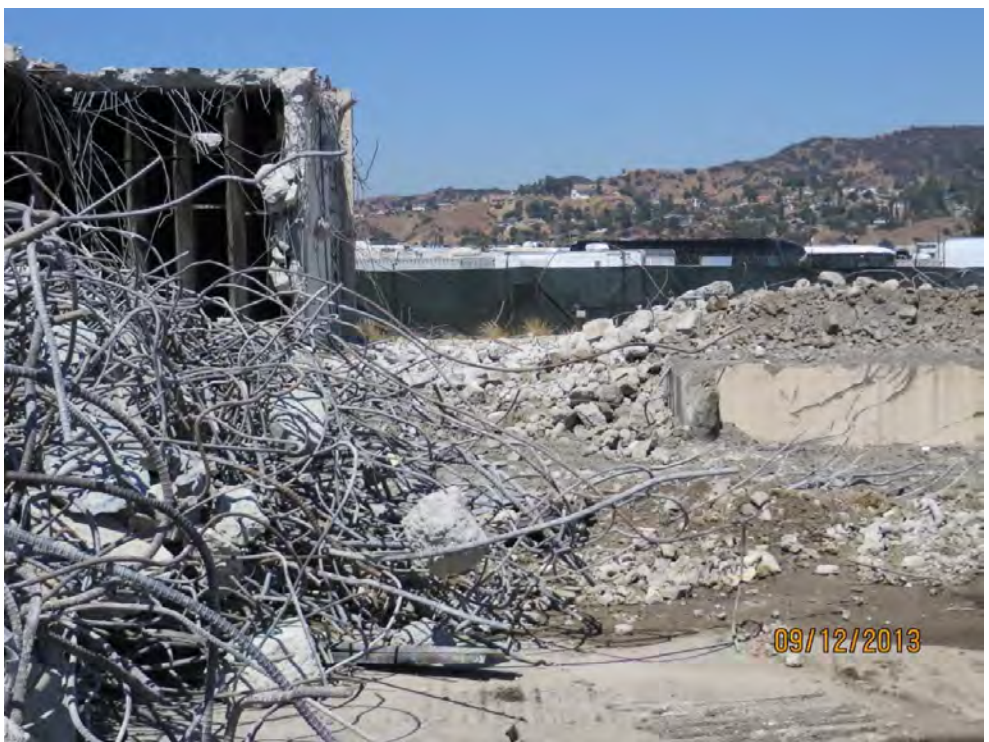
Photo Location: Test Cell #1, Control Room #1 and Test Cell #2	
Direction: North	
Survey Date: 9/12/2013	
Comments: A view of the remaining Test Cell #1 structure (top left) and Test Cell #2 raised concrete foundation (center right), approximately 2 feet above parking area grade.

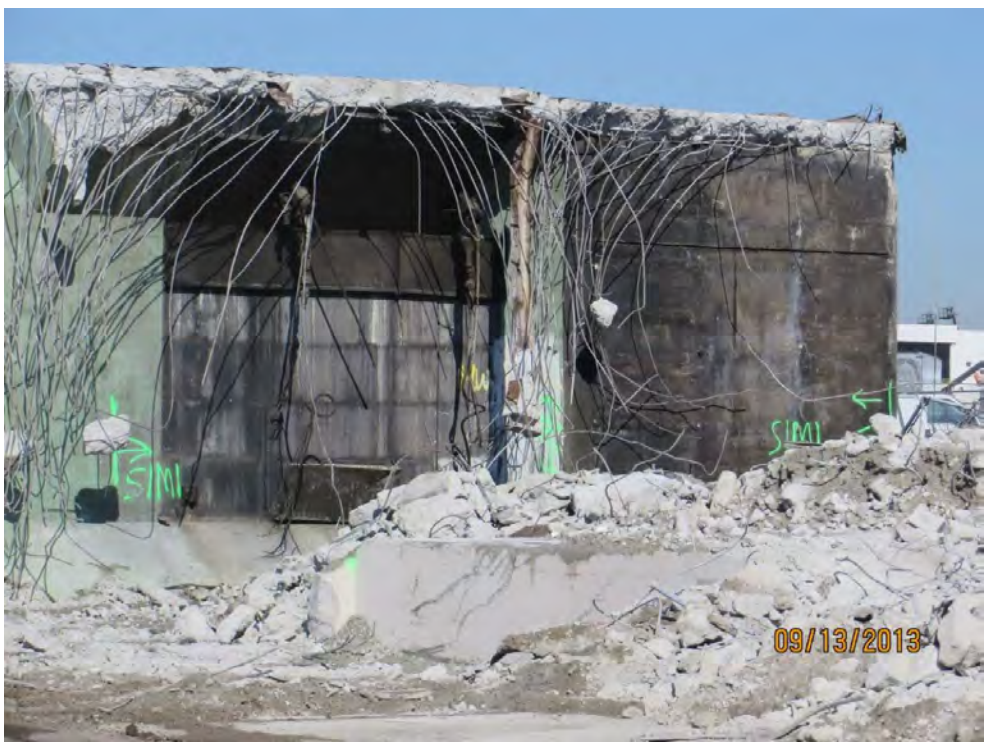
Photograph ID: 2

Photo Location: Test Cell #1	
Direction: West	
Survey Date: 9/13/2013	
Comments: A view of Test Cell #1 western wall marked with spray paint to designate concrete with TPH to be segregated for disposal to Simi Valley landfill.

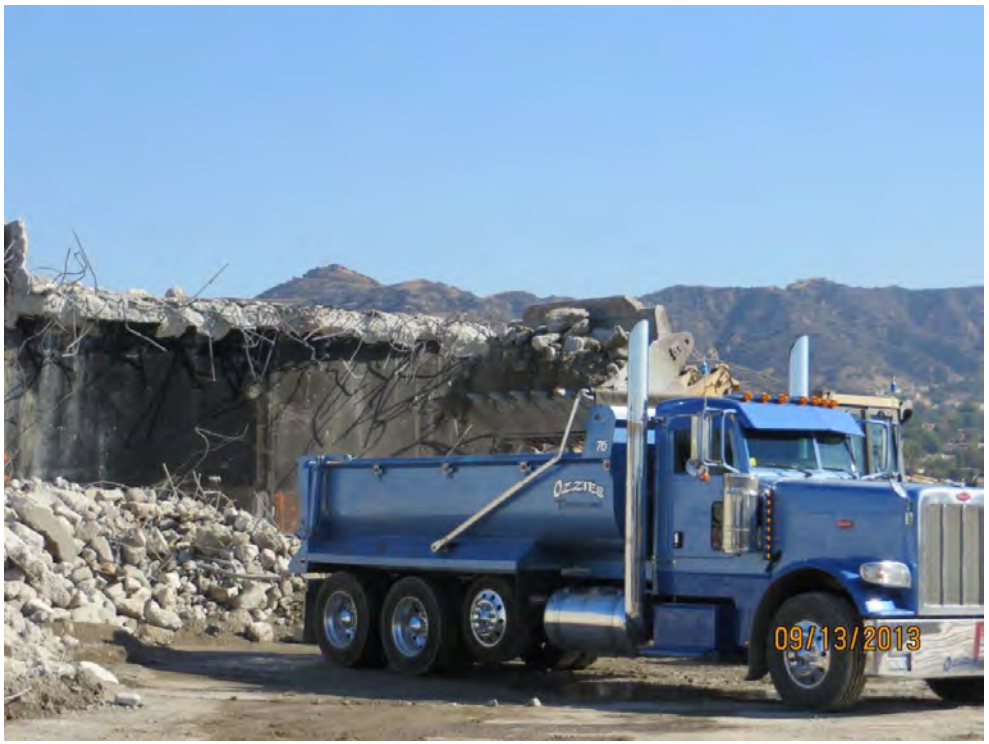
Photograph ID: 5

Photo Location: Parking Area	
Direction: Northeast	
Survey Date: 9/13/2013	
Comments: A view of sorted concrete being loaded for transportation to the recycling facility.

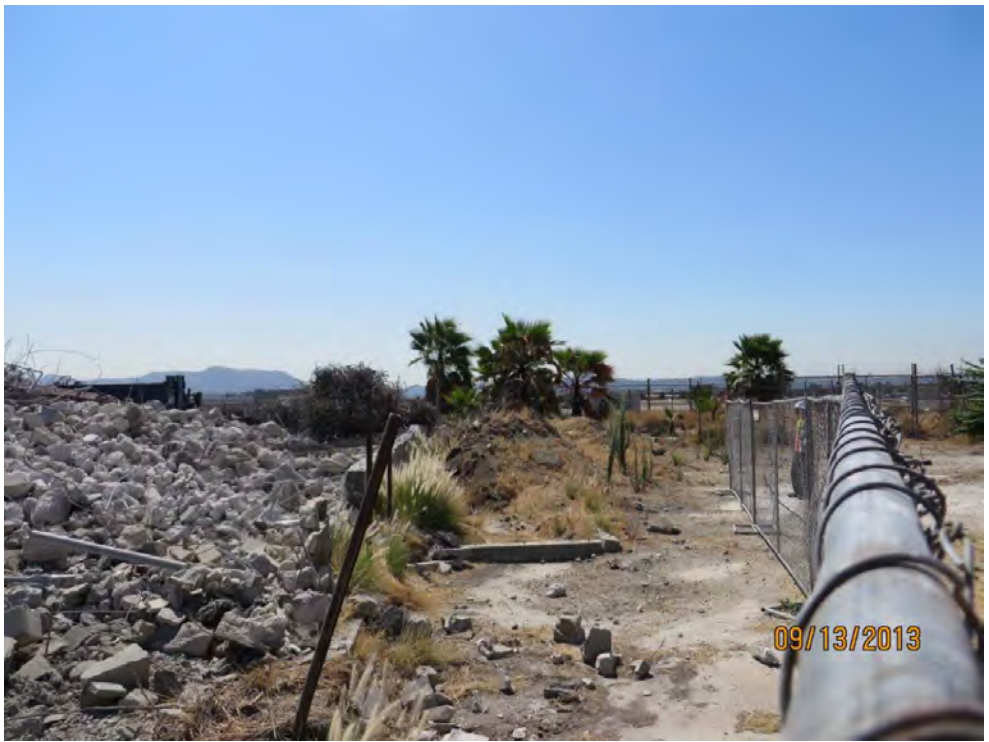
Photograph ID: 7

Photo Location: Western Site Boundary	
Direction: South	
Survey Date: 9/13/2013	
Comments: A view of the western site boundary with temporary fence installed.

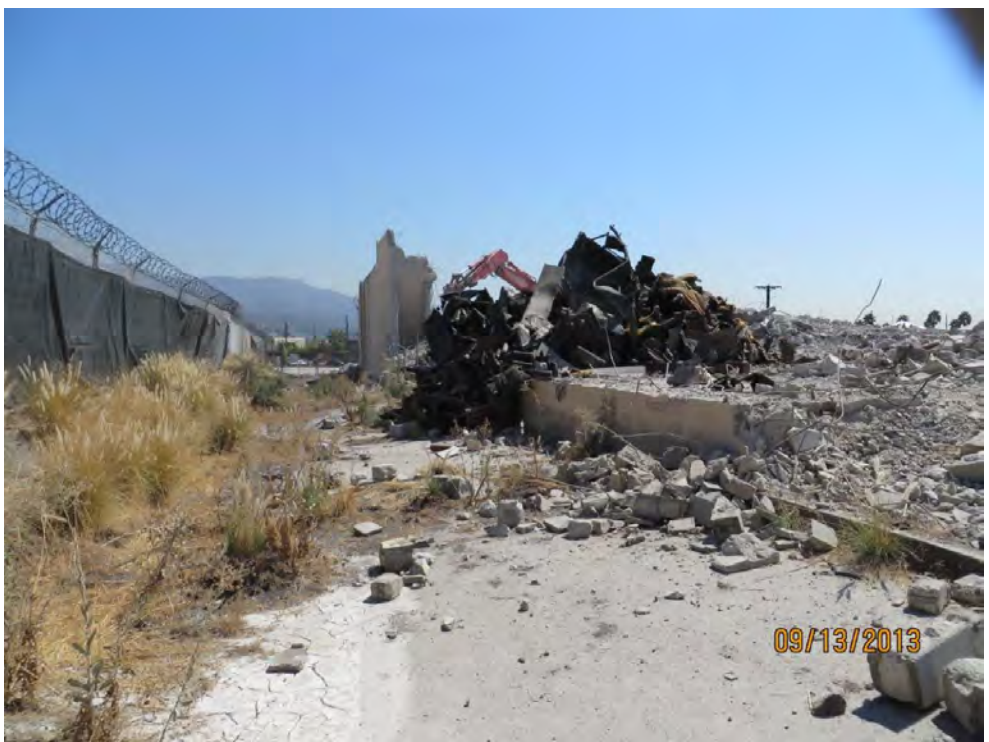
Photograph ID: 8

Photo Location: Northern Site Boundary	
Direction: East	
Survey Date: 9/13/2013	
Comments: A view of the northern site boundary and Test Cell #1 baffle material (center).

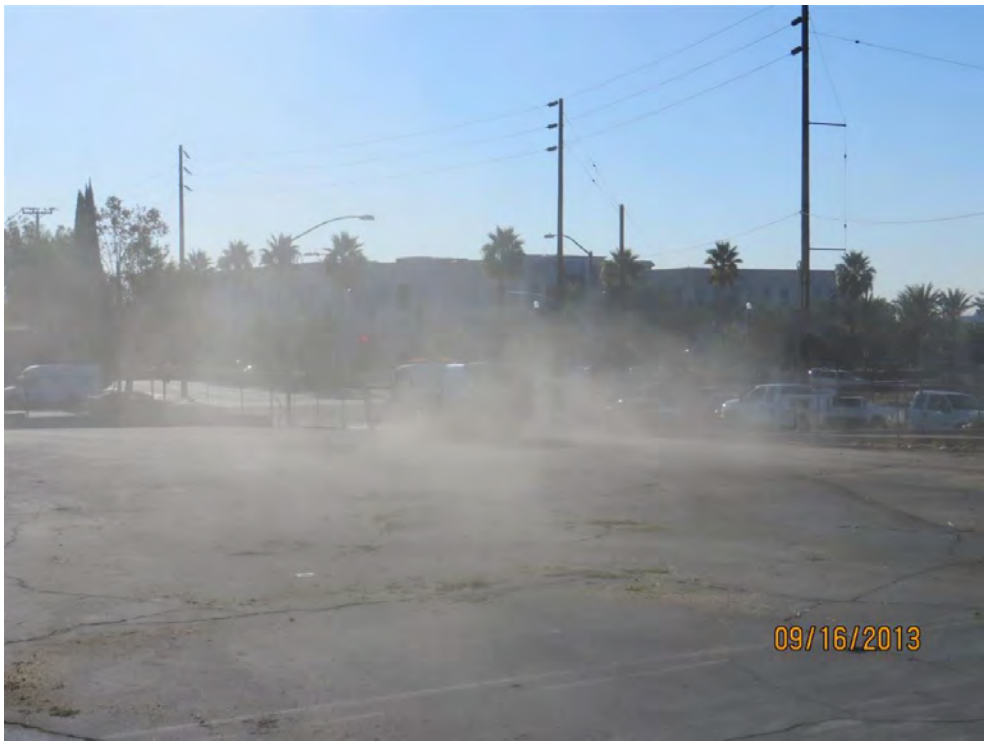
Photograph ID: 1

Photo Location: Eastern Adjacent Parking Lot	
Direction: Southeast	
Survey Date: 9/16/2013	
Comments: A view of dust created by a sweeper cleaning the eastern adjacent parking area after Burbank Airport crew completed weed abatement activities.

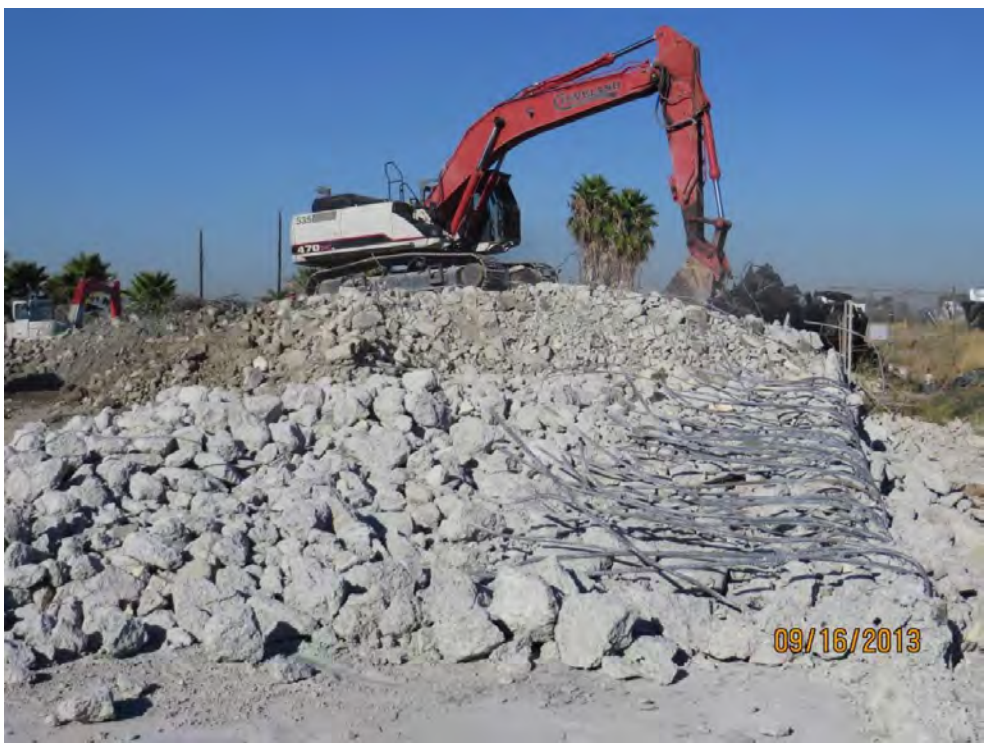
Photograph ID: 2

Photo Location: Test Cell #5	
Direction: West	
Survey Date: 9/16/2013	
Comments: A view of the segregated TPH impacted concrete located along the northern property boundary.

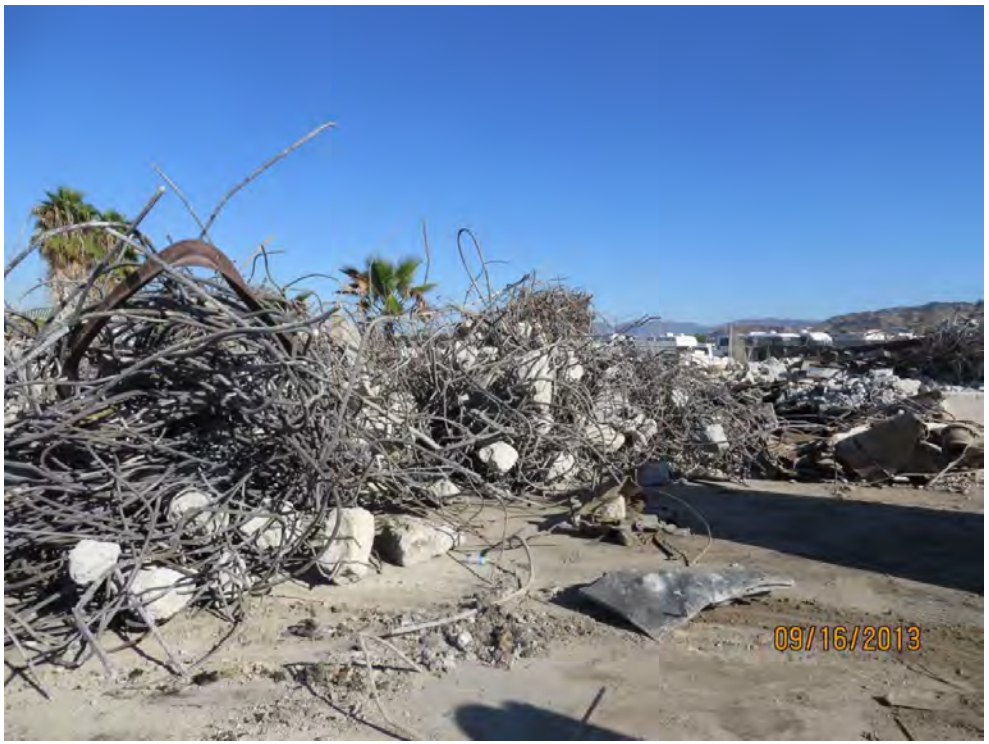
Photograph ID: 3

Photo Location: Southern Parking Area	
Direction: North	
Survey Date: 9/16/2013	
Comments: A view of rebar with concrete stockpile staged for further processing.

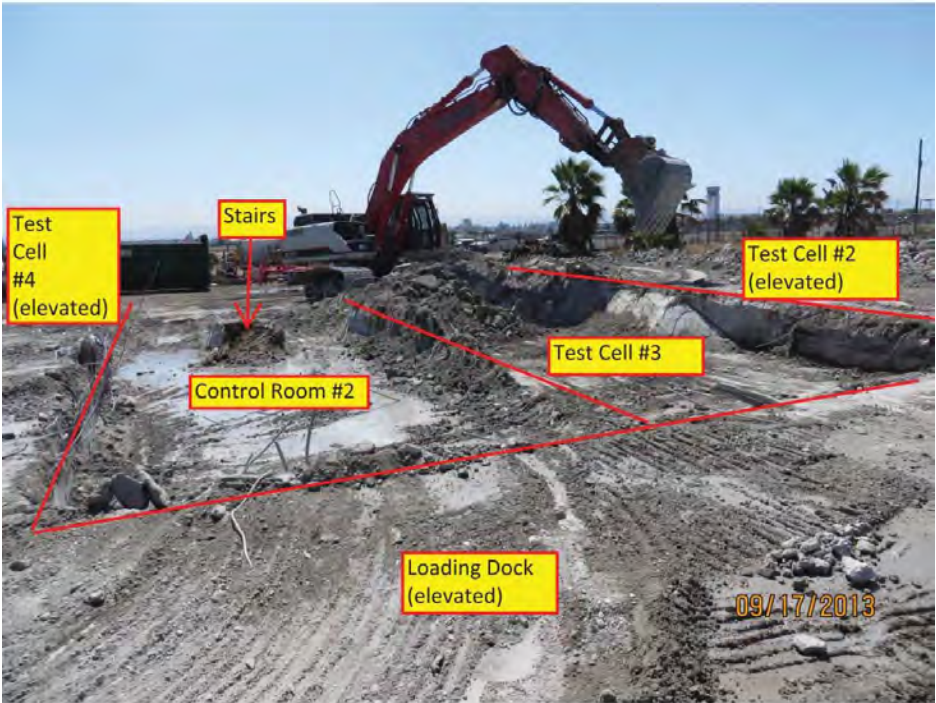
Photograph ID: 8

Photo Location: Test Cell #3 and Control Room #2	
Direction: South	
Survey Date: 9/18/2013	
Comments: A view of the elevated concrete slabs with identification labels.

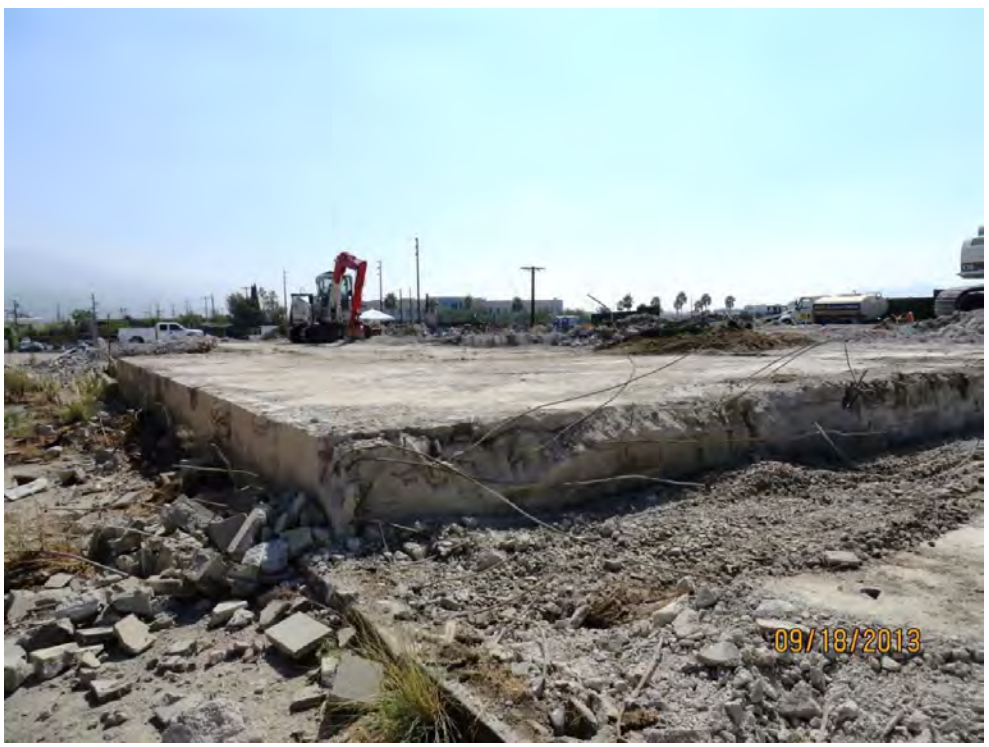
Photograph ID: 4

Photo Location: Loading Dock	
Direction: Southeast	
Survey Date: 9/18/2013	
Comments: A view of the elevated Loading Dock concrete slab estimated to be less 1 foot in thickness.

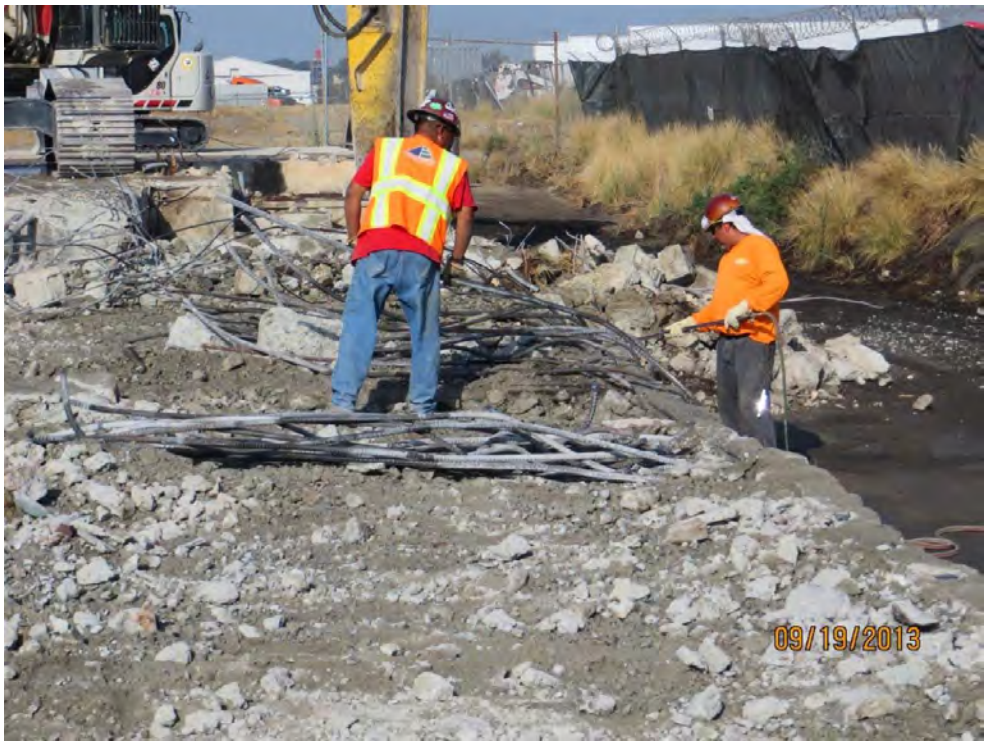
Photograph ID: 7

Photo Location: Test Cell #5	
Direction: West	
Survey Date: 9/19/2013	
Comments: A view of Aman crew members torch cutting rebar from remaining Test Cell #5 northern wall. Aman thoroughly saturated the surrounding work area before beginning hot work and a manned, charged water hose was staged directly adjacent to the work area.

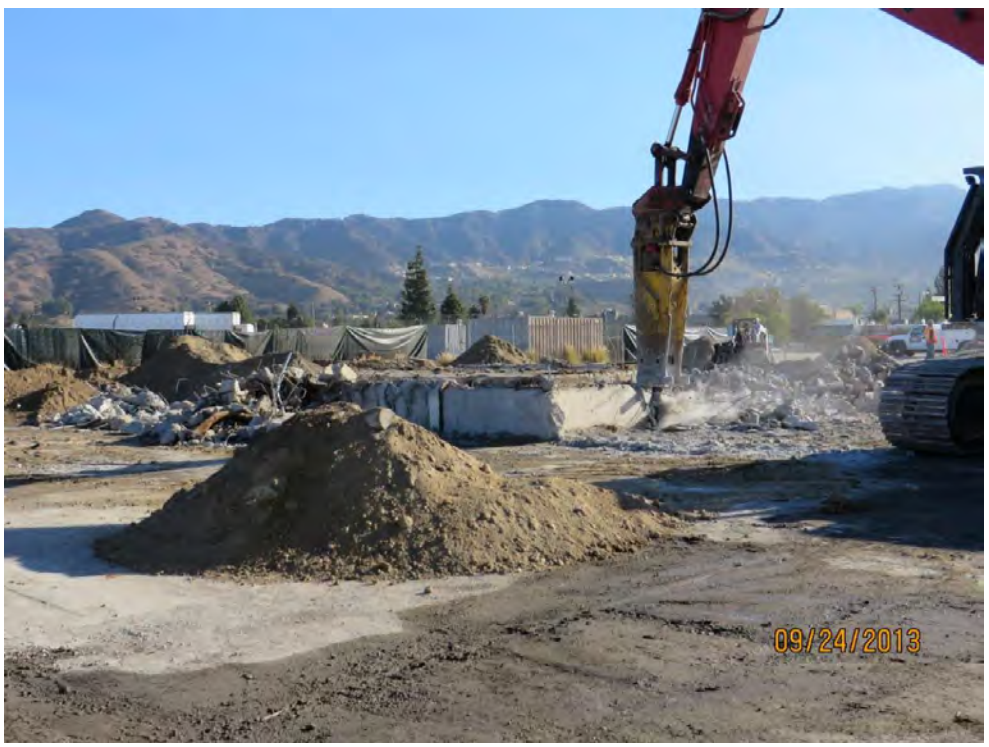
Photograph ID: 2

Photo Location: Test Cell #2	
Direction: Northeast	
Survey Date: 9/24/2013	
Comments: A view of the segregated soil stockpile (left) and demolition of Test Cell #2 elevated concrete slab (center).

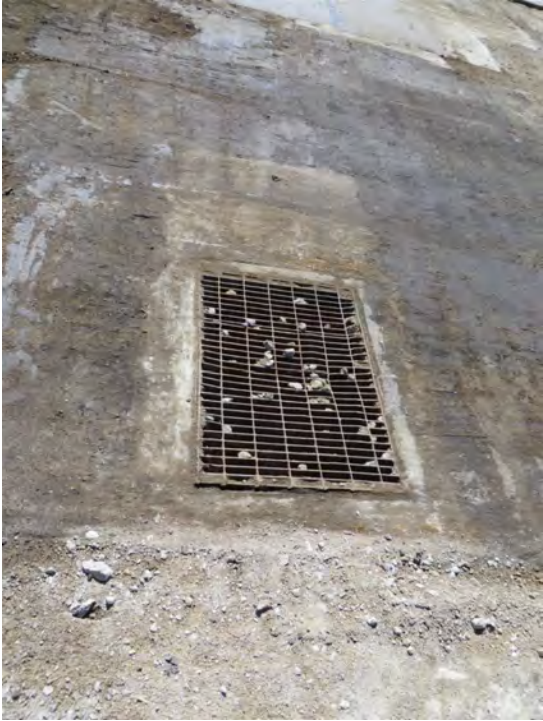
Photograph ID: 5

Photo Location: Former Elevated Loading Dock	
Direction: South	
Survey Date: 9/25/2013	
Comments: A view of a drain (approx. 2' x 3') located within the former Elevated Loading Dock area.

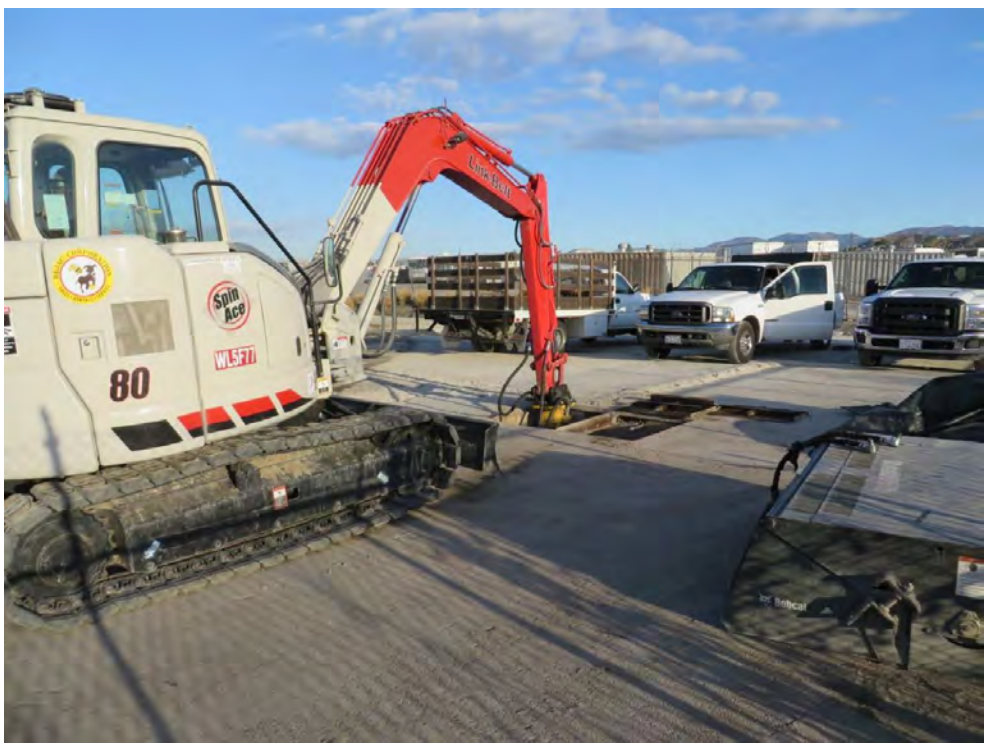
Photograph ID: 2

Photo Location: Parking Area	
Direction: Northwest	
Survey Date: 9/26/2013	
Comments: A view of the excavator breaking the electrical vault concrete bottom before backfilling with clean soil.

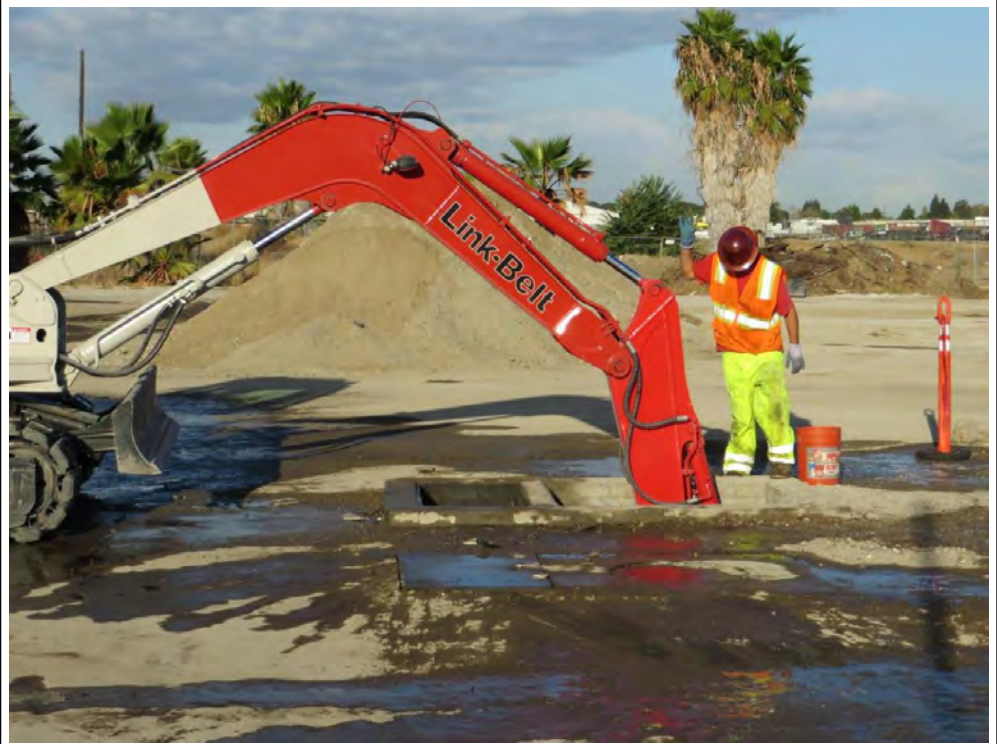
Comments:
A view of the excavator breaking the clarifier concrete bottom before backfilling with clean soil.
