Client:	GE Corporate Environmental Programs	Project:	Site Demolition Activities
Site Name:	Former Pacific Airmotive Facility	Site Location:	3003 N Hollywood Way, Burbank, California

Client:	GE Corporate Environmental Programs	Project:	Demolition Activities
Site Name:	Former Pacific Airmotive Facility	Site Location:	3003 N Hollywood Way, Burbank, California

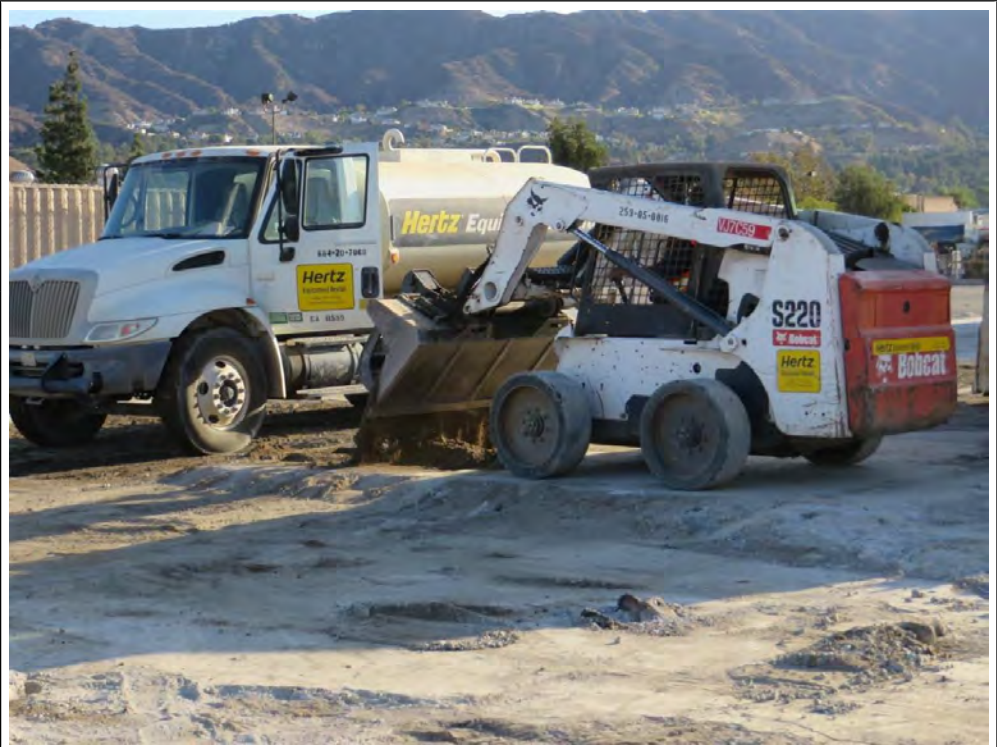
Photograph ID: 4

Comments:
A view of the skid-steer loader backfilling the sumps with clean soil.

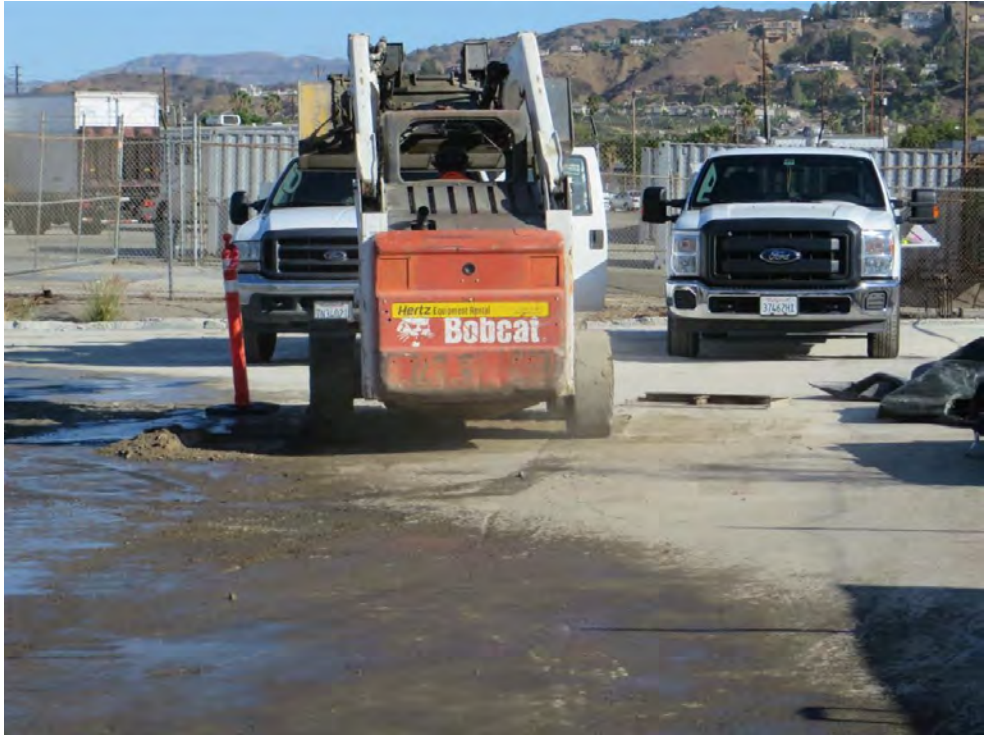
Photo Location: Parking Area	
Direction: North	
Survey Date: 9/26/2013	
Comments: A view of the skid-steer loader compacting the soil in the electrical vault.

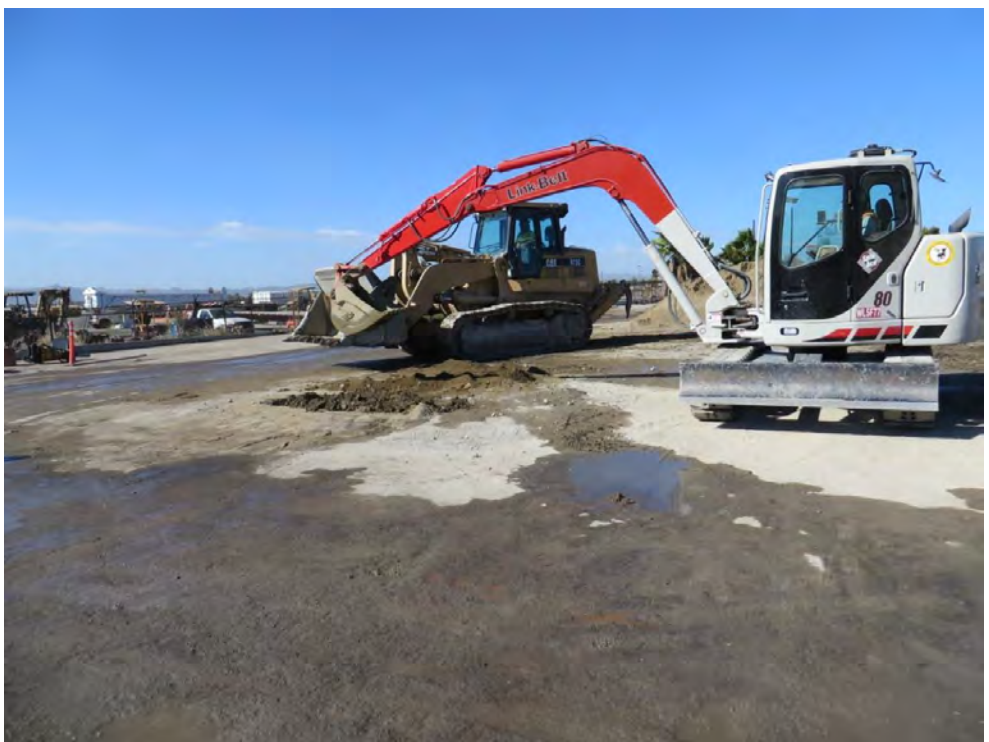
Photograph ID: 10

Photo Location: Parking Area	
Direction: Southwest	
Survey Date: 9/26/2013	
Comments: A view of the excavator compacting the soil in the clarifiers.

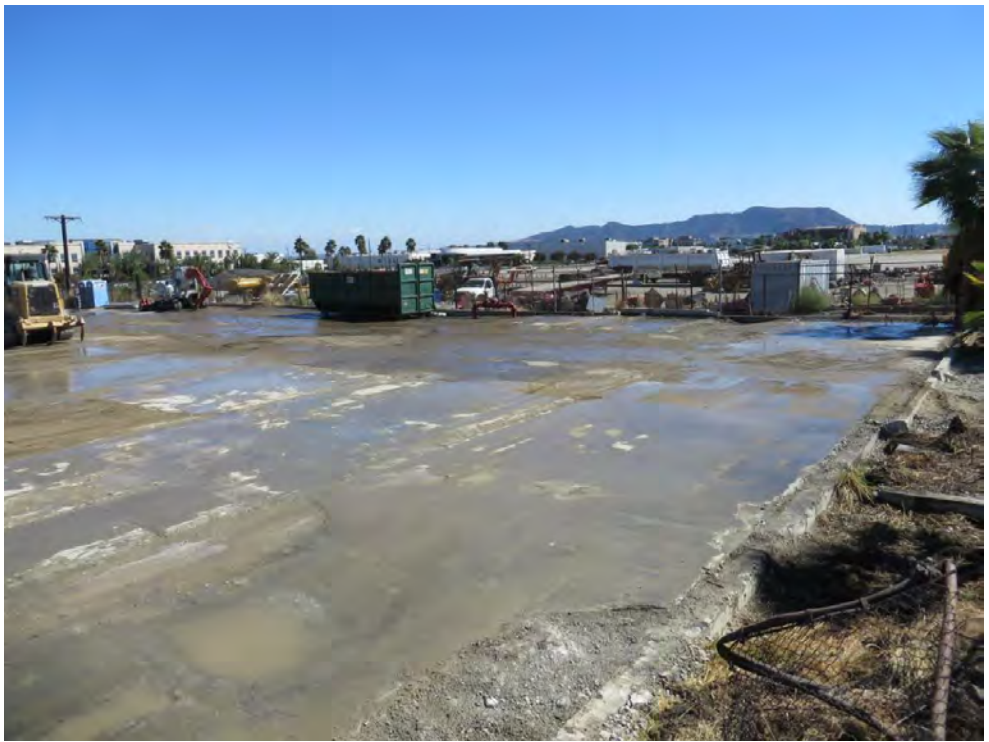
Photograph ID: 13

Photo Location: Western Boundary	
Direction: Southeast	
Survey Date: 9/26/2013	
Comments: A view of the southwestern corner of the site after surface clean-up activities.

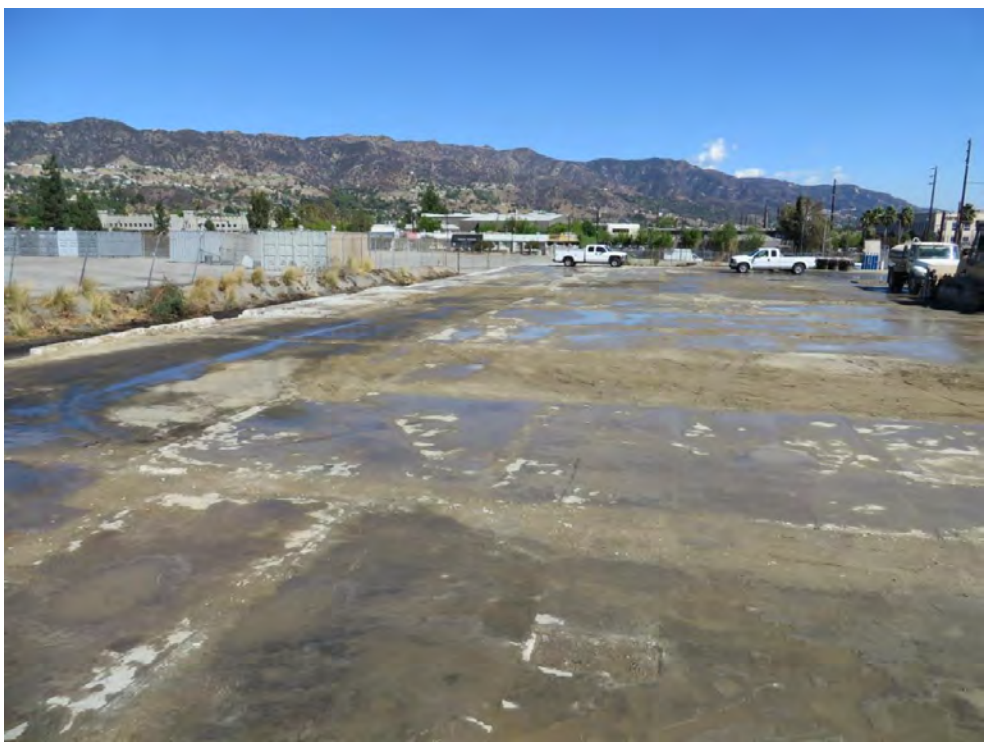
Photograph ID: 14

Photo Location: Northern Boundary	
Direction: East	
Survey Date: 9/26/2013	
Comments: A view of the northern half of the site after surface clean-up activities.

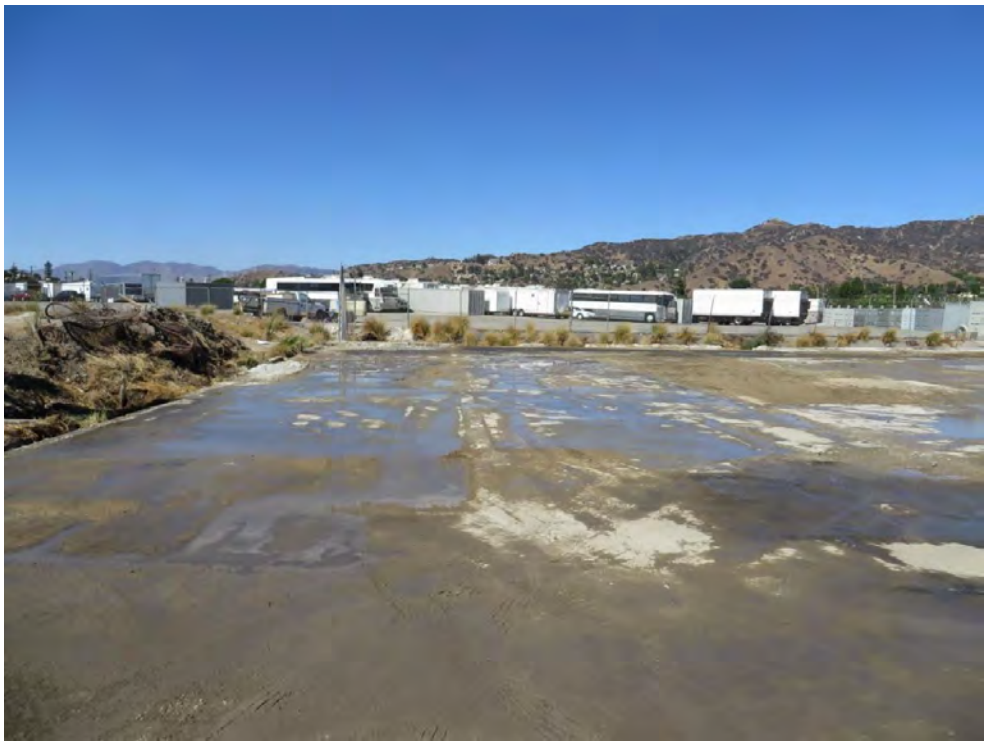
Photograph ID: 17

Photo Location: Western Boundary	
Direction: North	
Survey Date: 9/26/2013	
Comments: A view of the western half of the site after surface clean-up activities.
