VIEW STUDY FOR HILLSIDE PROJECT (3537 VIEWCREST DRIVE)

Existing Conditions and Objective:

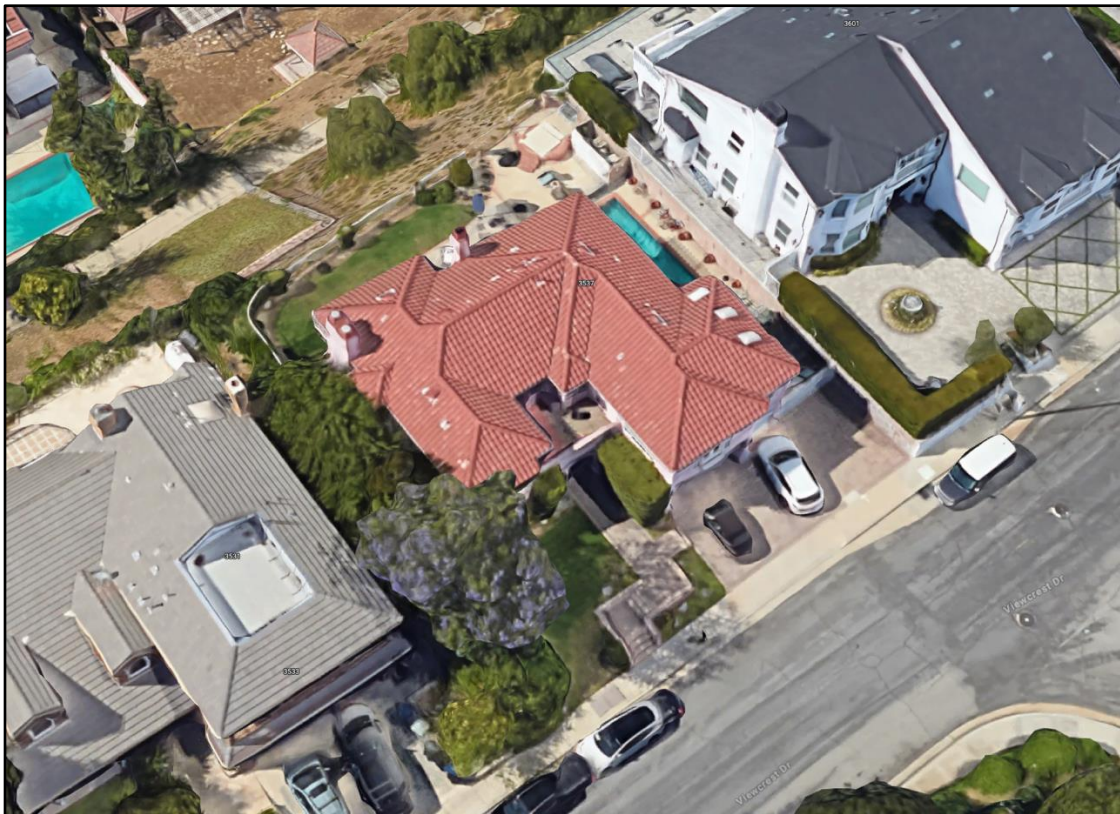
Figure 1: An aerial view of the subject property, 3537 Viewcrest Drive.

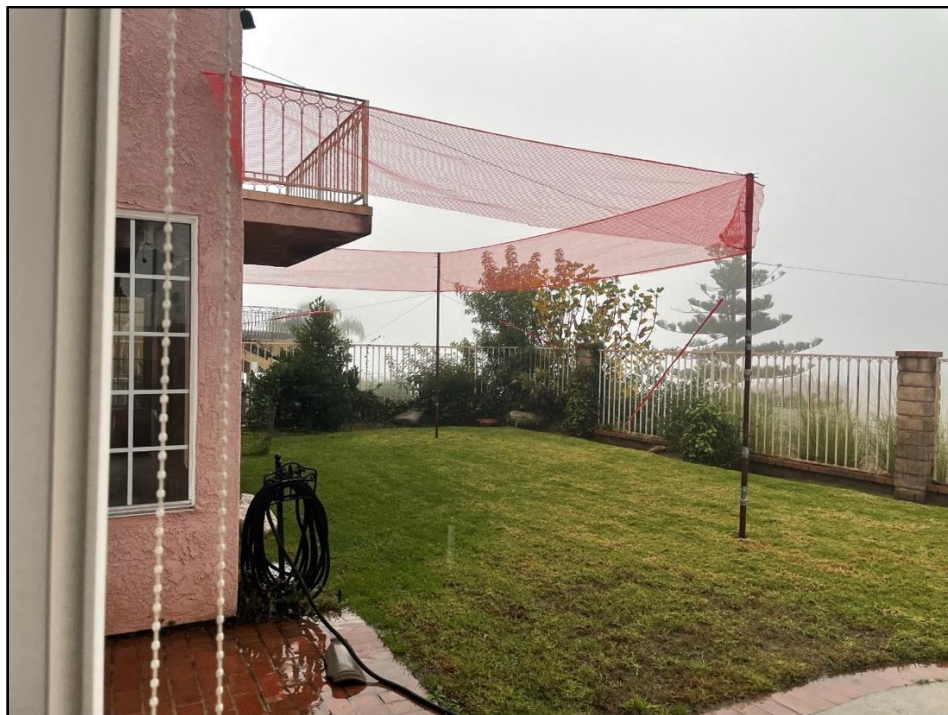
Figure 3: The photo above, taken during a site visit on December 21, 2023, shows the outline of the proposed attached trellis structure.

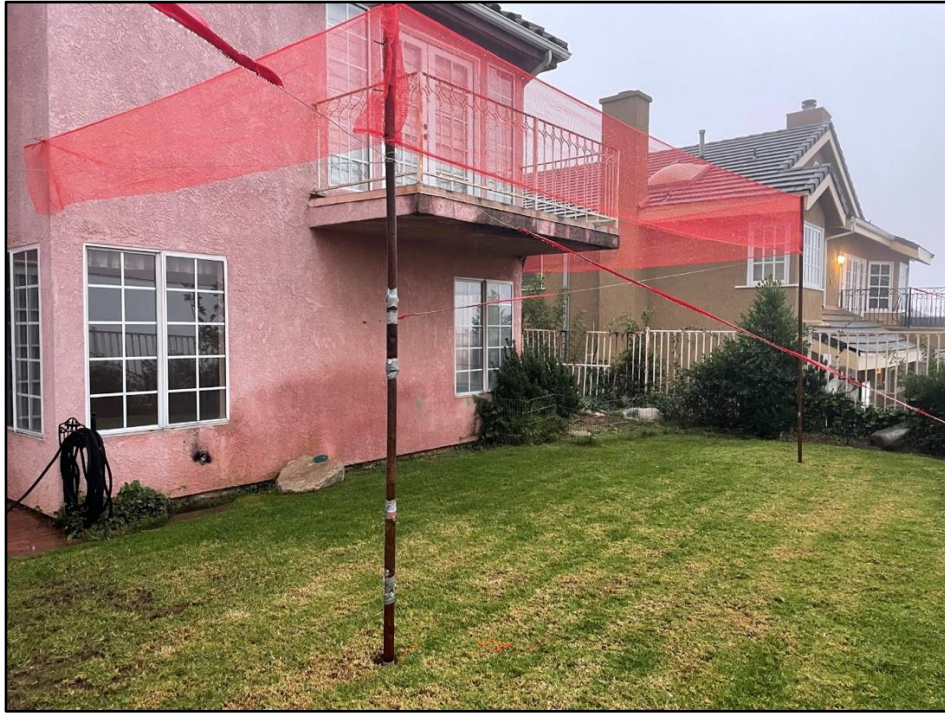
Figure 4: The photo above, taken during a site visit on December 21, 2023, shows the outline of the proposed attached trellis structure and the adjacent property (3531 Viewcrest Drive).

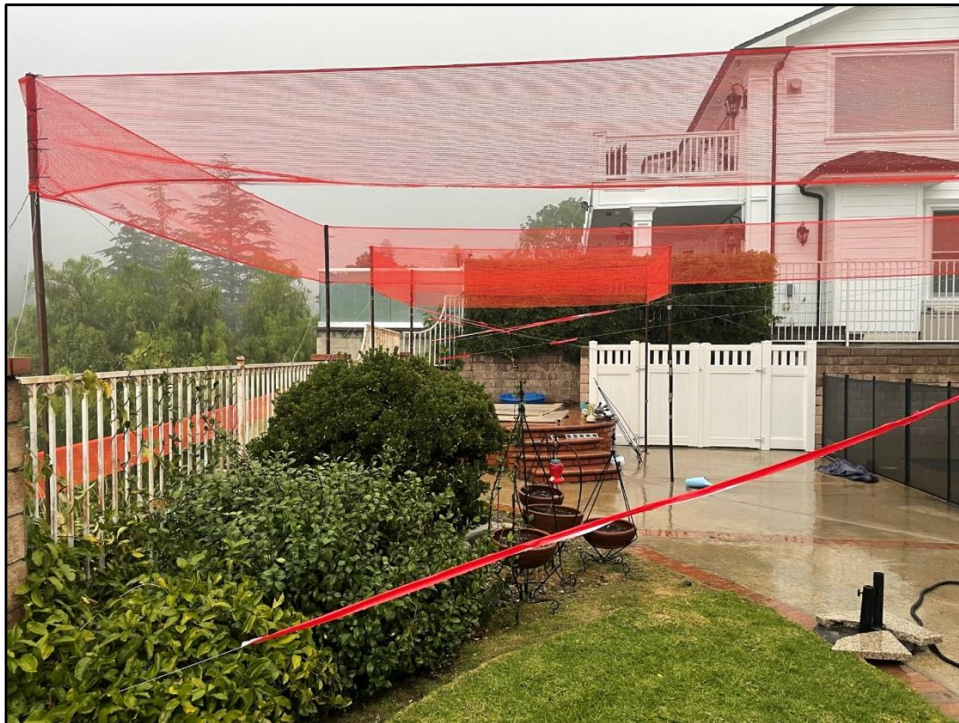
Figure 5: The photo above, taken during a site visit on December 21, 2023, shows the outline of the proposed detached trellis structure and outdoor BBQ kitchen and the adjacent property (3601 Viewcrest Drive).

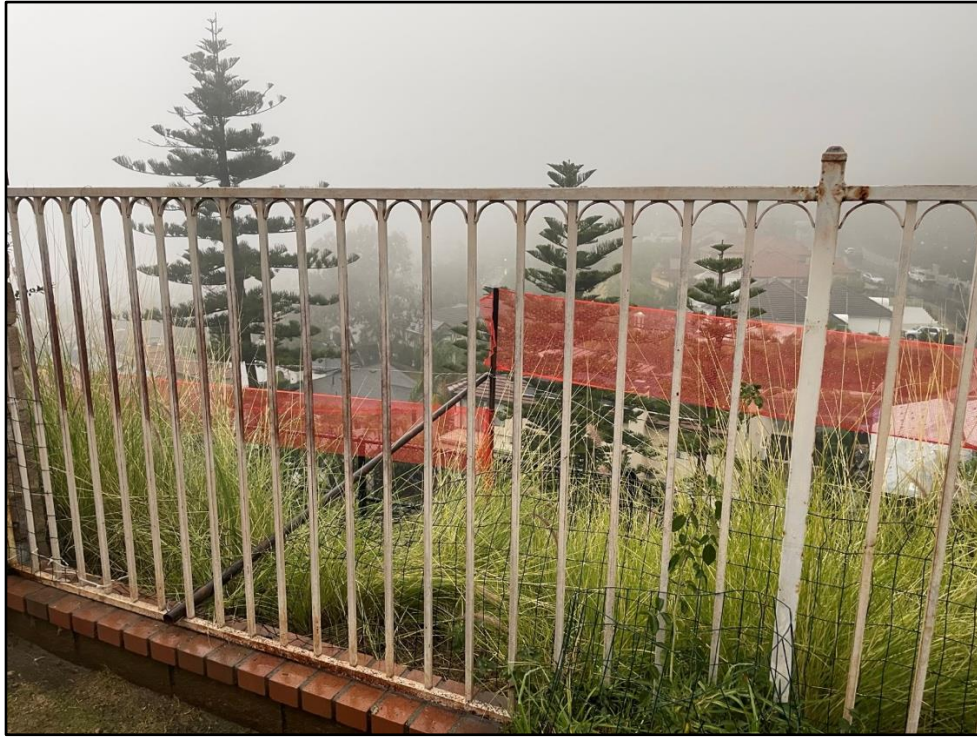
Figure 6: The photo above, taken during a site visit on December 21, 2023, shows the outline of the top of the proposed glass railing that would be above the proposed rear retaining wall.

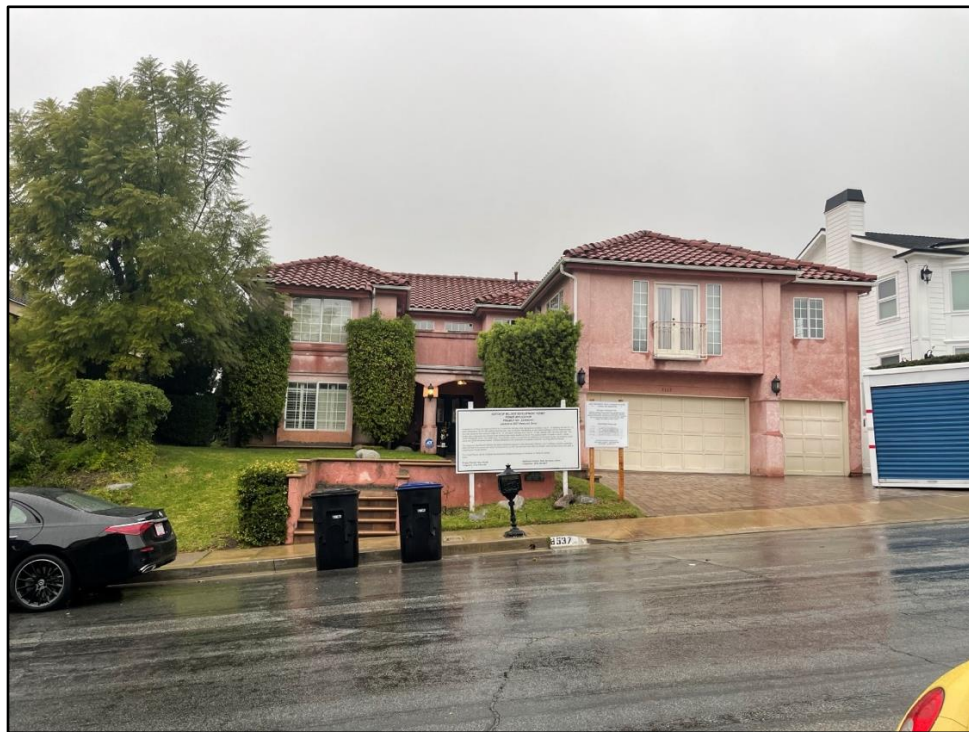
Figure 7: The photo above, taken during a site visit on December 21, 2023, shows the front of the subject property with the public noticing sign posted.

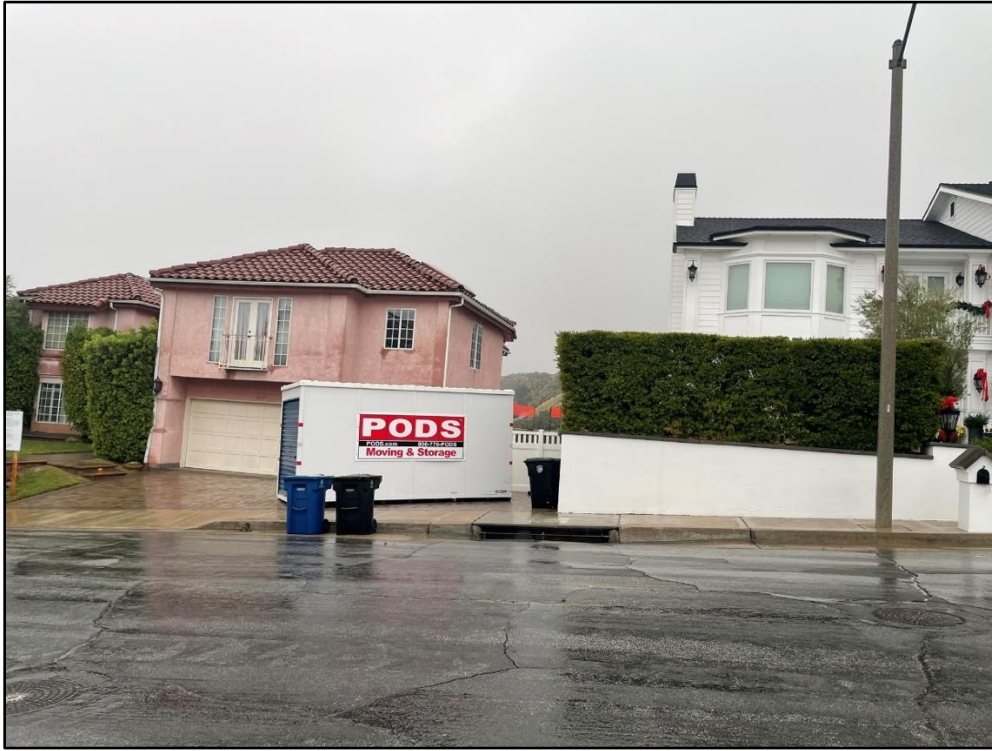
Figure 8: The photo above, taken during a site visit on December 21, 2023, shows the outline of the proposed structures as seen from the east side of the front of the subject property.

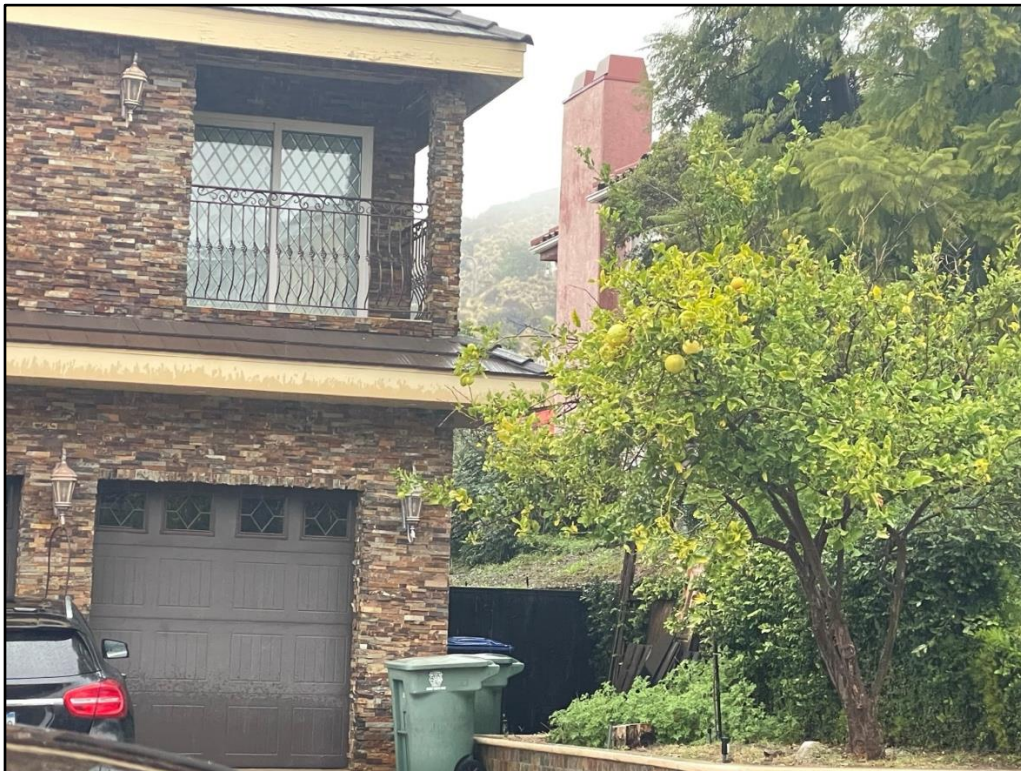
Figure 9: The photo above, taken during a site visit on December 21, 2023, shows the outline of the proposed structures as seen from the west side of the front of the subject property.

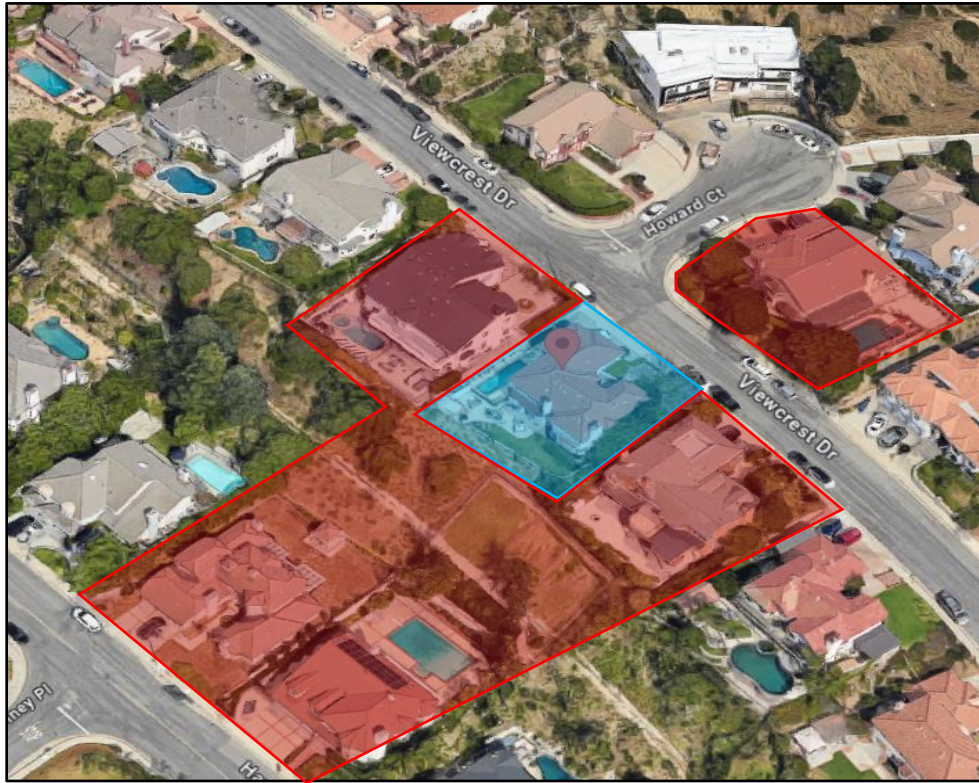
As part of City staff's analysis on December 21, 2023, property owners of neighboring properties located within the immediate vicinity of the project site (shown on Figure 10) were contacted by mail and informed of the proposed project, as well as of their opportunity to participate in the City's preparation of a view study. Staff did not receive any comments from surrounding neighbors regarding this project.

Figure 10: Identified in blue is the subject property. Identified in red are the neighboring properties that were contacted as part of the City's Story Pole and View Assessment (the View Study).
